Dunkellin River and Aggard Stream Flood Relief Scheme

Architectural heritage and conservation report on completed works at Dunkellin and Craughwell bridges which are protected structures. Final Report March 2022

March 2022

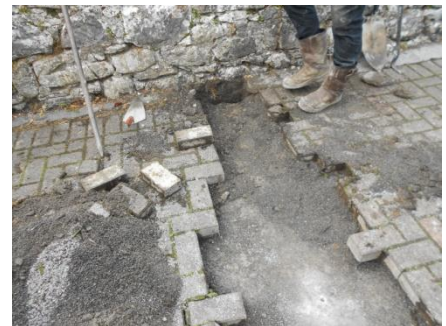
Photograph taken on 22 aug 2018 during exploratory works to establish construction below existing paving. Limited opening up is often necessary as part of research to allow informed decisions to be made about future works

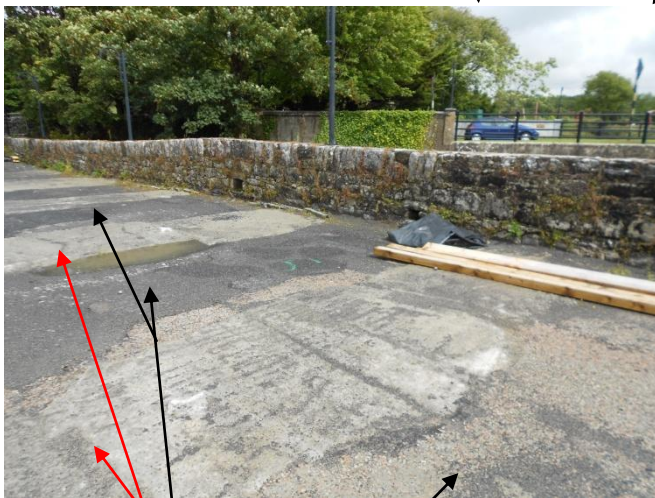
Skim layer of concrete over cobbles over arched vaults and mass concrete over the abutments

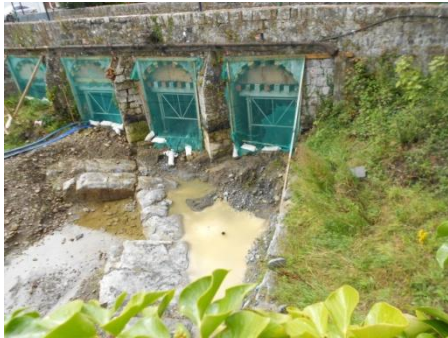
27 Aug 19. Note positioning of large boulders in river bed as part of OPW strategy for water management

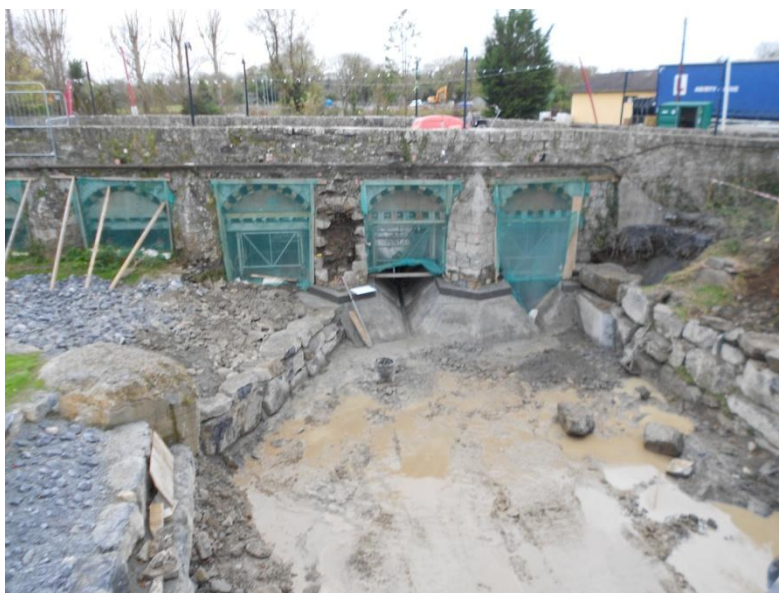
30 October 2019 general and close-up view of cutwater D/E following dismantling.

Consolidation of the cutwaters involved complete dismantling and rebuilding of the cutwater between arches D and E where a large sycamore was growing, and limited resetting of stones and some replacement of damaged or missing stones in the cutwater between E and F. Both cutwaters were re-pointed following rebuilding/repair. The work was done in October / November 2019, which was late in the year so an NHL5 mix was specified. The available setting time for the mortar was also curtailed by the imminent date for the reintroduction of the diverted river water.

Stones were numbered prior to dismantling and re-erected in their original positions. Some stones had suffered damage with pieces spalled off and arrises no longer sharp but flaws were accepted and new stone was not introduced. During rebuilding of cutwater D/E the core of the cutwater was filled with a concrete mix as work progressed. This was accepted due to the difficult conditions and time constraints on the job, and because, due to the hard nature of the limestone, the use of cement should not be detrimental to the stonework.

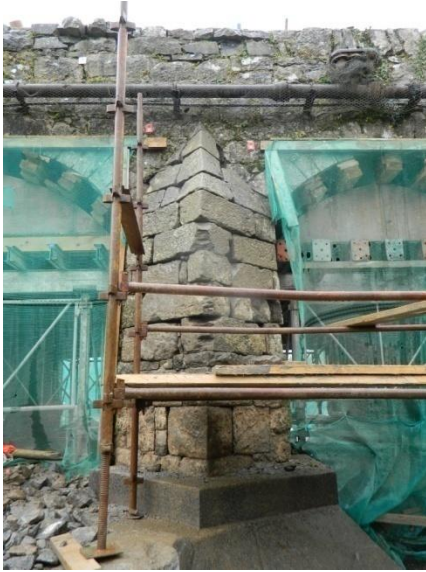
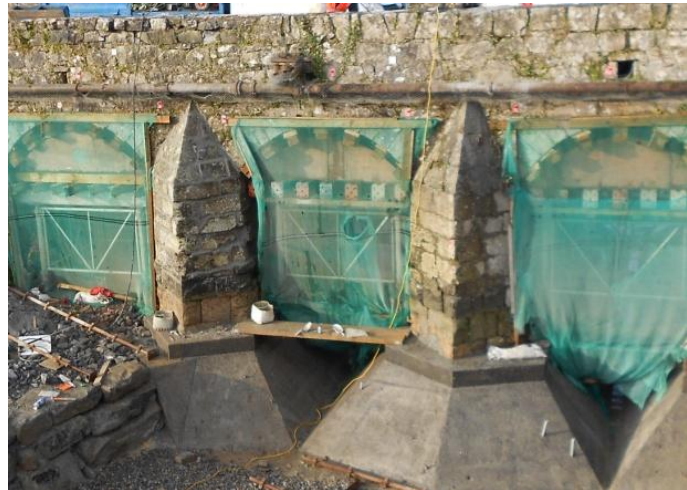
Cutwaters on 7 Nov 2019. Pointing D/E is done but not yet finished/beaten back.

Repaired cutwater D/E on 6 Nov 2019 prior to pointing. Lower stones have lost their sharp corners

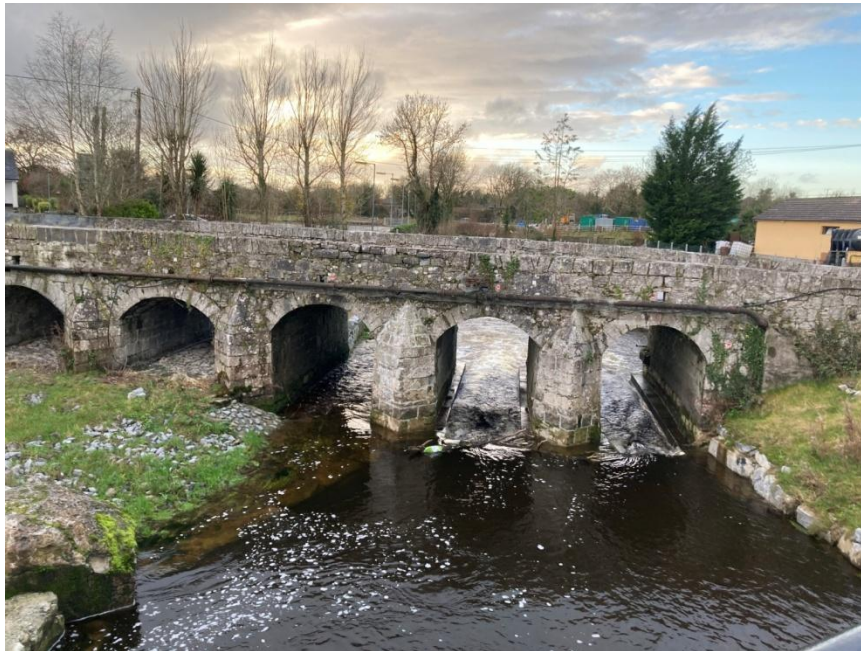
Work on completion – finish of the pointing in the joints is not satisfactory but natural weathering process is expected to improve the appearance. Time constraints in Nov 2019 did not allow revisiting of the work to improve the finish.

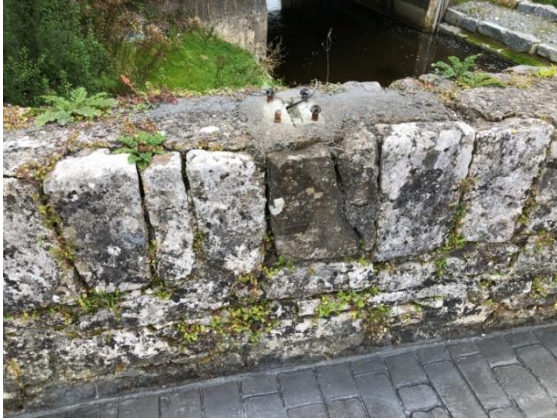
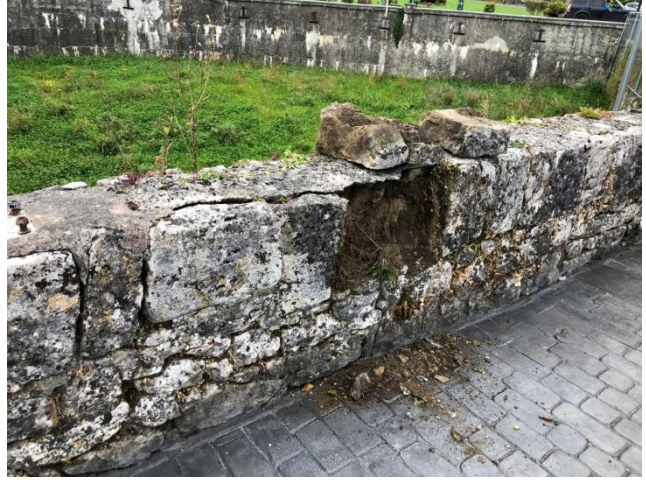
14 Sept 2020. Damaged stone and redundant light fixing. Tapping of wall to test for soundness revealed several loose stones

Repair of the parapet walls was due to be completed before the end of 2019 but due to various delays the work did not take place until 2020. Repairs were relatively minor in nature, consisting of localised resetting of loose stones, re-pointing, and repairs to the capping. The parapet walls had obviously been extensively repaired over the years with varying amounts of skill. It is the nature of bridge parapet walls that they are at high risk of mechanical damage due to vehicle impact. No alteration was made to the height of the parapet walls.

Budget did not allow general correction of previous ‘mistakes’ such as stones laid incorrectly or local concrete repairs, but where stones were loose they were rebbed in correct alignment where possible. An NHL3.5 lime/sand mix was used for repair and an NHL5 mix was used for the mortar capping.

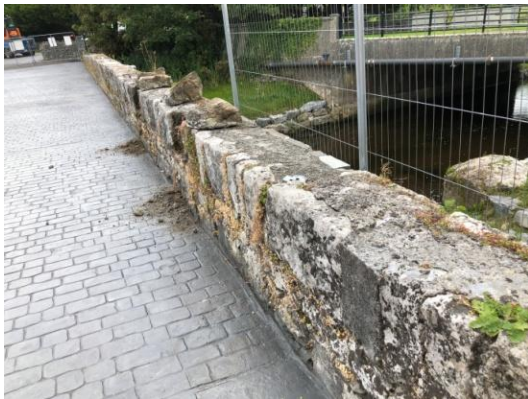
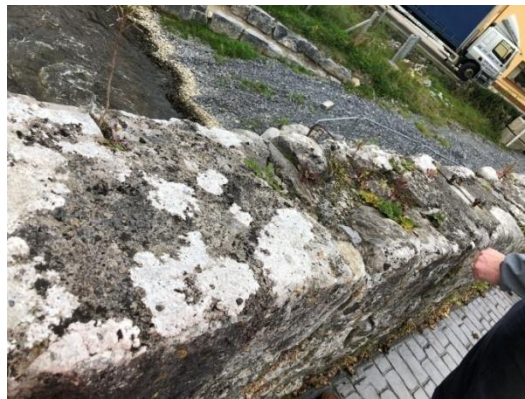
Capping in poor condition

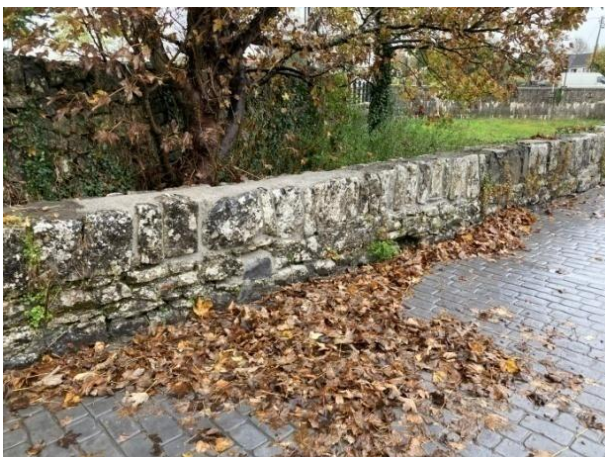
Repaired section of wall, Oct 2020, upstream side, north end

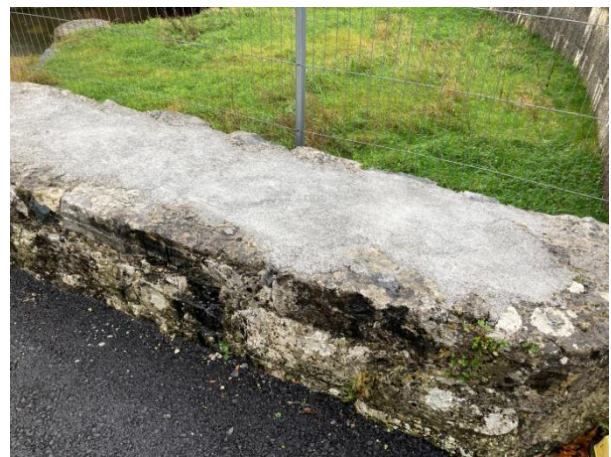
New mortar capping, upstream side, south end

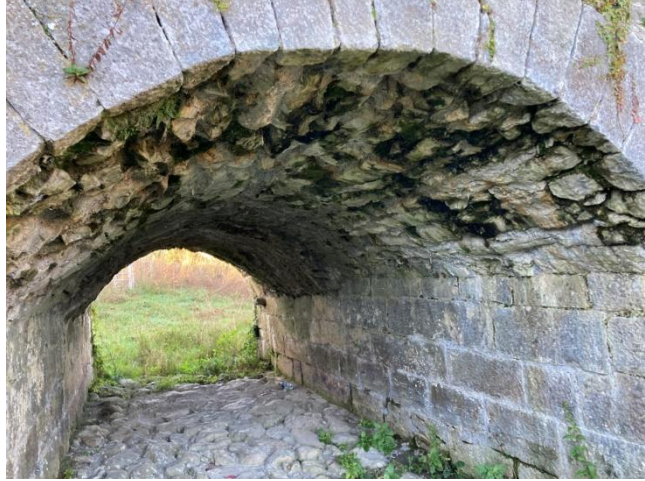
It will be necessary to undertake further works in these outer parts of the bridge. In November 2021 much growth of algae has established indicating that large amounts of water are penetrating. While there is no immediate evidence that conditions are significantly worsening⁶, saturation and liquid water moving through the fabric could cause mortar wash-out, loosening of stonework, and instability. Additional remedial works should be planned in the short term. The conservation officer should be consulted and grant aid may be available to assist in financing the work.

*Nov 2021 Extensive algae growth below
outer part of vault, upstream side.*

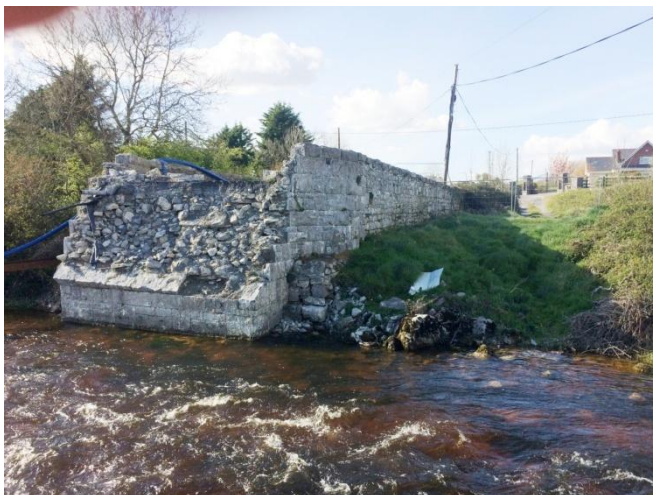
Photographs taken April 2019. Views of northern side of Arch F abutment following collapse. Note that the curved wall where the road narrowed at the bridge abutment survived. It was considered important that this example of skilled 19th century stone craftsmanship be preserved and this was done. Suggestions of widening the bridge which would have involved the loss of this element were rejected as not in line with good conservation practice.

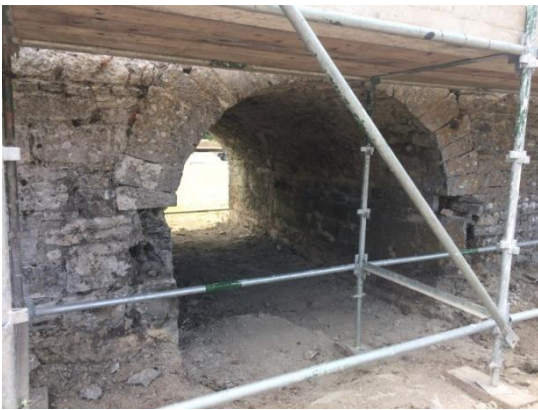
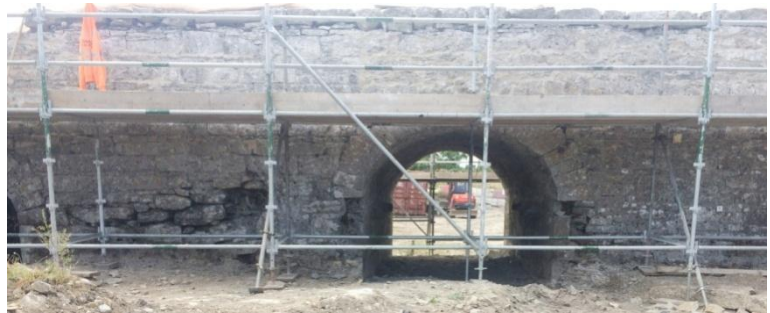
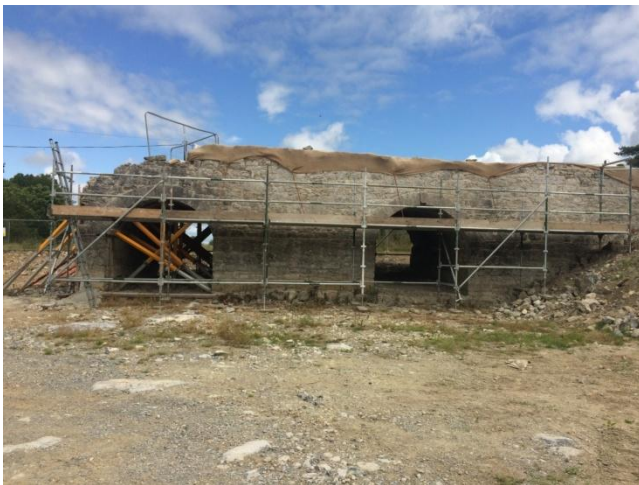
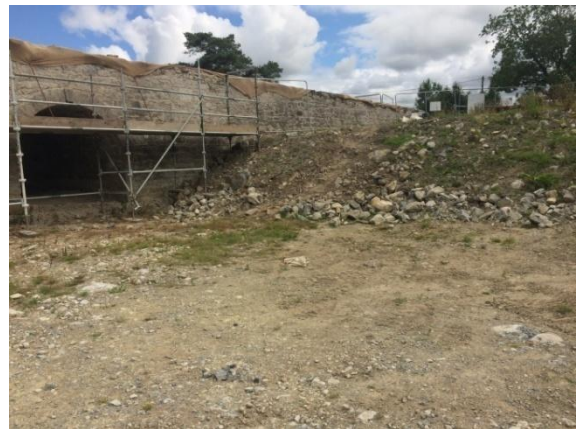
*Re-pointing and patch repair well
progressed on downstream face of bridge.*

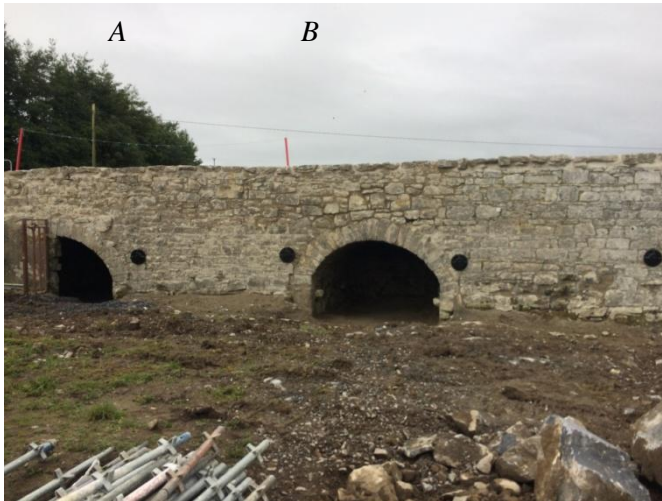
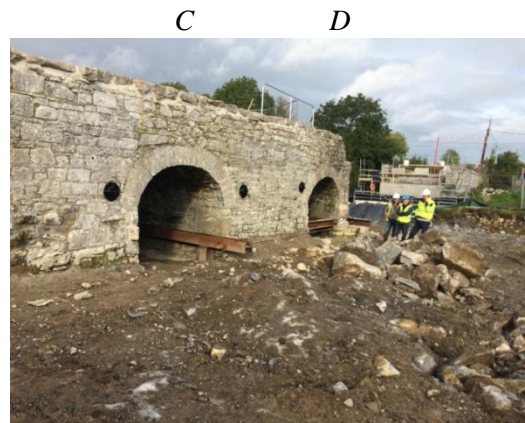
September 2019, upstream face, pattress plates and tie rods have been inserted. Stone repair and re-pointing complete

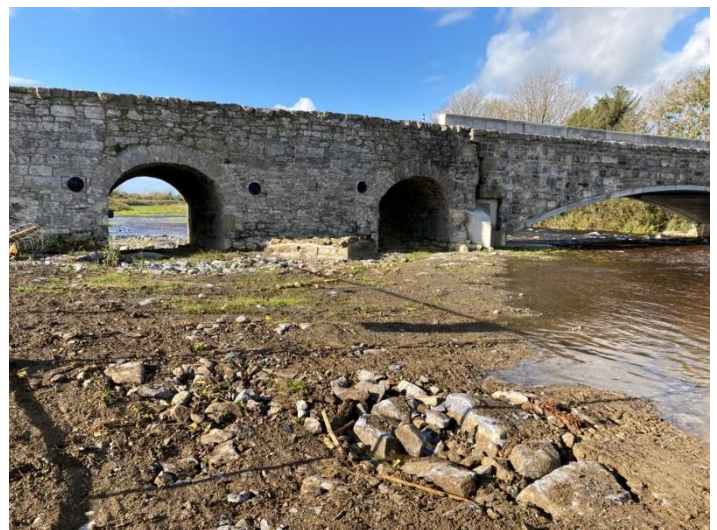
Upstream view with the uncovered base of the original stone cut water between arches C and D. The stonework of the cutwater was consolidated with displaced stones reinstated in original locations where this could be established. Other salvaged stone was used to consolidate the core and to replace a few missing facing stones where necessary for stability. In line with good conservation practice conjectural rebuilding was not undertaken.

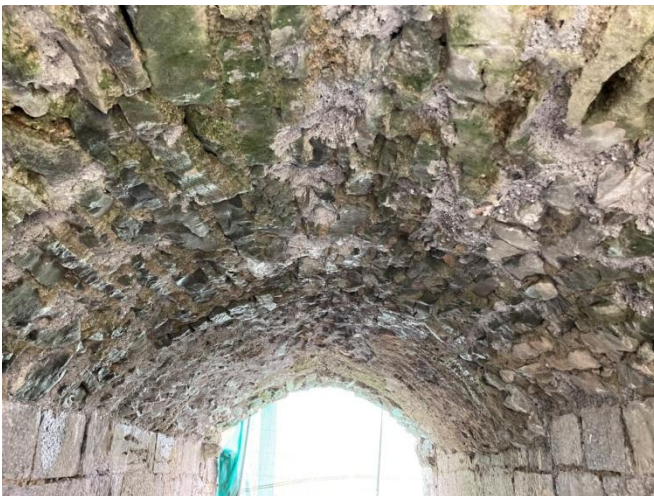
Consolidation not complete here on day of inspection

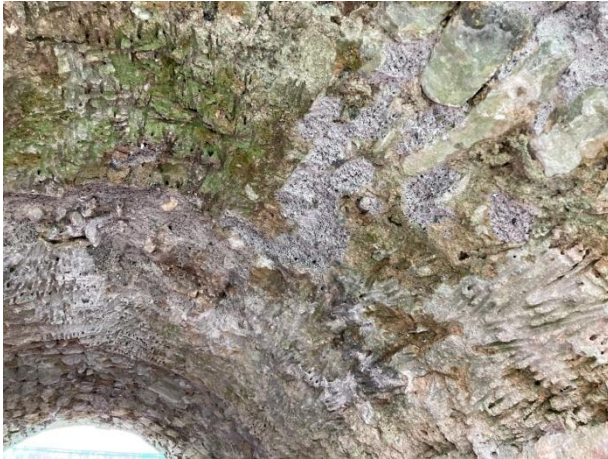
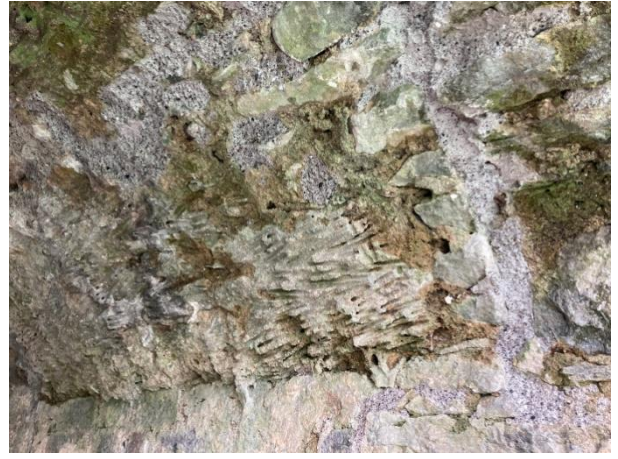
Further views looking upstream. Some loss of wicker noted on this side compared to extent recorded in April 2019

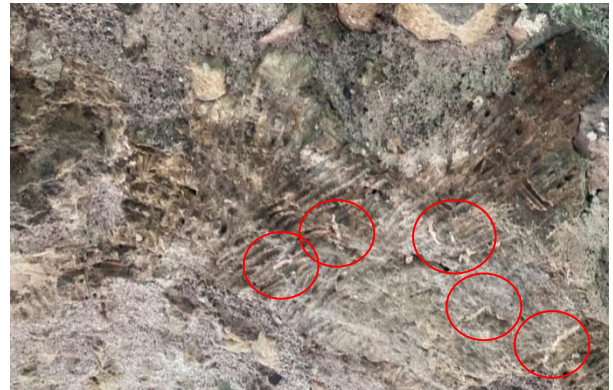
close-up of repair of cracks in wicker

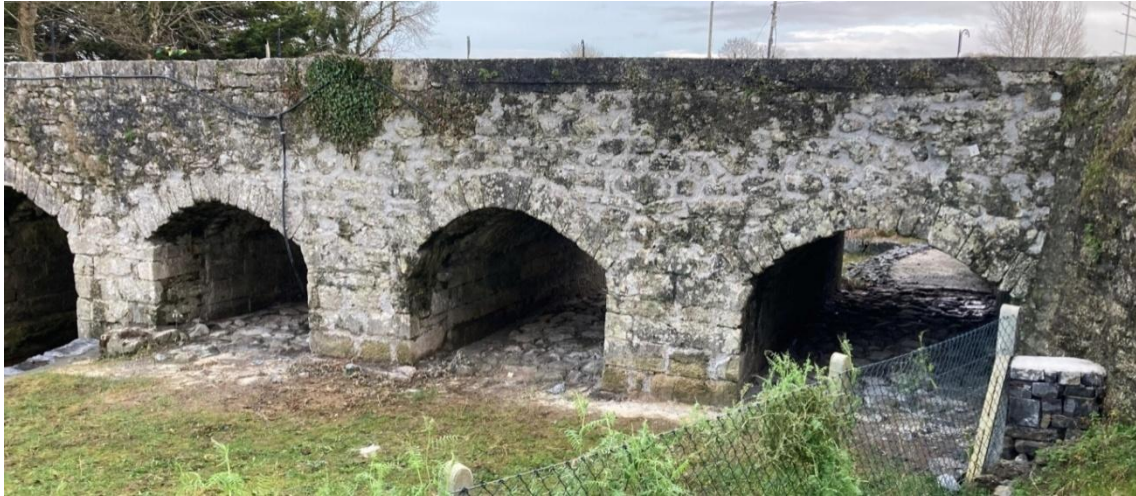
General view of re-pointed stonework above arches A, B, and C on the downstream side.

Time allowed some re-pointing of stonework on the west (downstream) side of the bridge face in tandem with the consolidation work below the vaults. This will help to mitigate the penetration of driving rain on this side, as well as generally consolidating the facing stonework.
