Groundwater Public Water Supply (PWS) Audit Report

Date of visit	05/03/2012 21:53:54		Water Service Authority	Galway County Council	
WFD Site Code	07_002		Site name	Ballygar	
Water Supply Zone Code	1200PUB1006	Name of Water Supply	Ballygar P.S.	Easting : 176525	Northing : 252950
Name of WSA Personnel 1	Tina Ryan		Job Title of WSA Personnel 1	Executive Scientist	
Name of WSA Personnel 2			Job Title of WSA Personnel 2		
Time In	21:53		Time Out	22:16	
Site Contact	Michael Killilea				
Meteorological conditions at the time of audit	Dry				
Meteorological conditions over the previous 24 hours	Wet				
Name of Auditor	Ronan Doyle

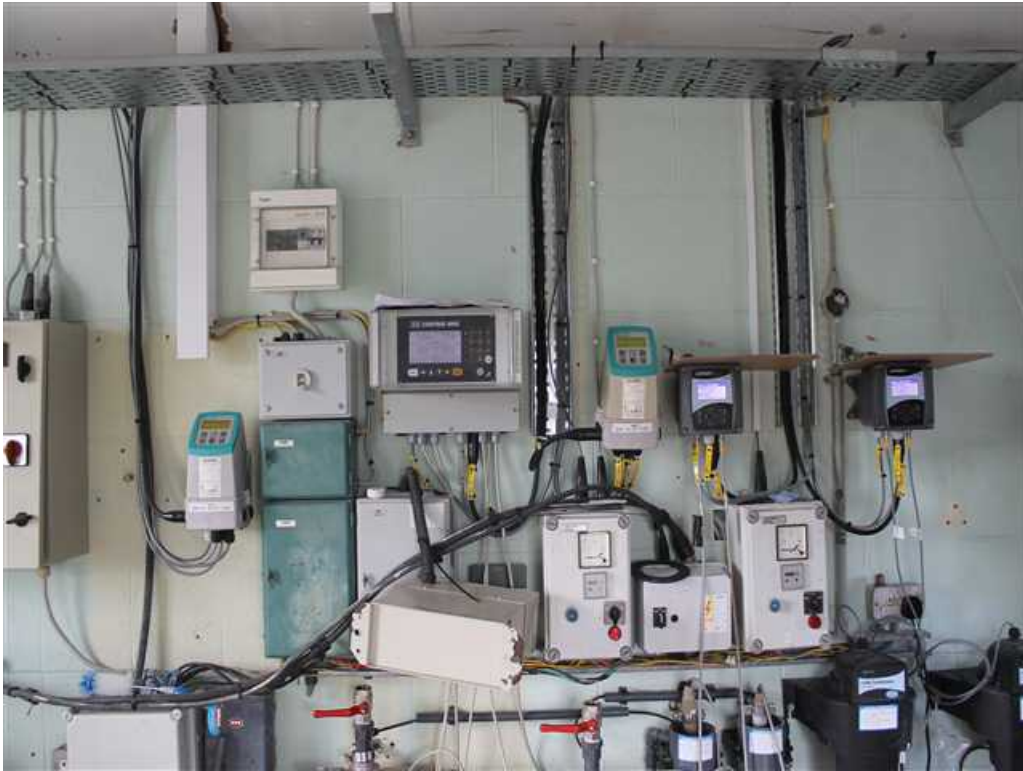
Chlorine monitors

34. What is the chlorine residual reading on the monitor at the time of the audit ?	0.61mg/l	
35. Is the chlorine monitor after the contact tank / clear water tank ?	Yes
