DERRYCLARE PEATLAND REHABILITATION

**Technical Note in Response to Further
Information Required – Galway County
Council (Ref. 23/60)**

Technical Note in Response to Further Information Required (FIR) – Galway County Council (REF. 23/60)

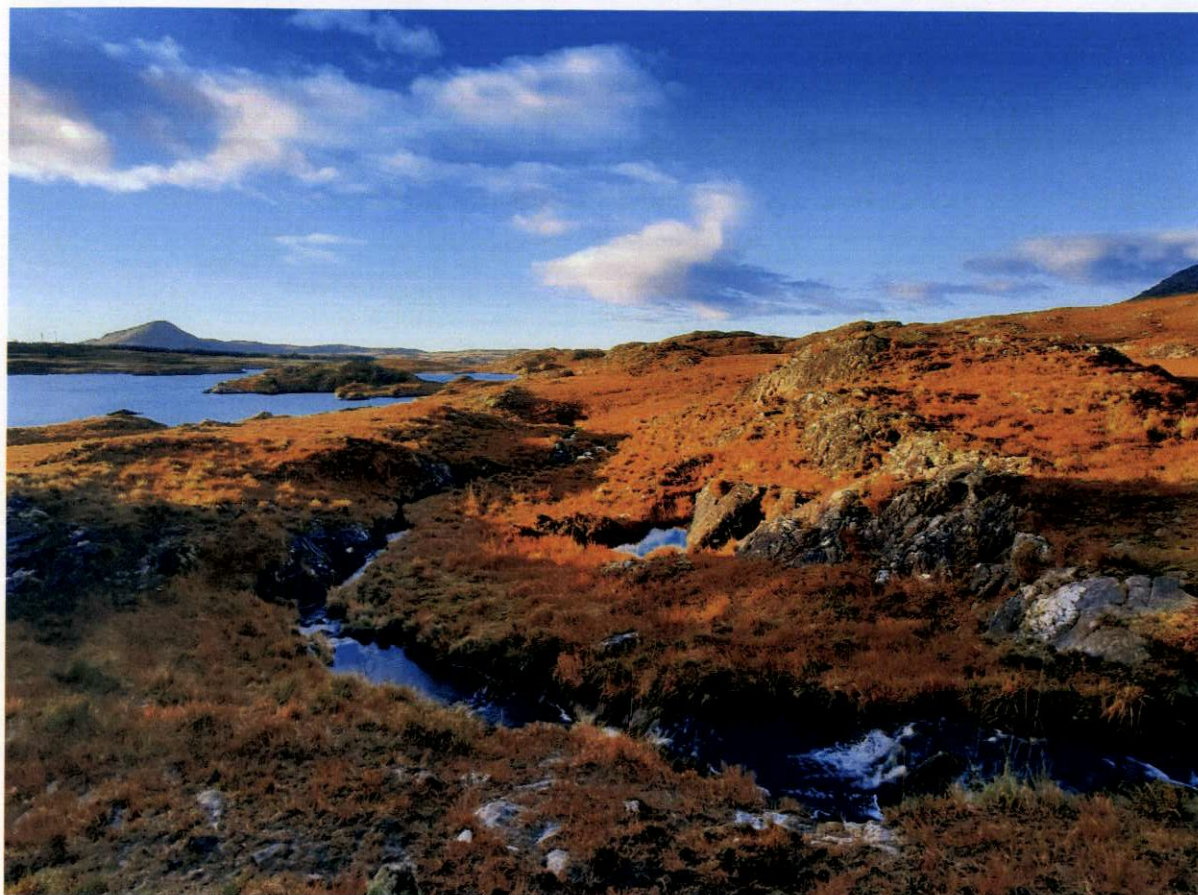
Plate 1 Photo taken from PP003 - western extent of site (view west)

The geomorphology at each of the survey points can be described as having a pronounced hummocky topography. This coupled with the occurrence of both observed and mapped ^[Ref. 4] bedrock outcropping, indicates the presence of shallow rock. Similar terrain can be clearly seen in the adjacent land to the north, south and west of the site, where there is significantly less vegetation coverage to obscure the terrain in its natural state (Plate 1).

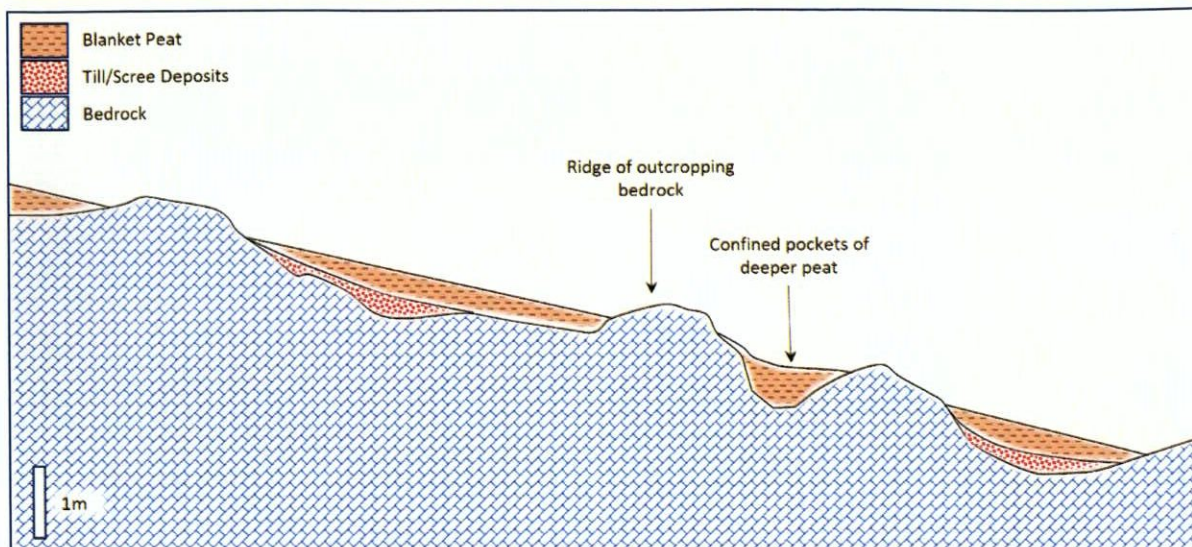
Figure 1 Conceptual cross-section through upland area (based on field observations)

As discussed in Section 4.2 of the Assessment Report, the bedrock outcrop pattern observed during the site walkovers form a series of staggered ridges across the site. These ridges generally form perpendicular to the direction of slope. Their presence is particularly evident in the upland areas to the west of the site. At these locations, the ridges form natural breaks across the slopes, thereby restricting the presence of laterally continuous peat layers. The areas of deeper peat found within the upland areas (such as at PP029) are often confined to pockets representing low points within the underlying bedrock, illustrated in Figure 1. Such terrain may not prevent small isolated peat slippages; however, it is believed that it does significantly reduce the risk of large-scale translational failures within the peat.
