N59 Oughterard Footbridge

Stage 1 Road Safety Audit

This report describes the findings of a Stage 1 Road Safety Audit associated with the N59 Oughterard Footbridge.

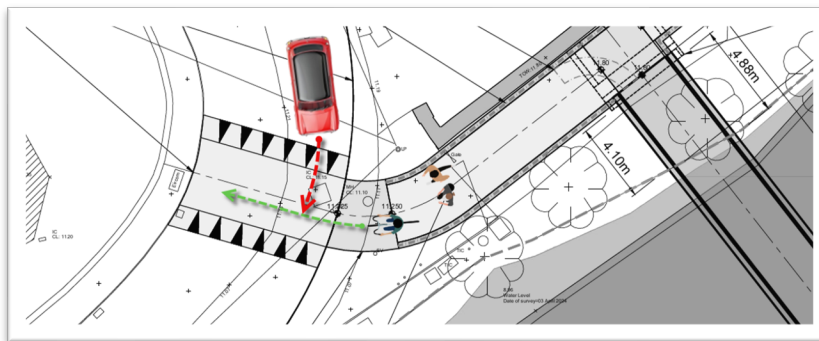
Location: Shared Footpath Approach to Raised Pedestrian Crossing

Some walkers and cyclists may carry momentum and step straight from the new shared footpath onto the crossing without checking for approaching vehicles. This could lead to conflicts between vehicles and vulnerable road users on the crossing.

Figure 2.1 – Cyclist & Walkers Crossing Without Due Care & Attention

Chicane gates (or kissing gates) should be installed on the approach to the crossing to mitigate the risk described.

2.1	Yes	Yes	<p>Please see the attached general arrangement drawing which shows the following measures to address this problem:</p> <ul style="list-style-type: none"> - Longer landing (5m) between the end of the north ramp and Carrowmanagh road. - Planter added between the end of the end of the north ramp and Carrowmanagh Rd.

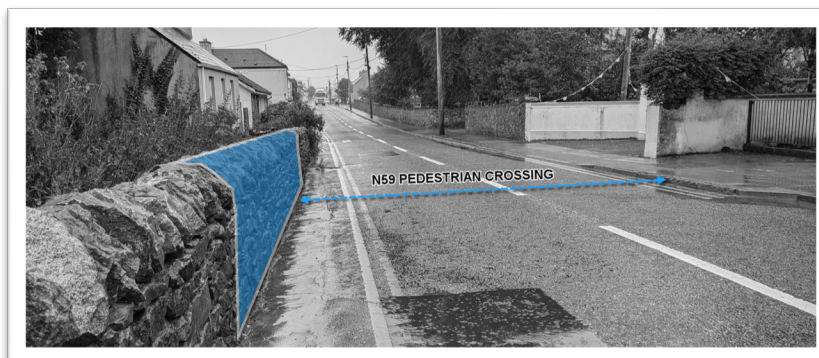
Location: N59 Pedestrian Crossing

The stone wall may partially obscure sight lines between vehicles approaching the crossing on the N59, and walkers approaching the road with the intention to cross. This could lead to conflicts between vehicles and vulnerable road users on the crossing.

Figure 2.2 – Stone Wall Which May Obscure Sight Lines at the Crossing

The crossing sight lines should be checked with appropriate adjustments made to the stone wall if required.

2.2	Yes	No	<p>The general arrangement drawing showed N59 road kerb line adjustment to provide a 700mm pedestrian dwell area in front of the masonry wall. This should provide the required sight distance for 50kph traffic (the actual speed of traffic is likely to be lower than this due to constraints).</p>	Yes

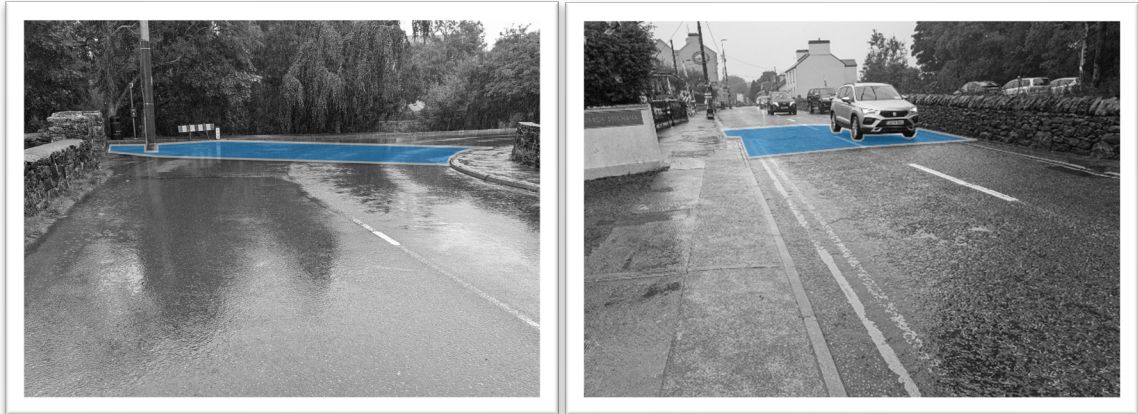
Location: Both Raised Pedestrian Crossings

Drivers are less likely to stop and give way to pedestrians on the uncontrolled crossings during commuter peak hours, when traffic flows are higher and the urgency for them to arrive at work on time is increased. This could lead to progression issues for pedestrians at the crossings (including school children and the mobility impaired) and conflicts between vehicles and vulnerable road users.

Figure 2.3 – Location of Northern Crossing of Local Road (Left) and N59 Crossing (Right)

Appropriate control measures should be installed on the crossings with the intention of prioritizing the progression of pedestrians over the passage of vehicles.

2.3	Yes	Yes	<p>Please see the attached general arrangement drawing which shows zebra crossings to address this problem.</p>
