GEOTECHNICAL & PEAT STABILITY ASSESSMENT REPORT

DERRYCLARE PEATLAND REHABILITATION

Prepared for: MKO Ltd

Date: February 2023

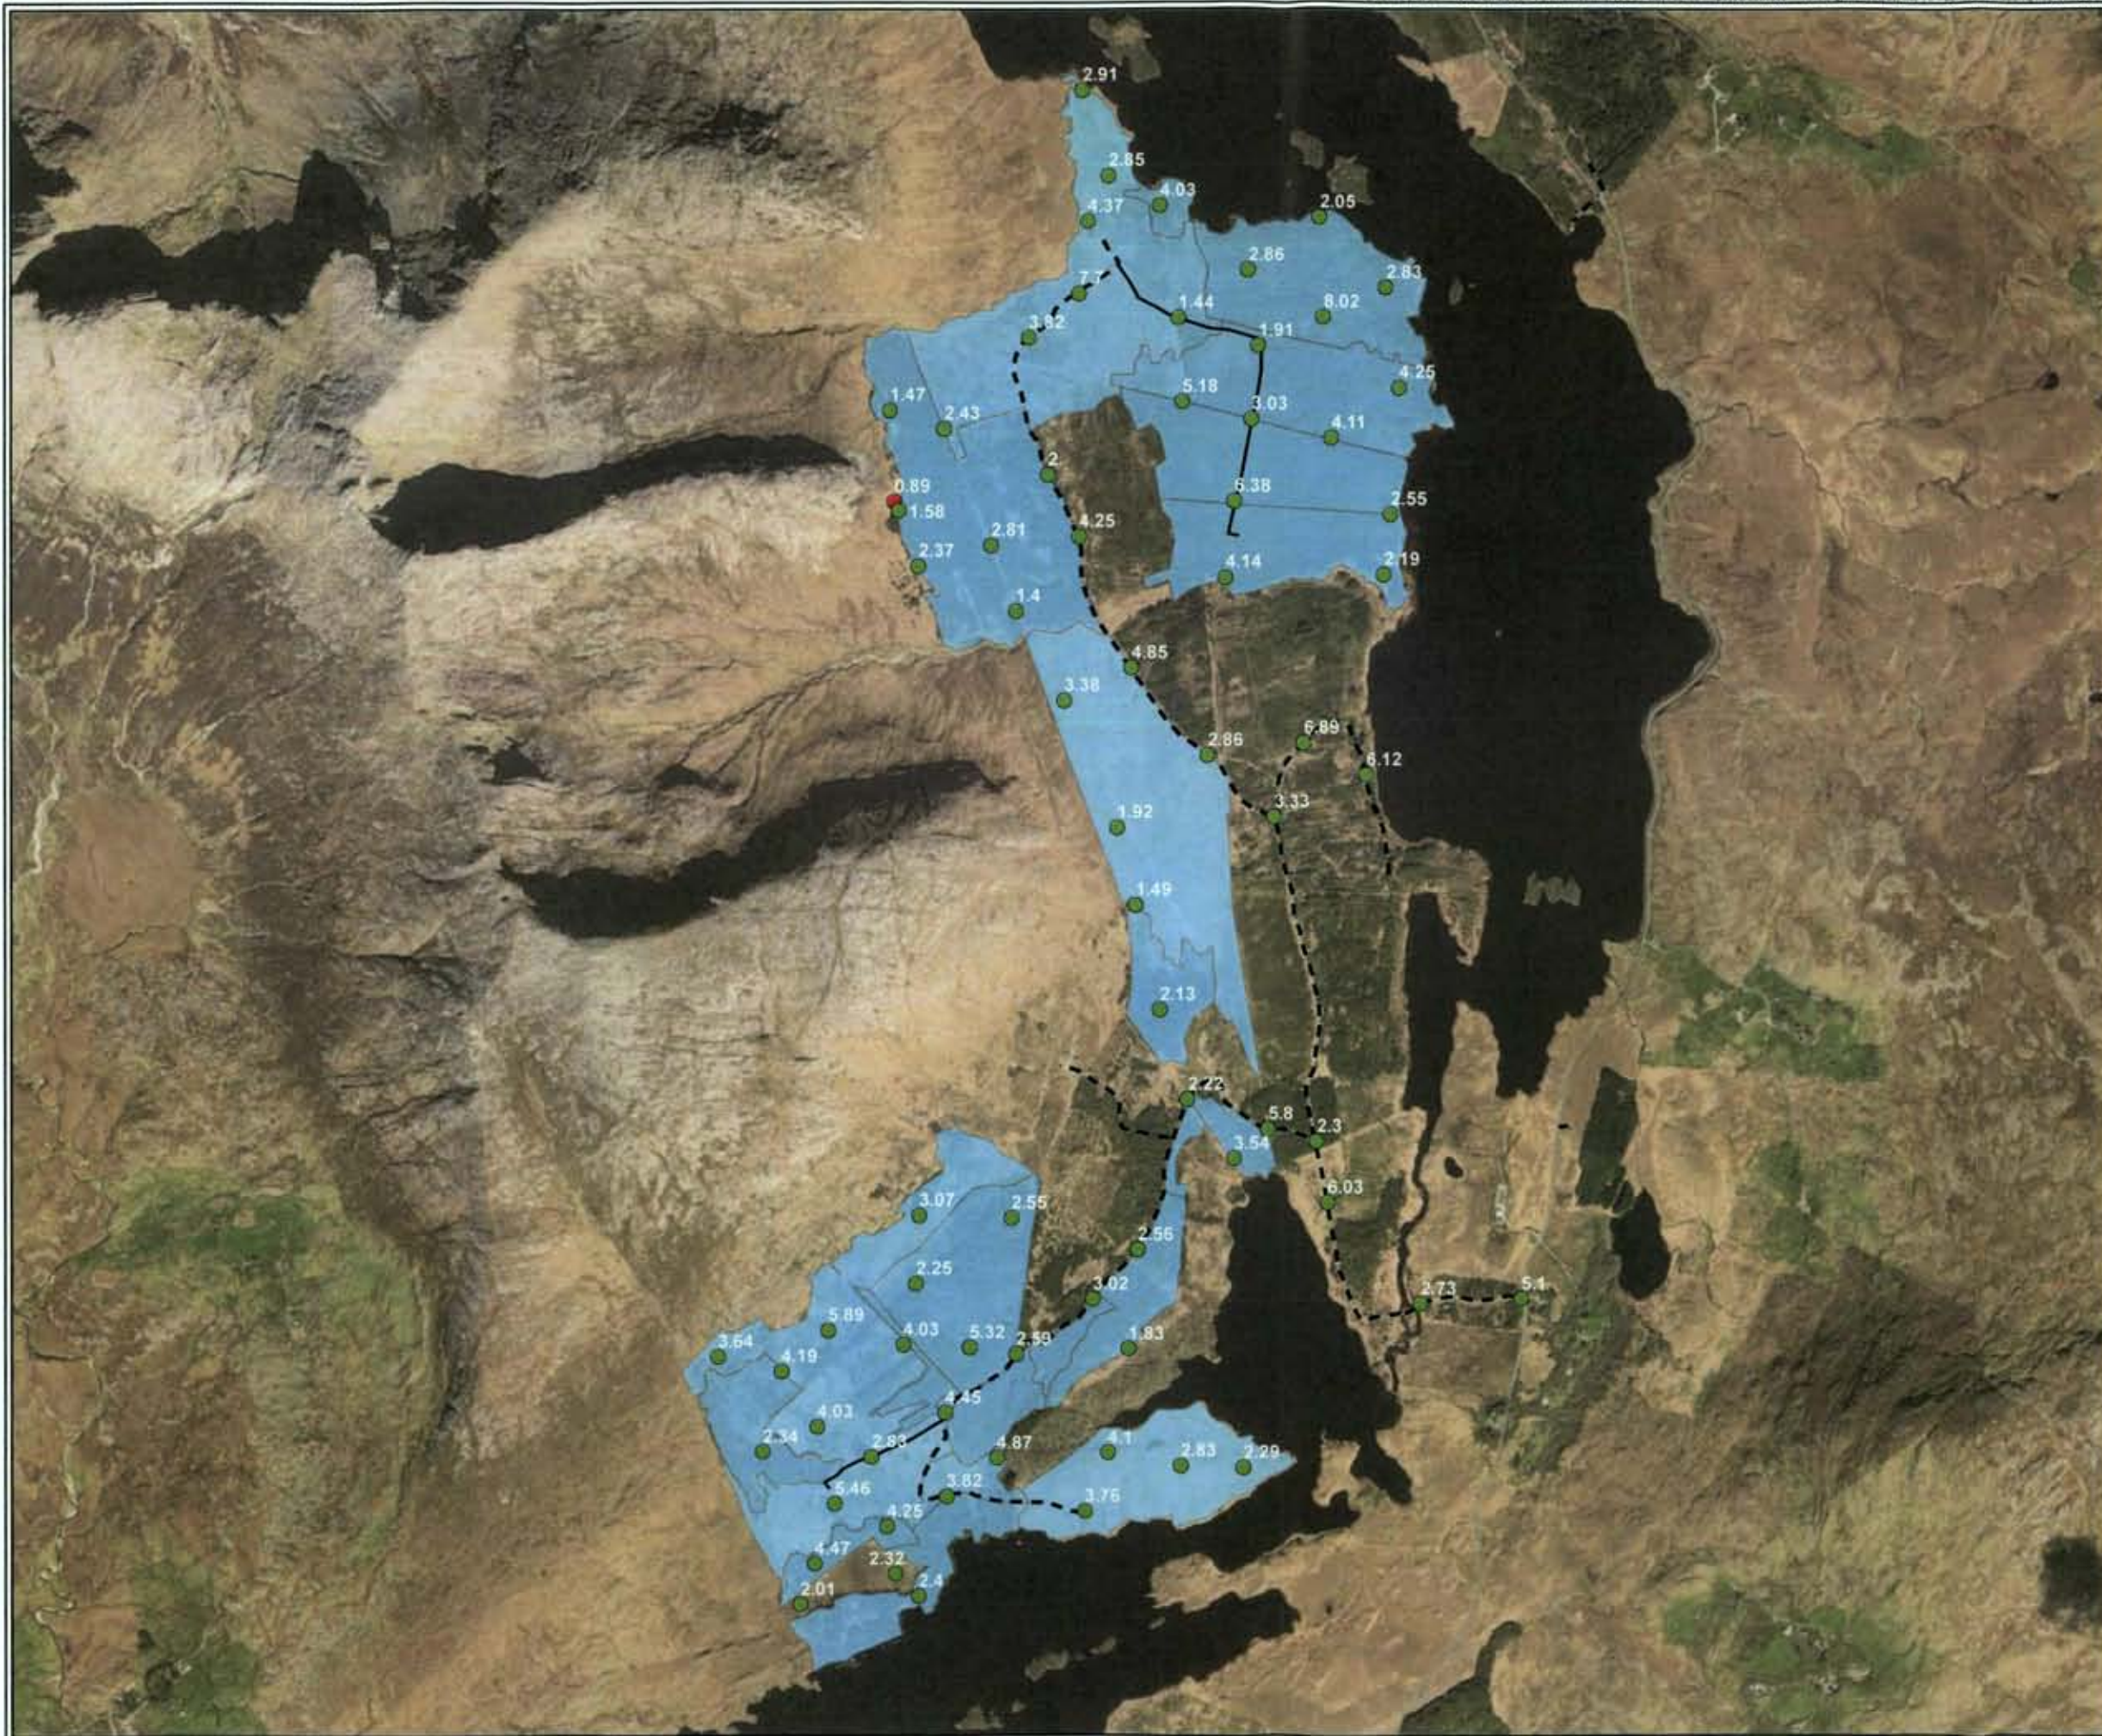
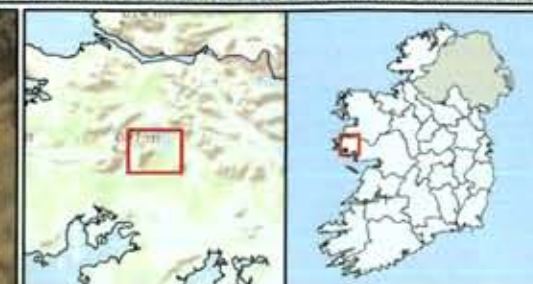
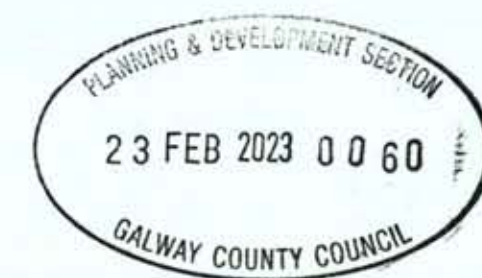
TITLE: Factor of Safety Plan - Short Term Condition (Undrained)	
PROJECT: Derryclare Peatland Rehabilitation	
FIGURE NO:	6-1
CLIENT:	MKO
SCALE: 1:20000	REVISION: 0
DATE: 09/02/2023	PAGE SIZE: A3

FOS (Undrained Condition)

- <1
- 1 - 1.3
- > 1.3

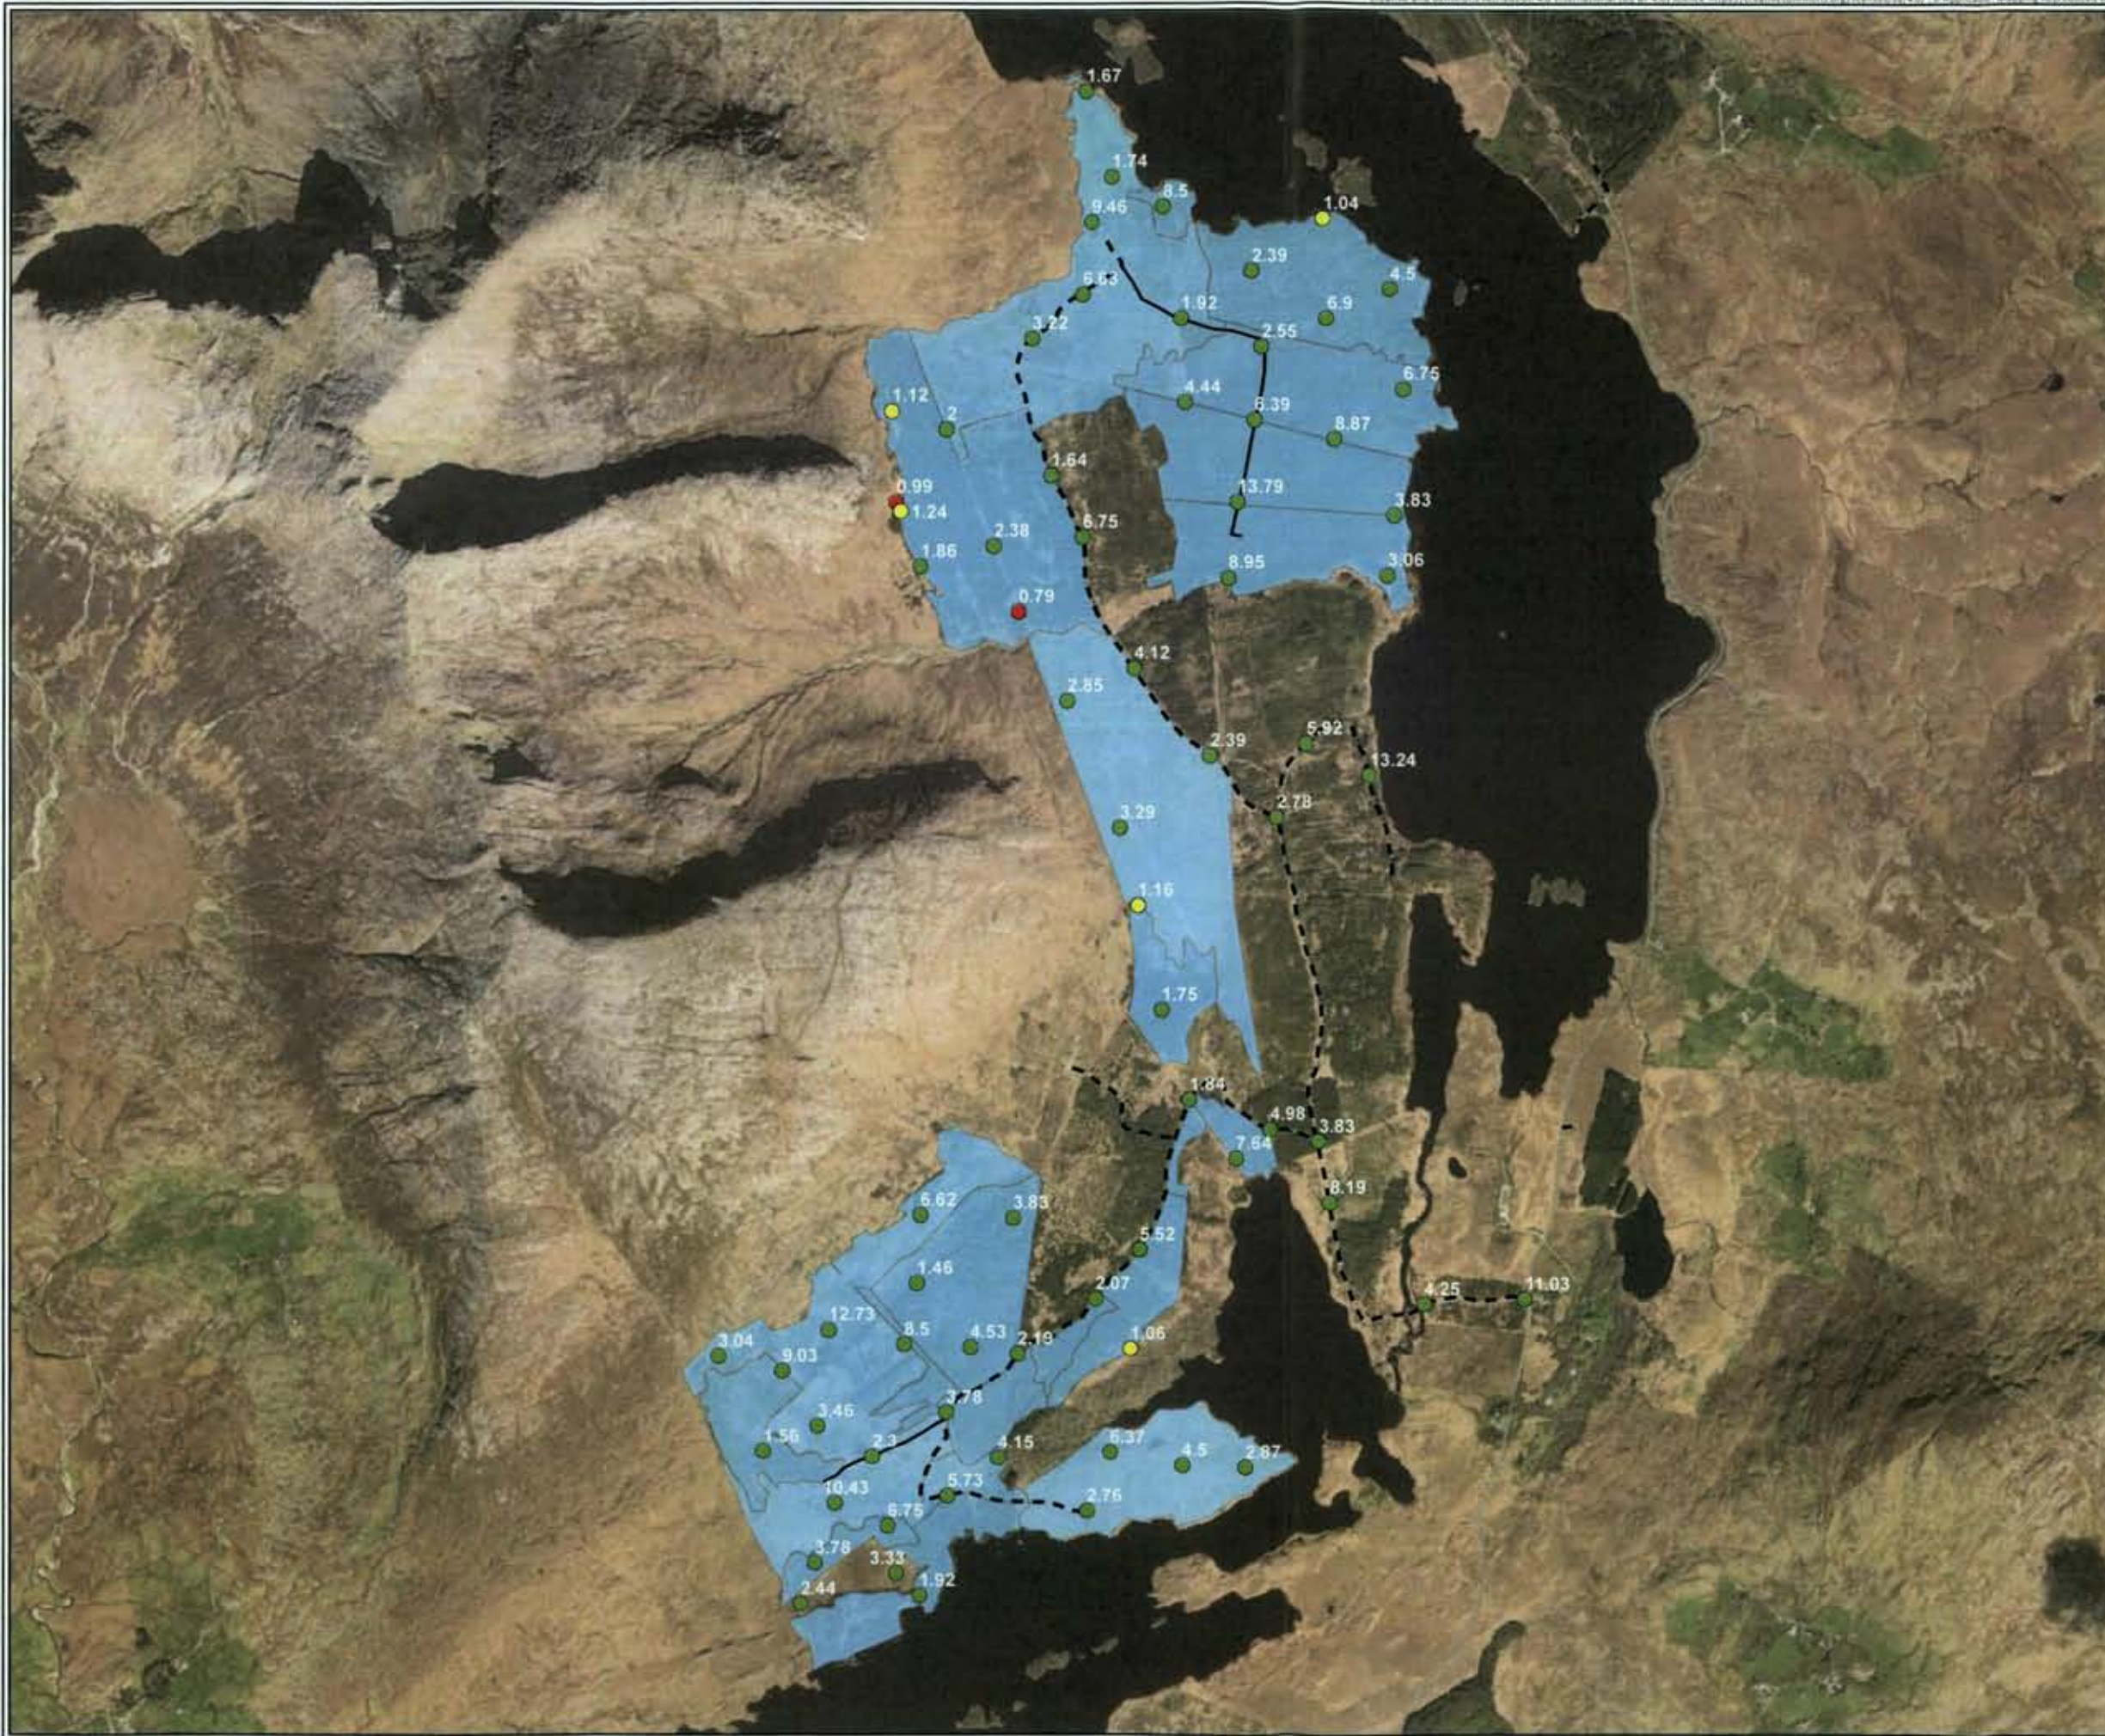
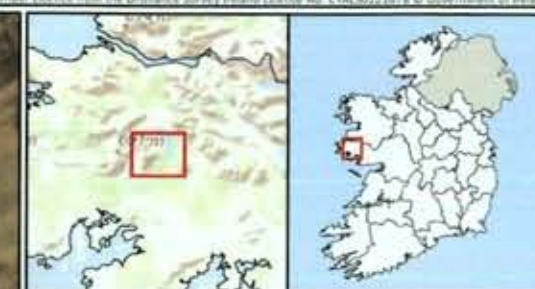
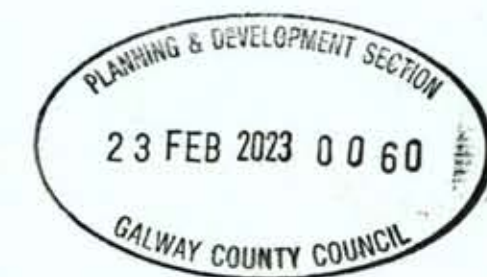
TITLE: Factor of Safety Plan Long Term Condition (Drained)	
PROJECT: Derryclare Peatland Rehabilitation	
FIGURE NO:	6-2
CLIENT:	MKO
SCALE: 1:20000	REVISION: 0
DATE: 09/02/2023	PAGE SIZE: A3

FOS (Drained Condition)

- <1
- 1 - 1.3
- > 1.3
