HYDROLOGY AND HYDROGEOLOGY

Ecological Report- Derryclare

Part 1: Habitat Survey

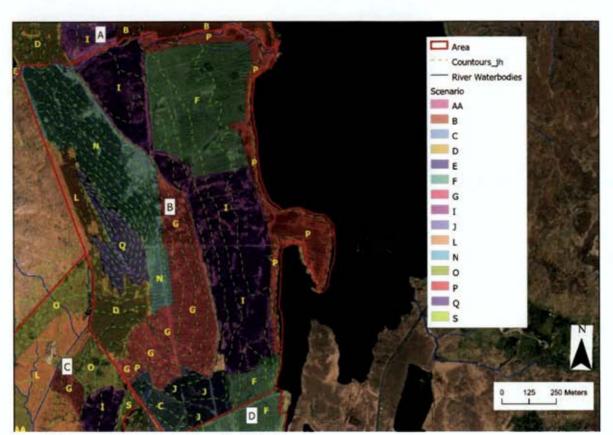
slope have been considered. Areas with similar attributes were grouped under different scenarios (Figure 7). This exercise was carried out in order to assess the great variety of attributes over a large site. Pressures within each scenario area are described and proposed actions to achieve target habitats described (Table 2).

Figure 7 Management Scenarios for Area B (See Table 2)
