5 Years Annual Monitoring of Rahasane Turlough

– Post works on FRS

Galway County Council

December 2021

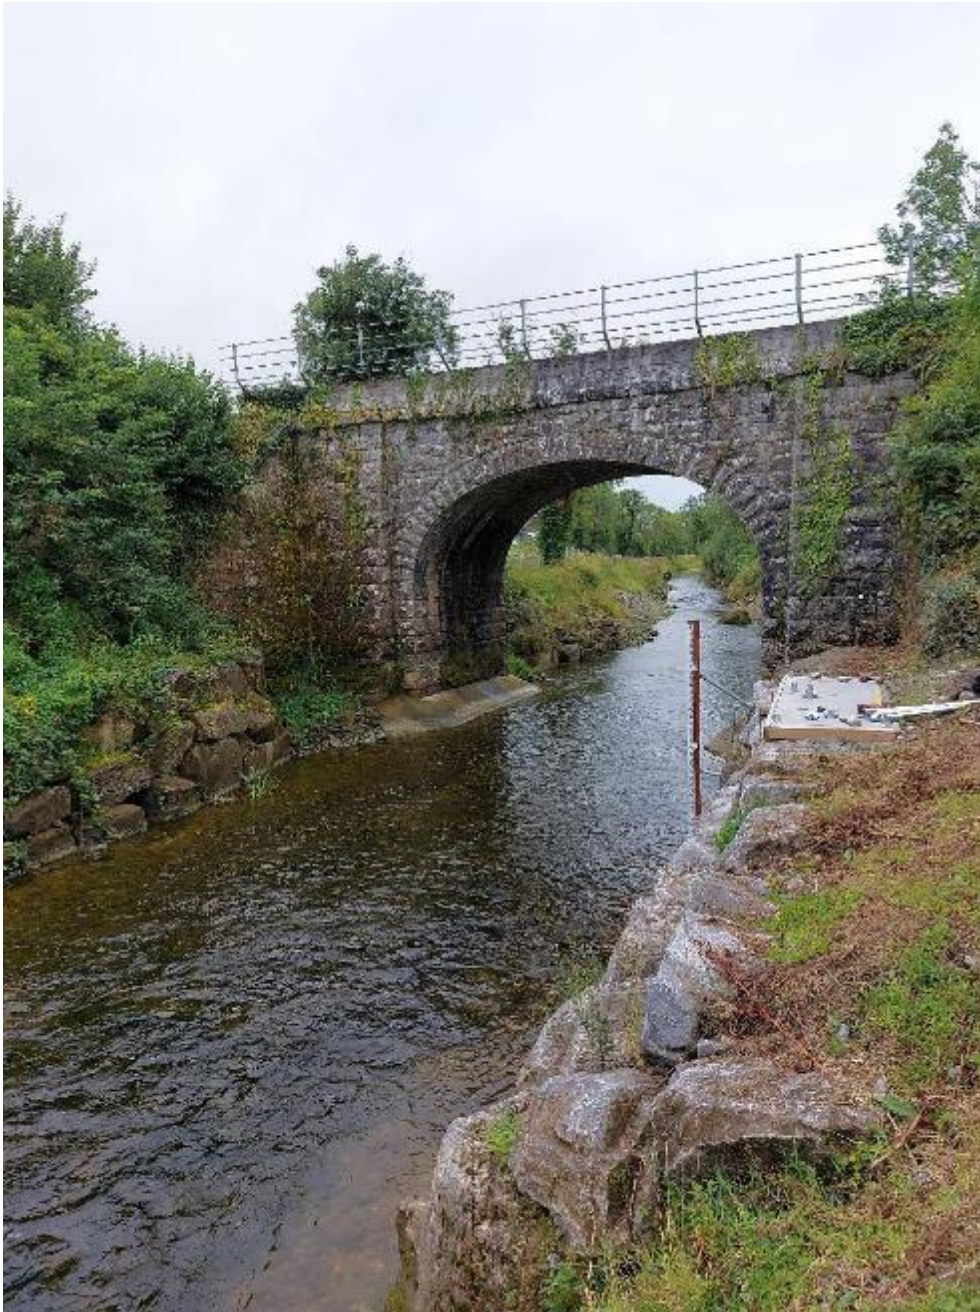
Figure 1 New OPW Hydrometric Station Craughwell 29007 (looking west).

Craughwell 29007, Figure 1, is a new hydrometric station on the Dunkellin River, approximately 230 m downstream of former monitoring station 29007. The latter was replaced with the new station following the construction of the FRS through Craughwell village. New station 29007 is located upstream of a bridge and is positioned to measure the river levels where the natural river course and the FRS are combined. It records the water level and temperature at 15-minute intervals using an OTT PLS sensor. The data are stored in a data logger and automatically loaded to a server via solar-powered telemetry.

The riverbed at the hydrometric station appears relatively clean (i.e. free of vegetation or other obstacles). The riverbanks are built up with rocks for stability purposes, to a level of approx. 2.7 m above the stream bed. There is a concrete structure which slopes 45° towards the stream at the base of the nearby bridge.

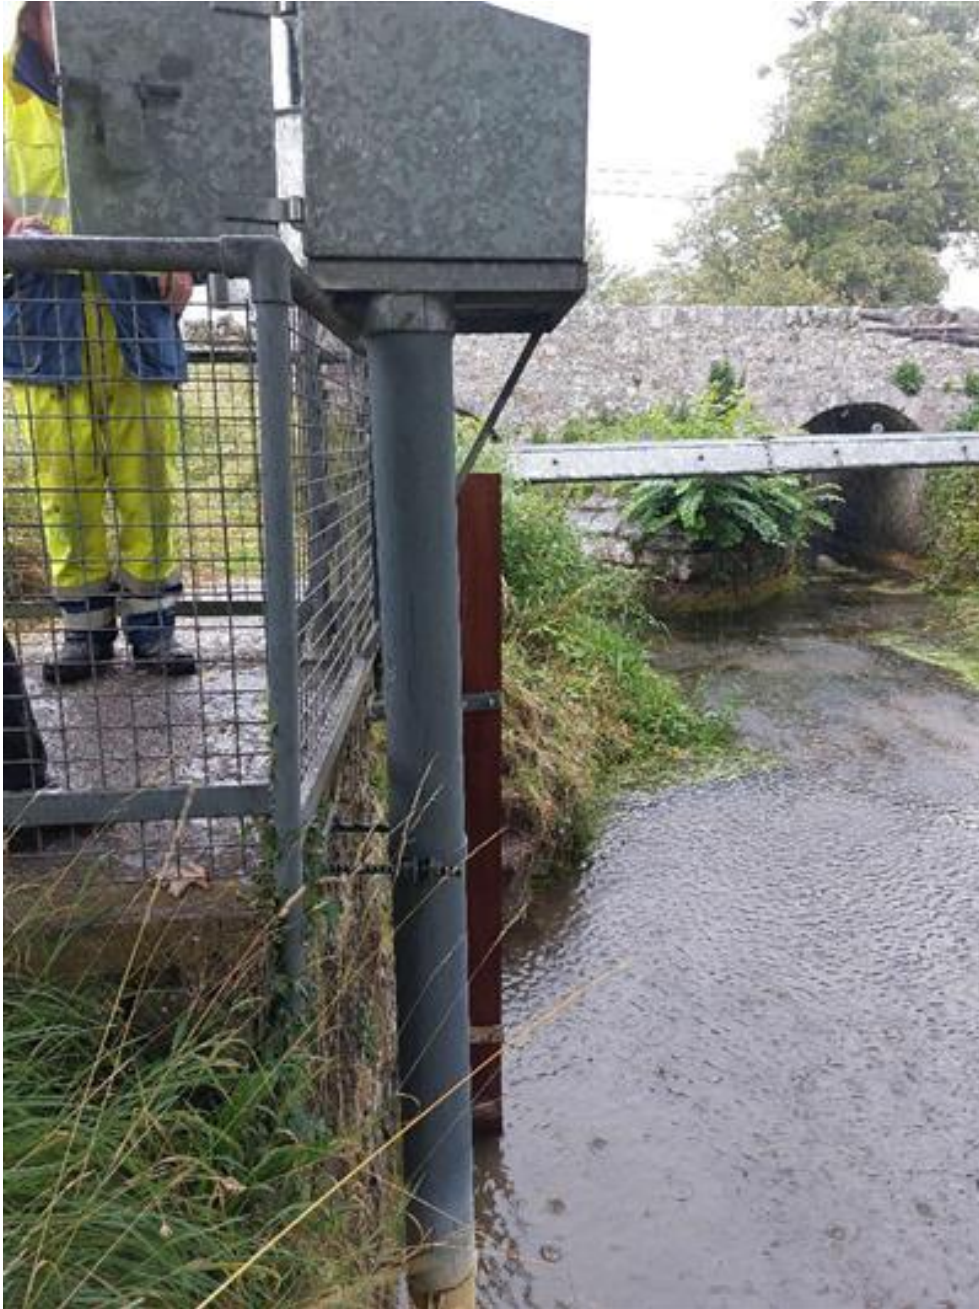
Figure 2 Aggard Bridge 29010 Hydrometric Station (looking downstream).

The stream banks are heavily vegetated and the profile of the tributary changes over short distances. Downstream, the flow is channeled under a bridge.

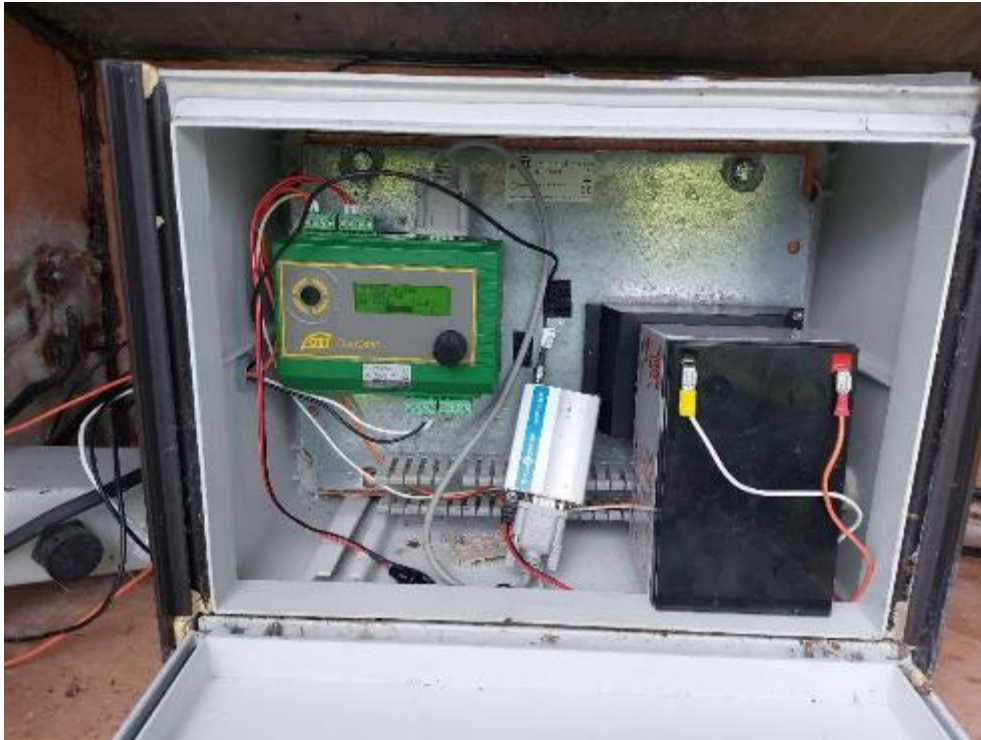
Figure 3 Data logger at the Aggard Bridge 29010 Hydrometric Station.

stored in an in-situ data logger (Figure 3). The data are automatically transmitted to a server via solar-powered telemetry.

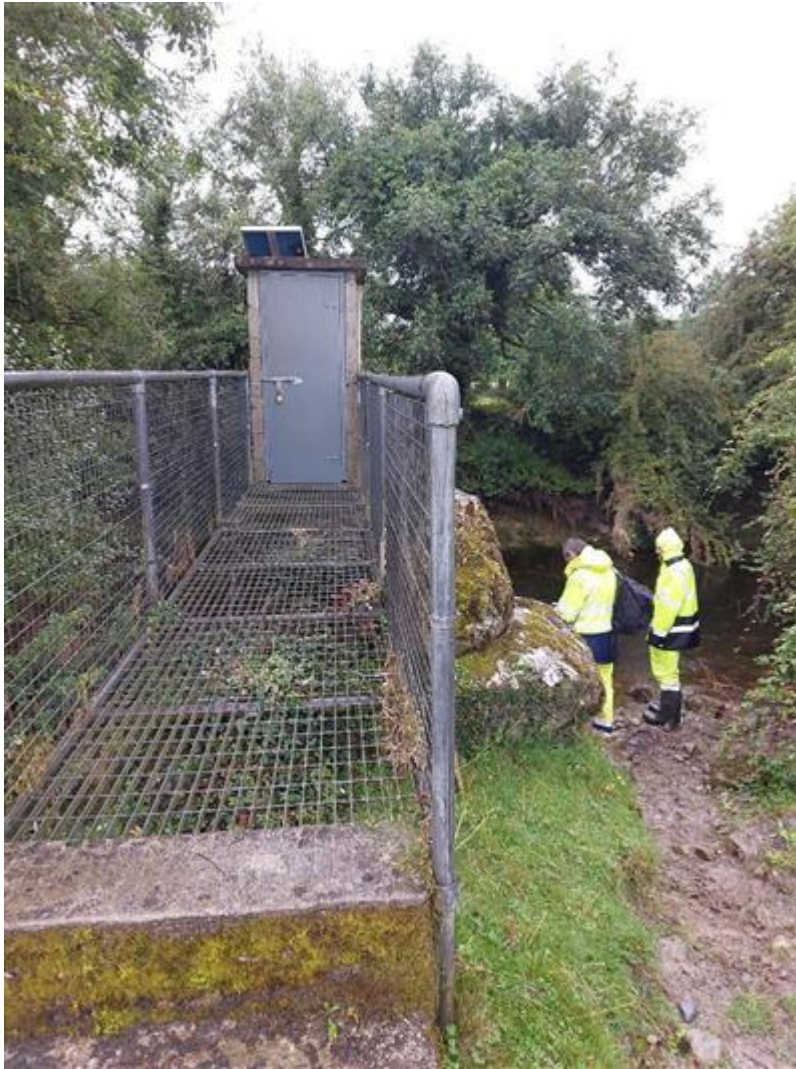
Figure 4 Rahasane Turlough 29002 Hydrometric Station

Rahasane Turlough 29002 (Figure 4) records the water level and temperature of the Dunkellin River downstream of the Rahasane Turlough SAC. Data are recorded at 15-minute intervals using an OTT sensor, and locally stored in a data logger. The data are automatically loaded to a server via solar-powered telemetry.

The riverbanks at and upstream of the monitoring station are heavily vegetated.

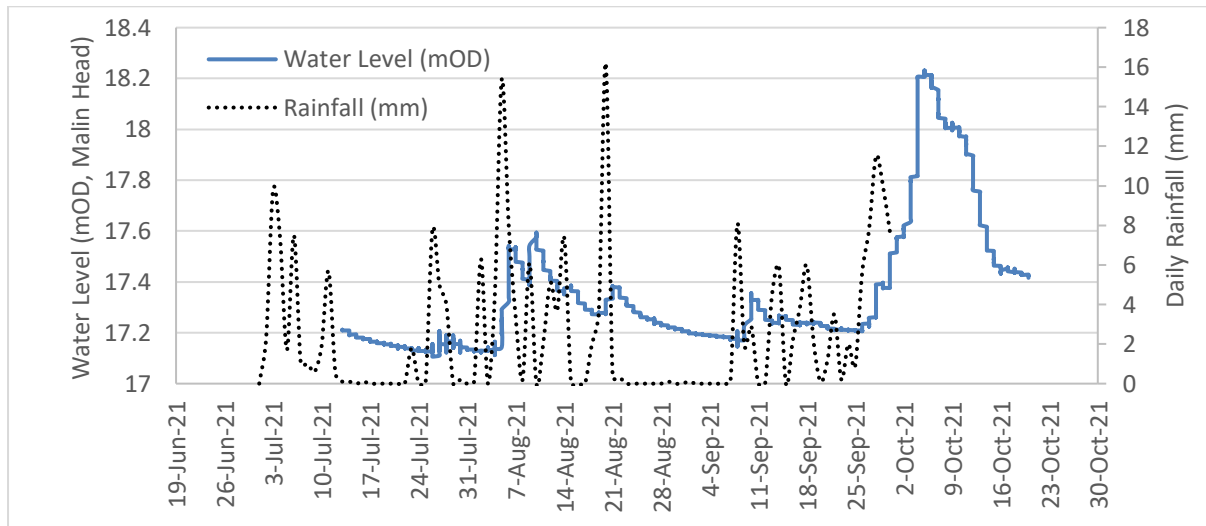
Figure 5 Craughwell 29007, Q3 2021 Water Level and Rainfall (Athenry) Data.

Water level data for Q3 from replacement station Craughwell 29007 (Figure 5) are available from 13/07/2021, which is the date when the new station was commissioned. During the available period of record, water levels ranged between 17.1 mOD and 18.16 mOD (mean =

17.2 mOD). Water levels were at their lowest in July, corresponding with a prolonged dry period. This was followed by a sharp water level rise to 17.6 mOD at the beginning of August which is caused by a large rainfall event. Water levels also responded significantly to rainfall that occurred in late-September/early October.

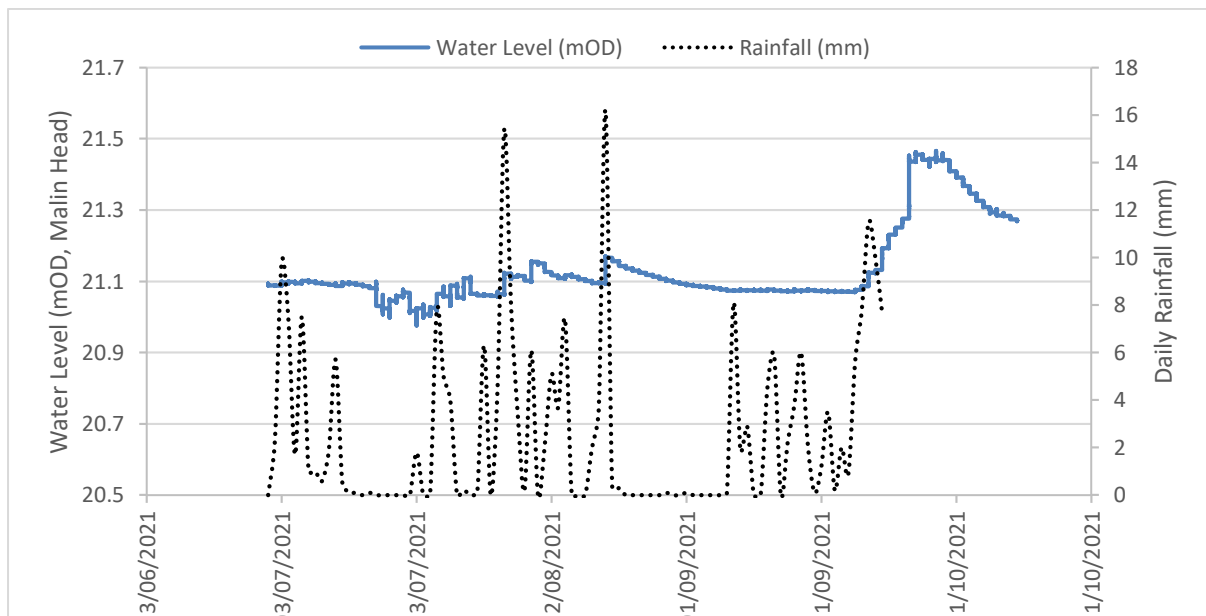
Figure 6 Aggard Bridge 29010, Q3 2021 Water Level and Rainfall (Athenry) Data.

Water level data for Q3 from Aggard Bridge 29010 are presented in Figure 6. Water levels over this period ranged from 20.9 mOD to 21.5 mOD (mean = 21.1 mOD). The data incorporate some ‘noise’ but the water levels response is generally very similar to that described for replacement Station 29007.

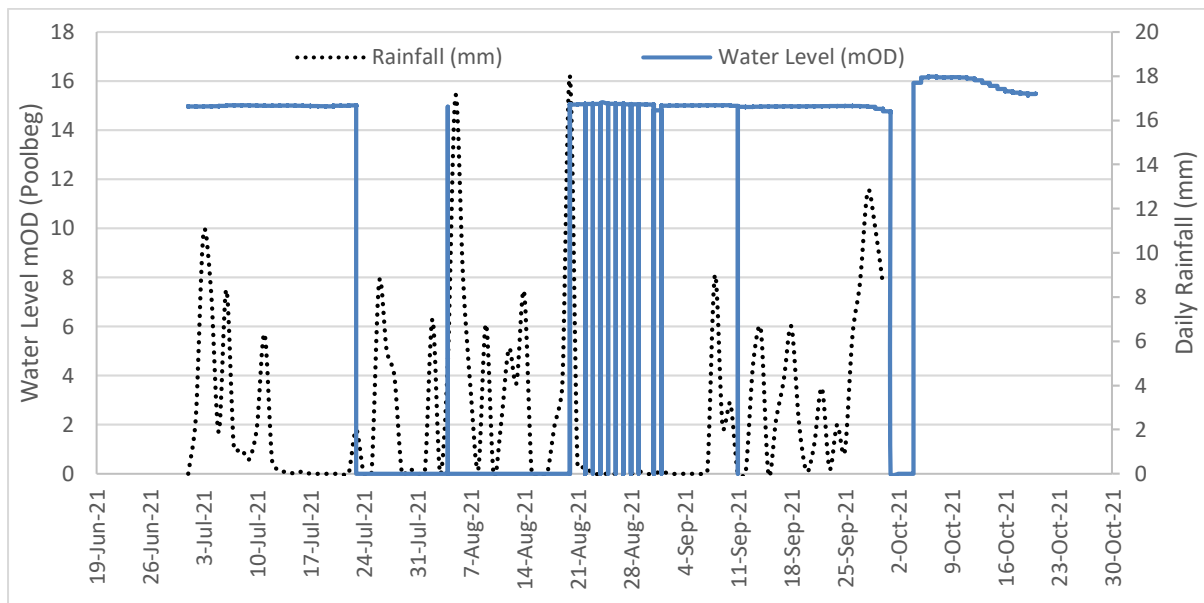
Figure 7 Rahasane Turlough 29002, Q3 2021 Water Level and Rainfall (Athenry) Data.

Water level data for Q3 from Rahasane Turlough 29002 are shown in Figure 7. OPW reported problems with the recording of data at this station, which is evident in Figure 7. Data quality

issues have been recently rectified and the corrected data will be presented in subsequent reporting.

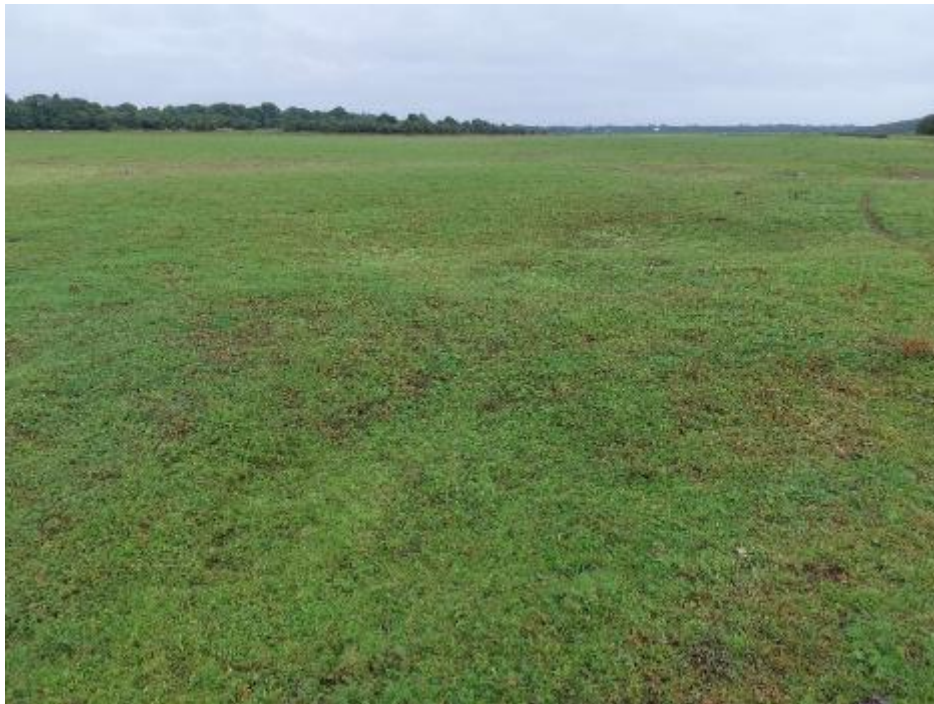
Figure 8 ID 3 - shallow depressions

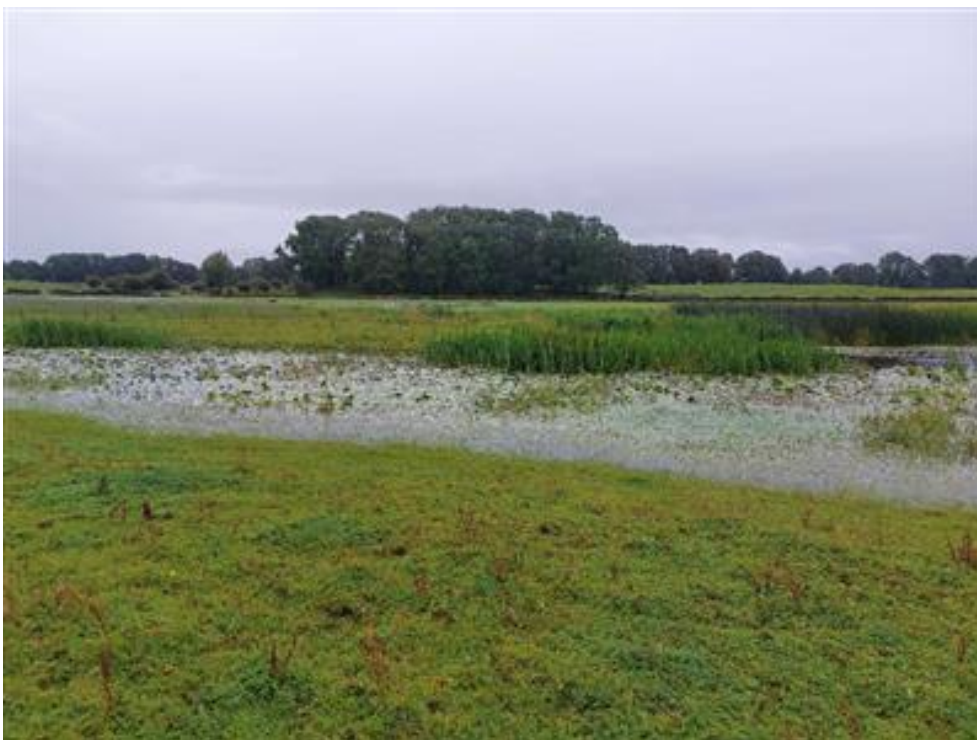
Figure 9 ID 6 - wetland vegetation

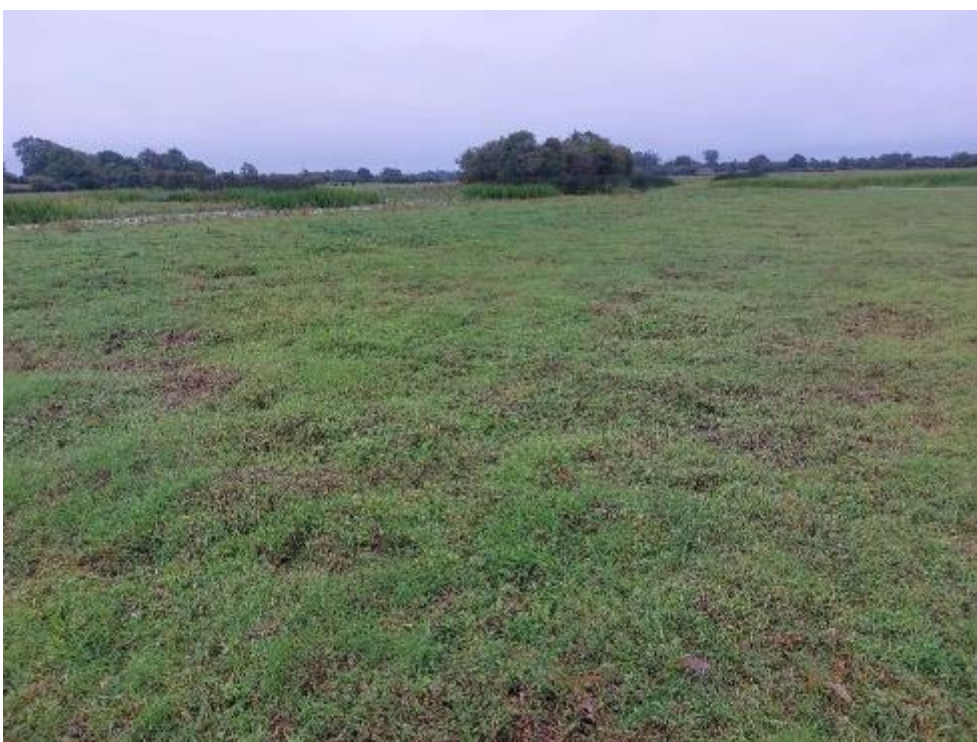
Figure 10 ID 7 - shallow depressions

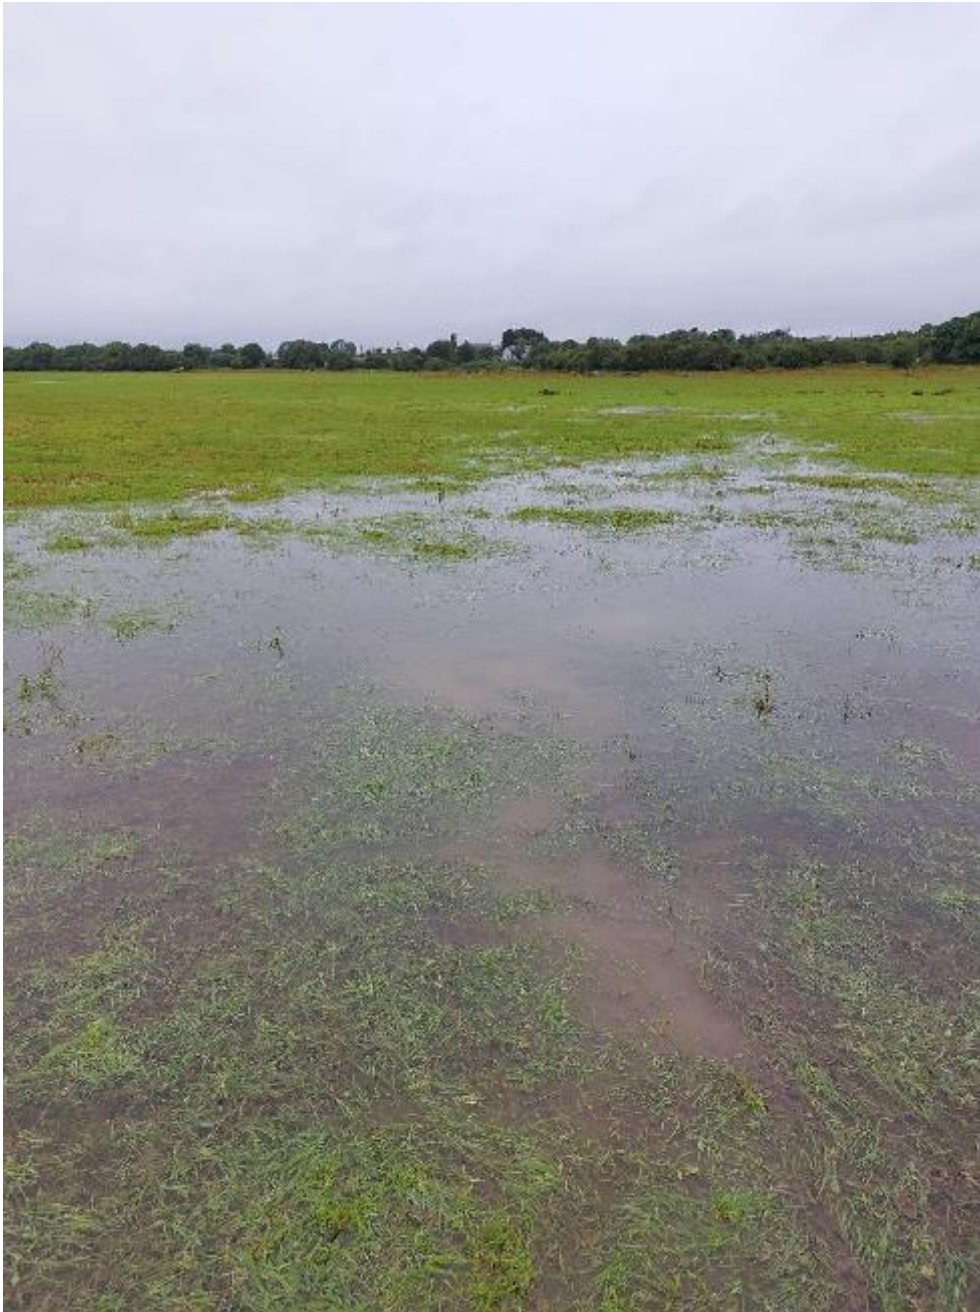
Figure 11 ID 8 – Enclosed depression – possible swallow hole/estavelle

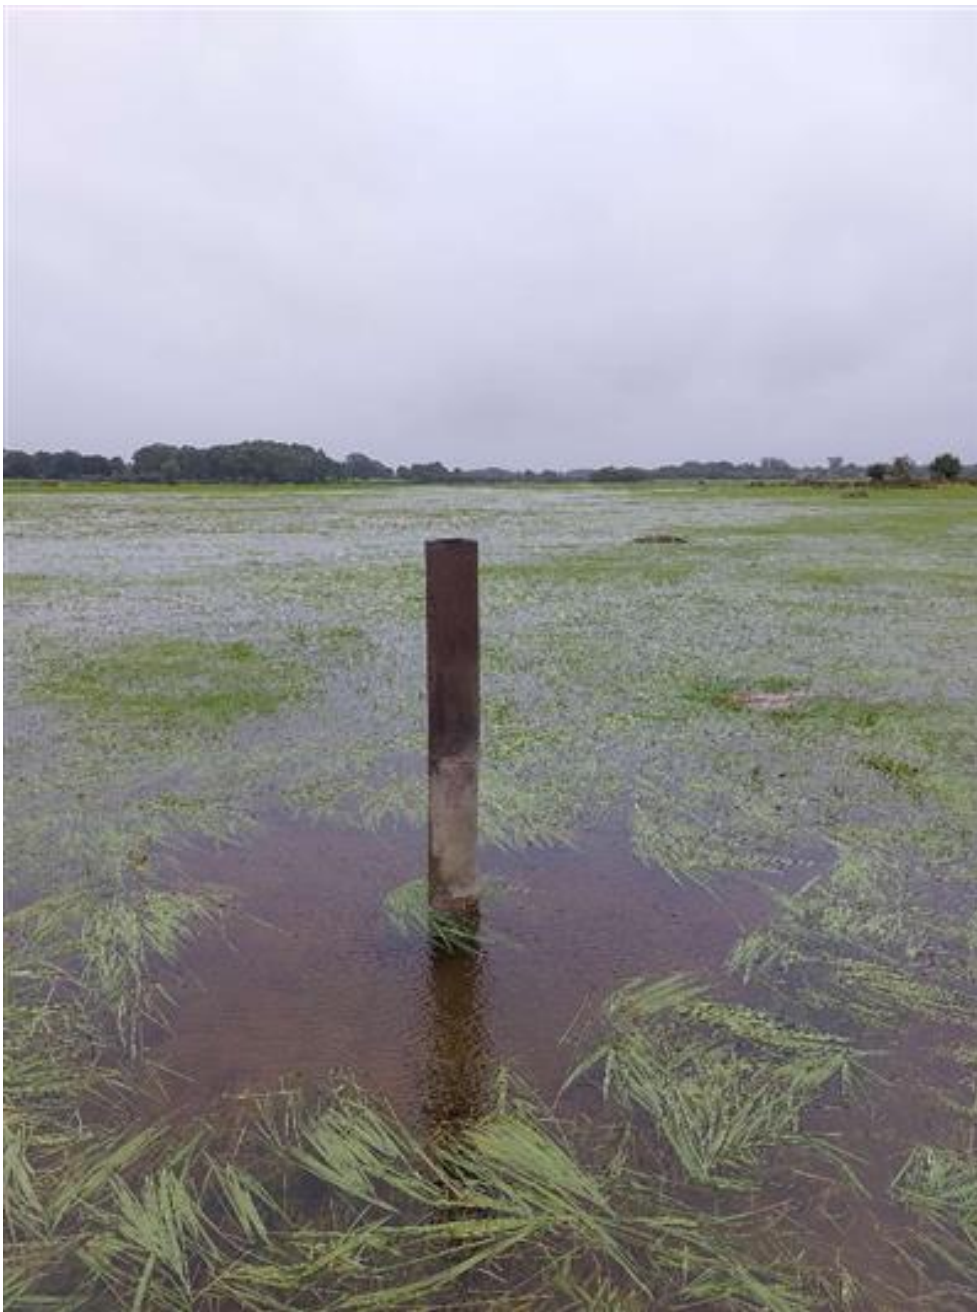
Figure 12 ID 9 – Monitoring well (condition unknown)

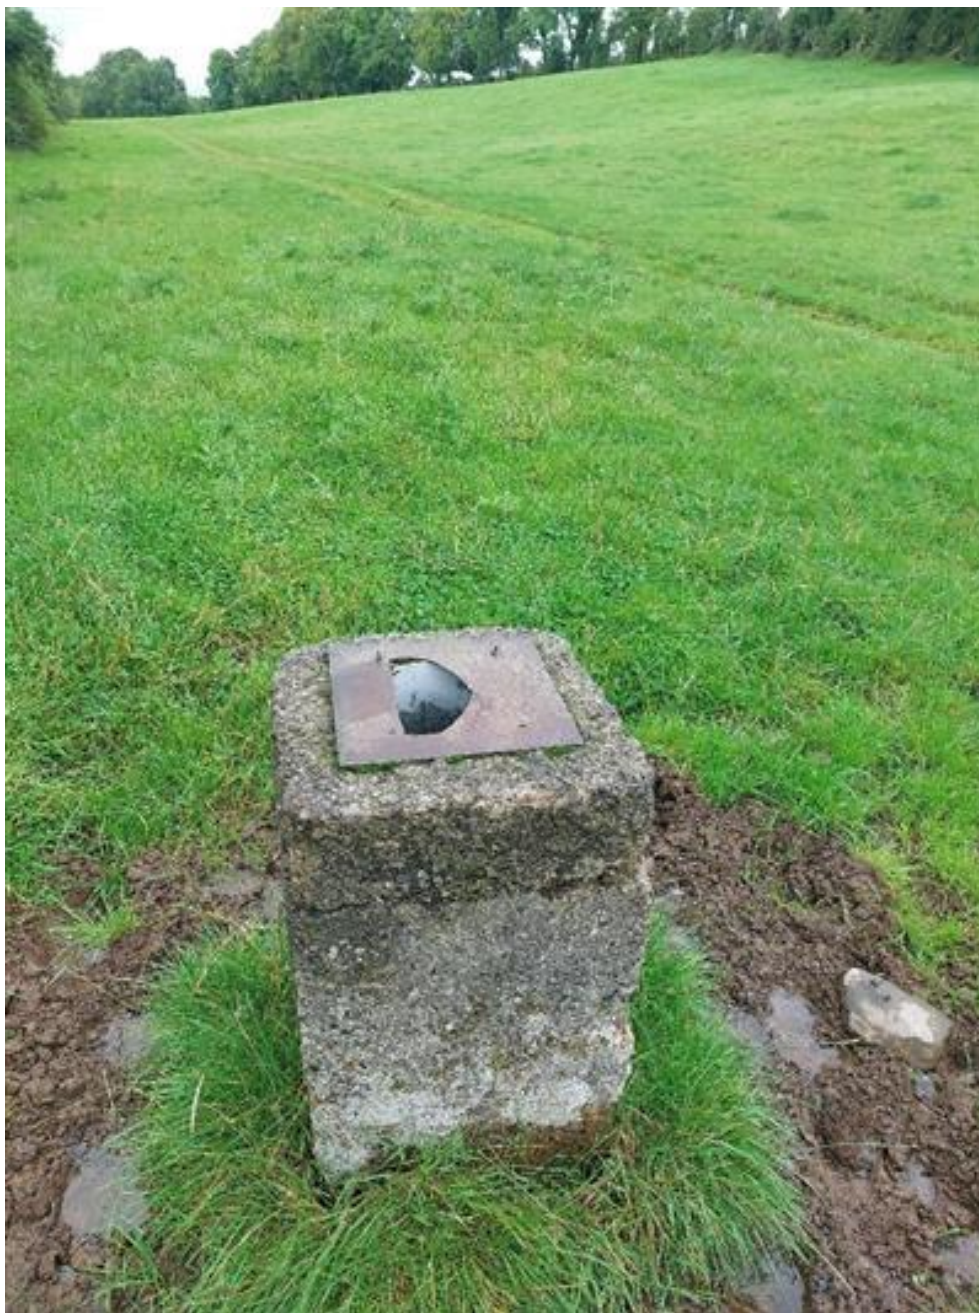
Figure 13 ID 10 – Monitoring well (condition unknown)

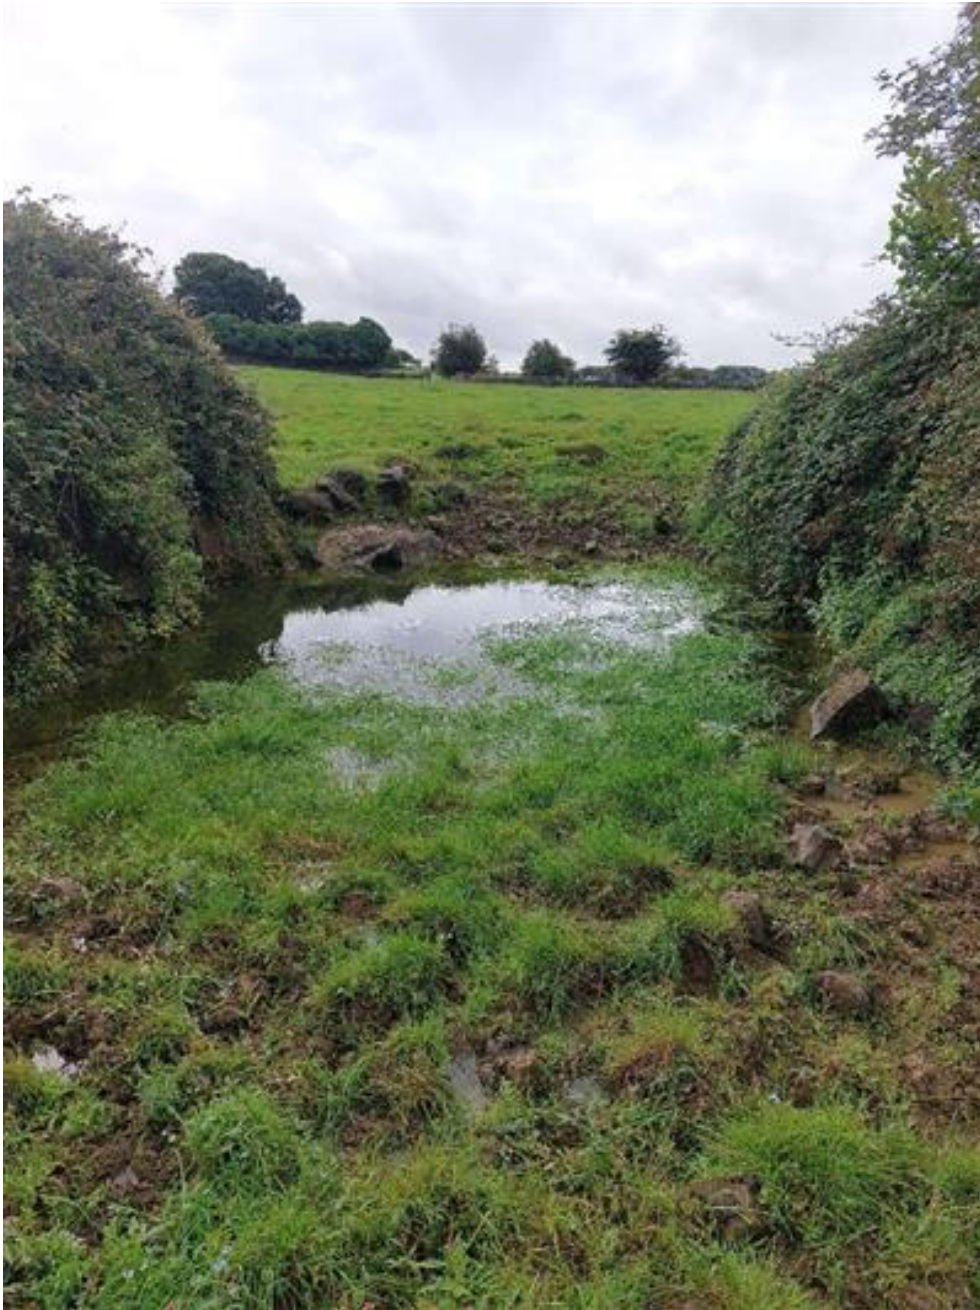
Figure 14 ID 11 Enclosed depression - possible estavelle

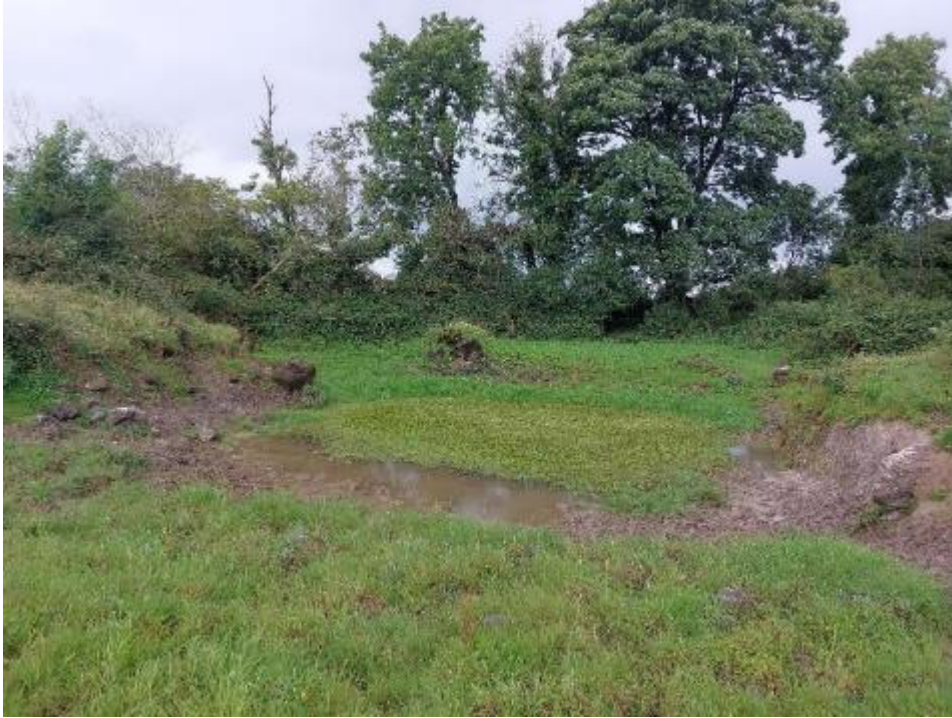
Figure 15 ID 12 – Enclosed depression - possible estavelle

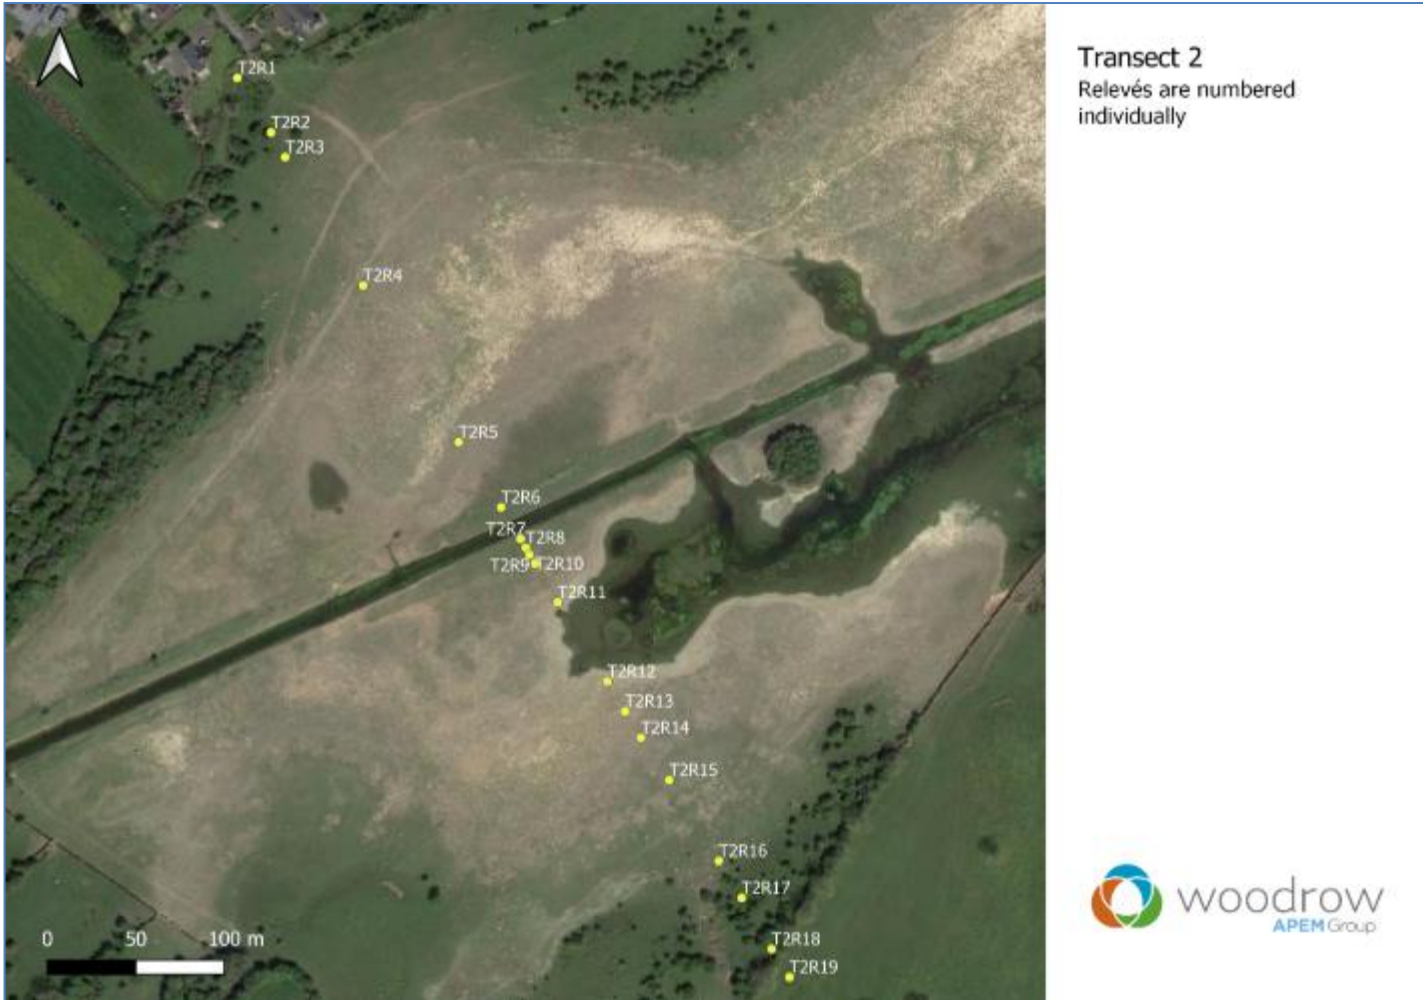
Figure 17 Transect 2 and the surrounding area, Rahasane Turlough, Co. Galway

Three transects were selected for resurvey from those defined by RPS (2016): Transects 2, 4 and 6. These transects are shown in Figures 16 to 19. These transects were selected in order to give as broad a coverage of the turlough as possible in the time available, and to cover a diversity of habitat types with a representative geographical spread. This selection process made use of the review of the previous datasets as described above, as well as drone footage of the region carried out by CDM Smith during the summer of 2021.

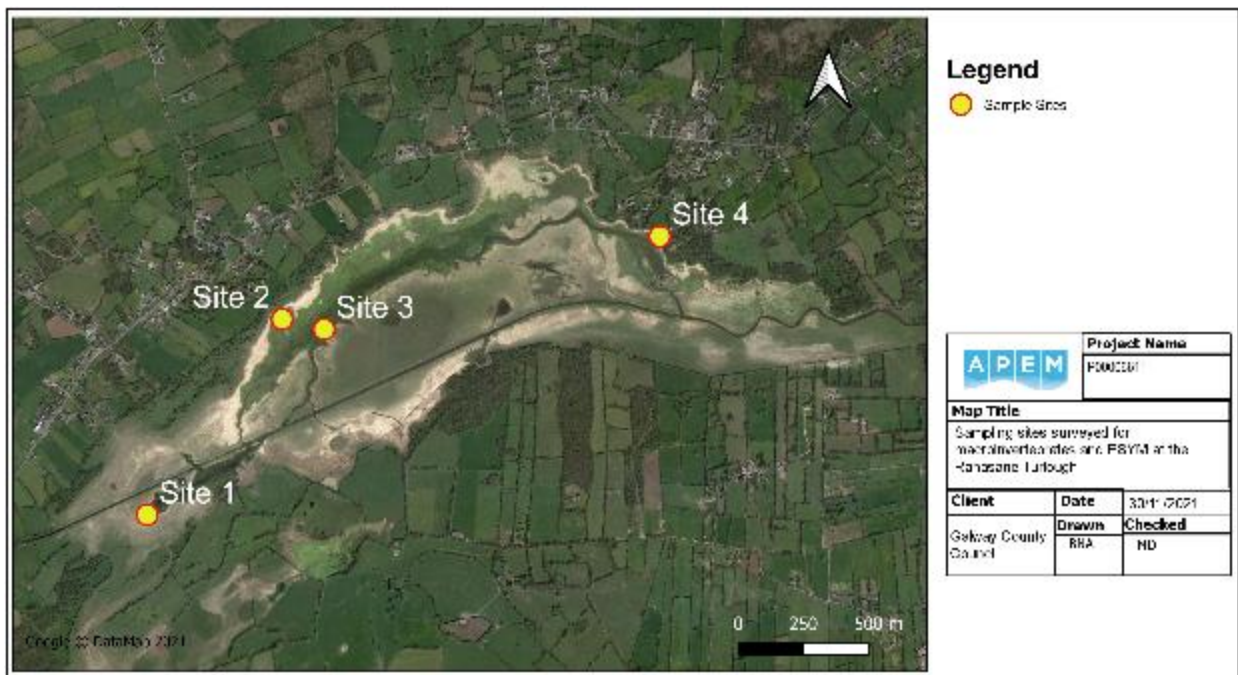
Figure 20 The four sampling sites surveyed for macroinvertebrates and PSYM analysis

Macroinvertebrate sampling was carried out at four locations at the Rahasane Turlough on 25 August 2021 (Figure 20). The substrate at each site was comprised of semi-permanent wetted areas with grazed grassland, with submerged, emerging and floating leaved aquatic plants present.

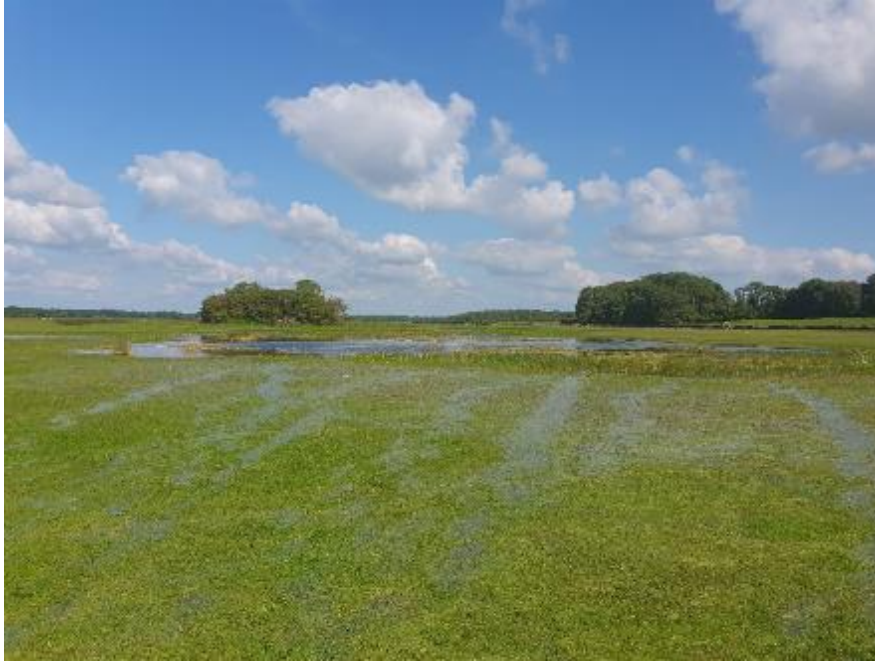
Figure 21 Photo of Site 1

The survey was conducted by sweep netting through the submerged vegetation at all mesohabitats present at each location, using a standard pond net with 1mm mesh size for a period of 1 minute at sites 1 and 4 and 30 seconds each at sites 2 and 3 which were near one another (bringing the total to a 3-minute sample) as outlined in the PSYM method by Howard (2002). The samples were preserved in Isopropyl alcohol on site to be returned to the lab, where they were combined into a single composite sample, for as detailed an identification as possible (genus and species where possible).

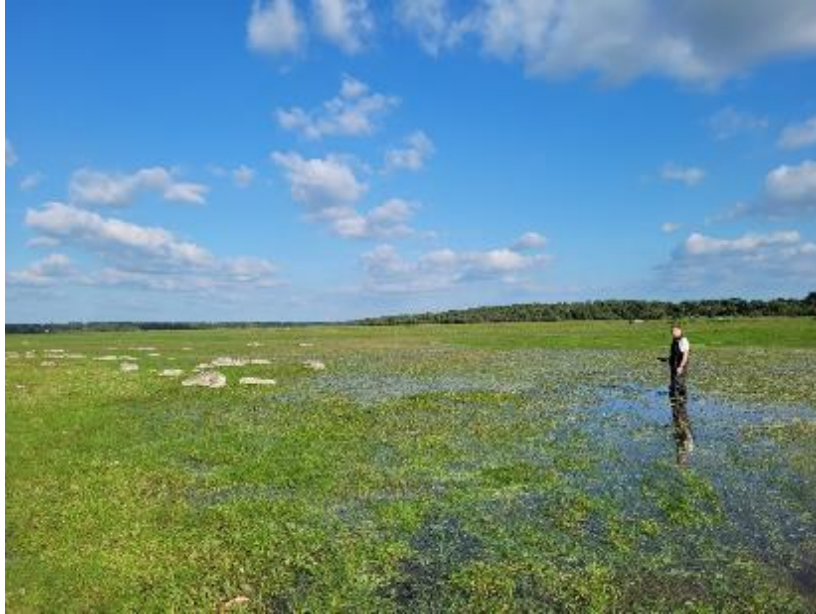
Figure 22 Photo of Site 2

Pond macrophytes were surveyed by wading the perimeter of the dry and shallow water areas at each of the four locations, with deeper areas sampled using the pond net. Species were recorded on the PSYM plant recording sheet as outlined in Howard (2002). A list of the macrophyte taxa recorded can be found in Appendix 3 of this report.

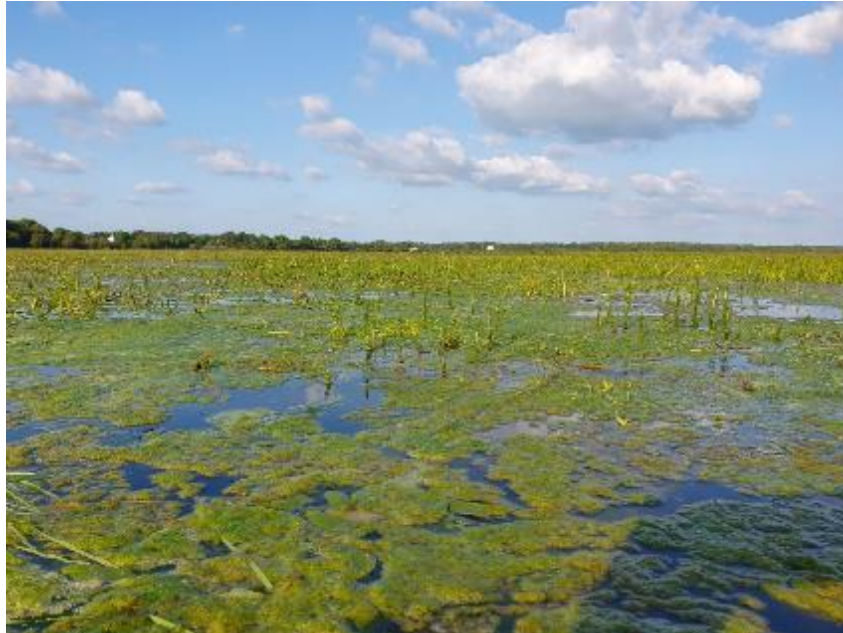
Figure 23 Photo of Site 3

2000) and the taxonomic richness of beetles is negatively correlated with nutrient enrichment in standing waters. Therefore, these results suggest potential nutrient impact at the site. Slimy floating algae was visually observed at all sites, but with increased coverage at Site 3 (Figure 23), as were livestock and horses, providing further evidence of nutrient impact.

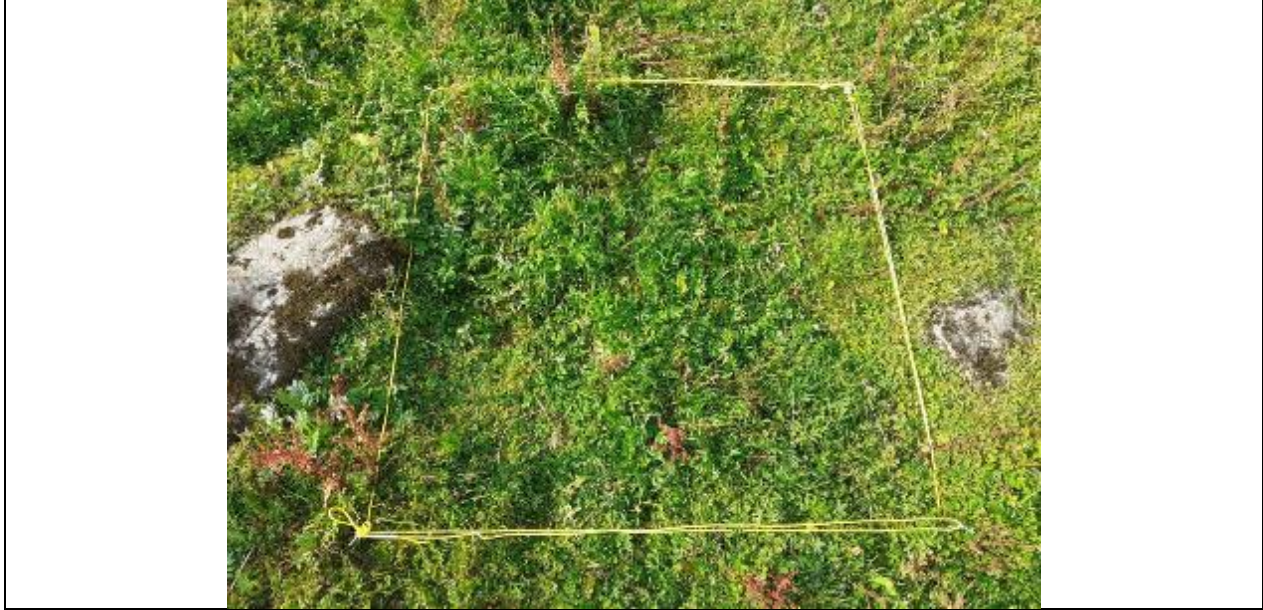
Table 14 Notes and photo from Relevé 4, Transect 2 (T2R4), Rahasane Turlough

Comments, notes, or threats:

An area that is level overall but locally undulating. It is grazed by sheep and ponies, with some dunging and poaching evident. The ground was dry underfoot at the time of the survey.

The vegetation at this location is dominated by creeping bent (*Agrostis stolonifera*) and silverweed (*Potentilla anserina*), with abundant common marsh-bedstraw (*Galium palustre*) and water forget-me-not (*Myosotis scorpioides*). Water-pepper (*Persicaria amphibia*) and water mint (*Mentha aquatica*) also featured significantly in the vegetation. Some yellow cress (*Rorippa* sp.) was noted in the quadrat.

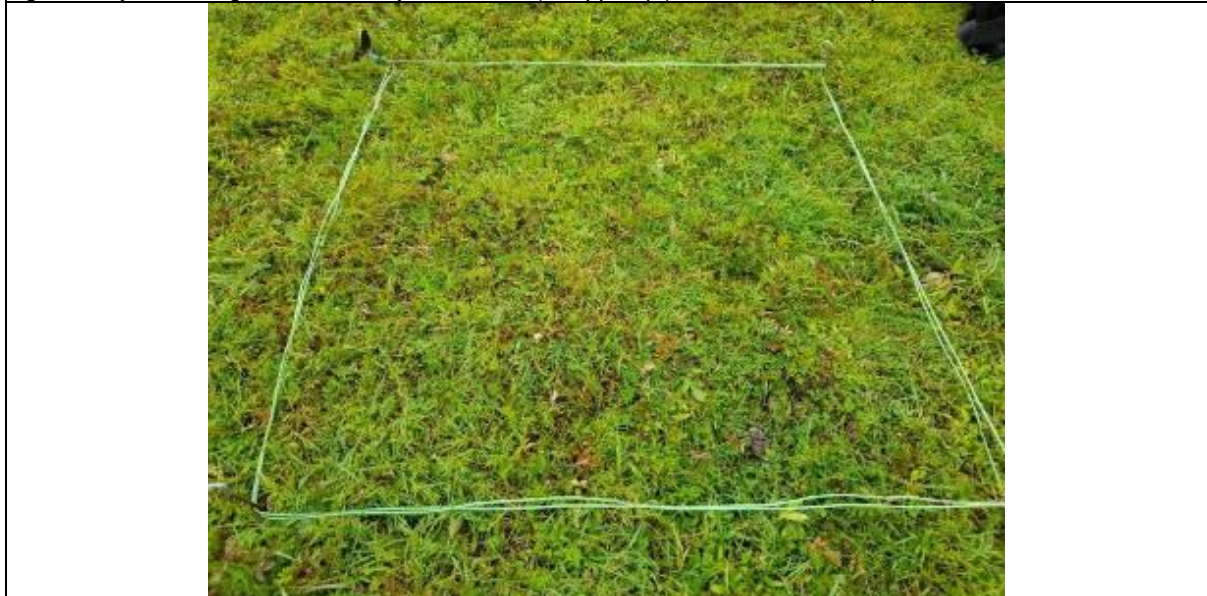
Table 15 Notes and photo from Relevé 6, Transect 2 (T2R6), Rahasane Turlough

Comments, notes, or threats:

Grazed grassland, which is close-cropped by sheep and a few horses. The relevé is located on a slight rise by the river. The ground in this area was dry underfoot at the time of the survey.

No bare ground was observed; the vegetation though short was quite dense with some overlapping of layers observed. The vegetation was dominated by silverweed (*Potentilla anserina*), white clover (*Trifolium repens*) and creeping bent (*Agrostis stolonifera*) and appeared somewhat improved in character.

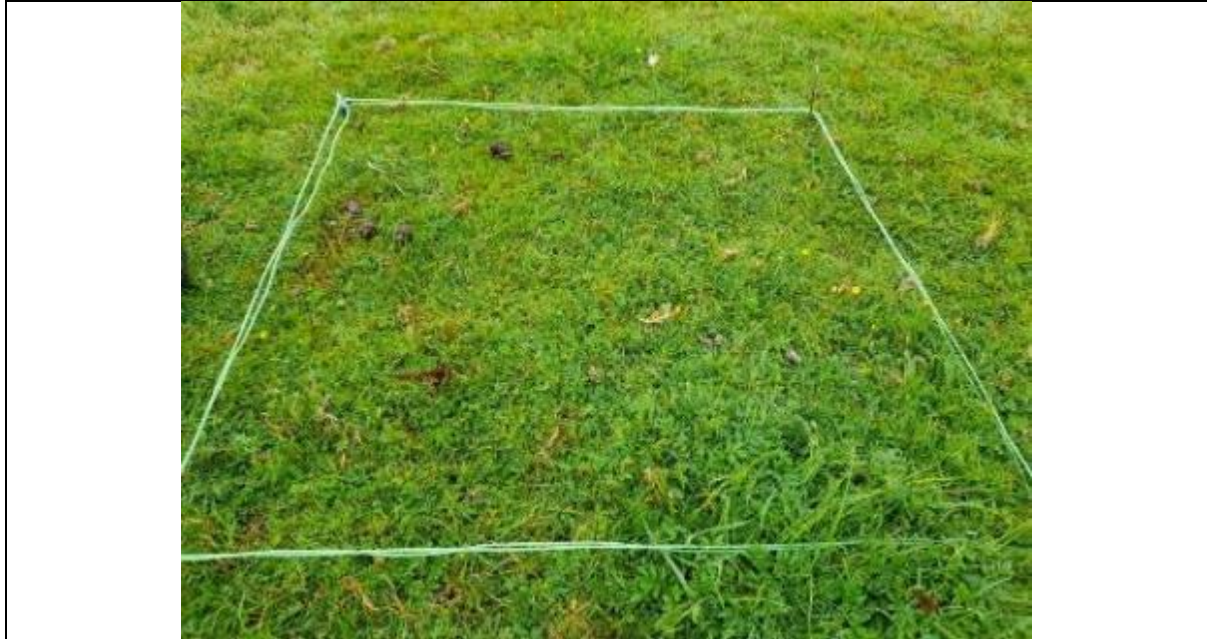
Table 16 Notes and photo from Relevé 12, Transect 2 (T2R12), Rahasane Turlough

Comments, notes, or threats:

An area that was 3 metres from standing water at the time of the survey. The vegetation was grazed very short by sheep, with some bare ground and poaching by sheep. There was also some poaching observed in the general area outside the quadrat. The ground in this area is level and was firm and dry underfoot at the time of the survey.
