5 Years Annual Monitoring of Rahasane Turlough

– Post works on FRS

Galway County Council

December 2021

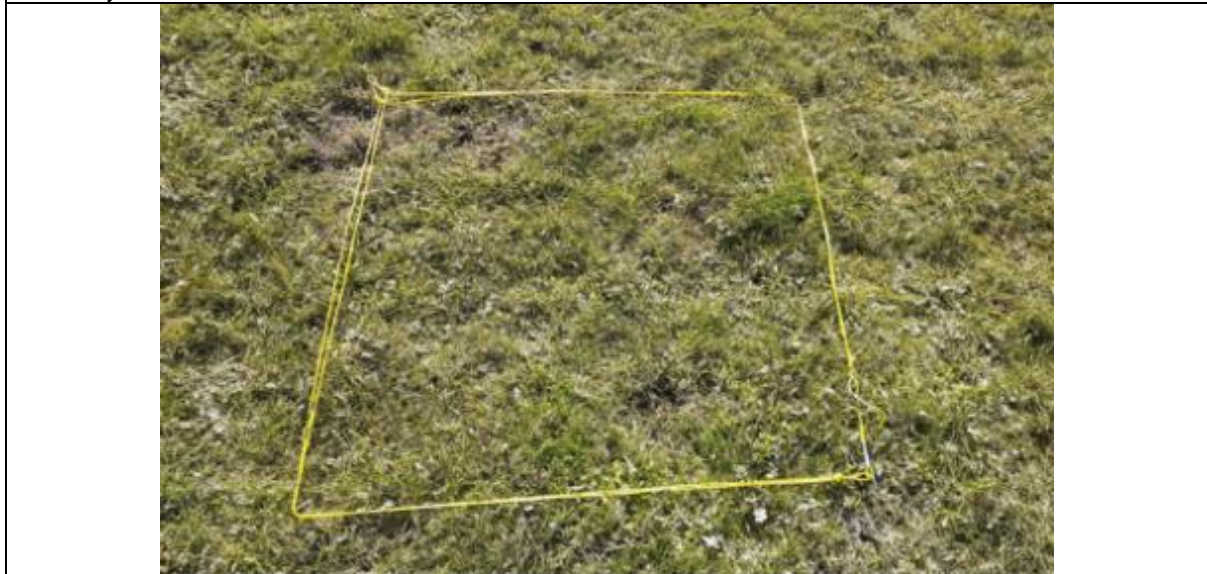
Table 17 Notes and photo from Relevé 16, Transect 2 (T2R16), Rahasane Turlough**Comments, notes, or threats:**

This relevé is located on a slight north-facing slope, near some hawthorn trees. The ground was very firm and dry. The general area around the quadrat has occasional mossy rocks. The area was tightly grazed by sheep at the time of the survey, posing a threat from overgrazing and poaching.

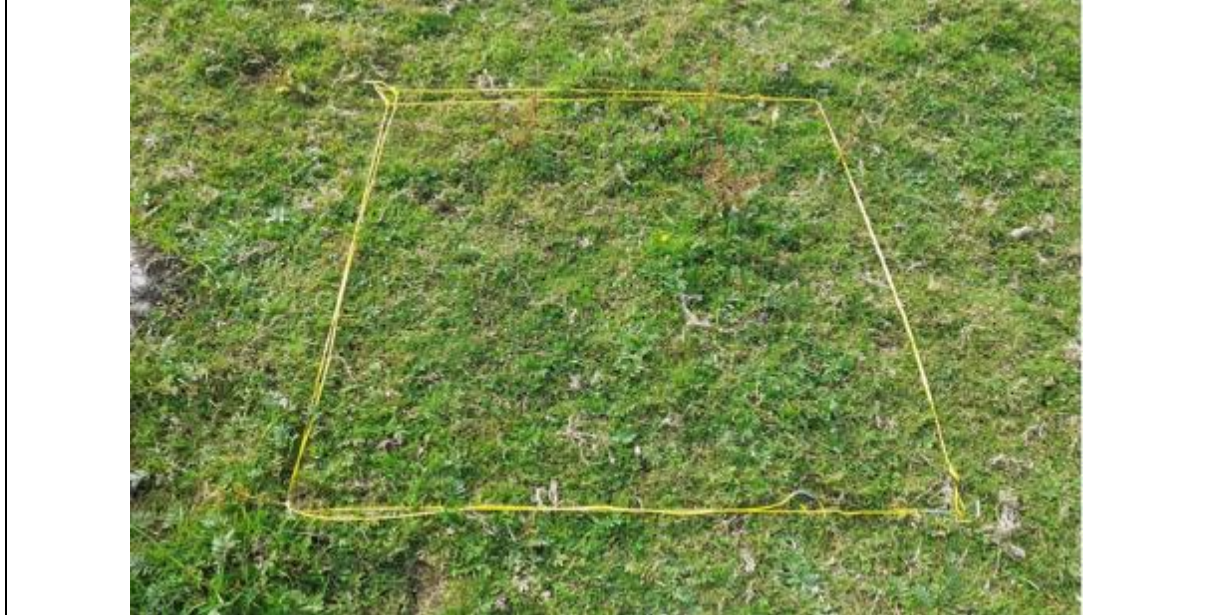
**Table 18 Notes and photo from Relevé 5 Transect 4 (T4R5), Rahasane Turlough****Comments, notes, or threats:**

The ground in this area has a slightly undulating surface and the relevé is located approximately 30 metres from the water's edge. No poaching was recorded within the quadrat, but some slight poaching was noted in the surrounding area. Autumn hawkbit (*Scorzoneroides autumnalis*) was present in some of the surrounding area but not recorded within the quadrat.

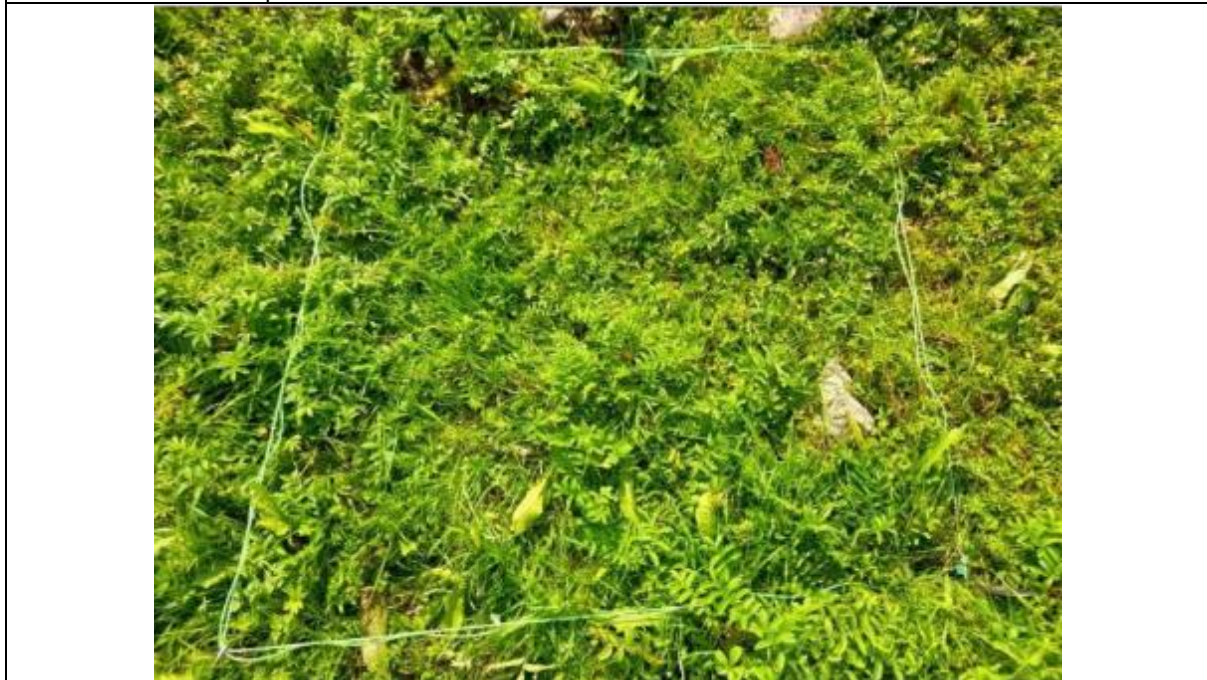
Table 19 Notes and photo from Relevé 12 Transect 6 (T6R12), Rahasane Turlough

Comments, notes, or threats:

This relevé is located within an area of level ground, at the margin of the rise up to the central channel. This area is grazed by sheep and cattle, and some dung was present at the time of the survey. The ground was dry and firm underfoot at the time of surveying.

The vegetation is dominated by silverweed (*Potentilla anserina*) and creeping bent (*Agrostis stolonifera*). Common sedge (*Carex nigra*), creeping buttercup (*Ranunculus repens*), water forget-me-not (*Myosotis scorpioides*), red fescue (*Festuca rubra*), curled dock (*Rumex crispus*) and common marsh-bedstraw (*Galium palustre*) are all quite abundant in the vegetation.

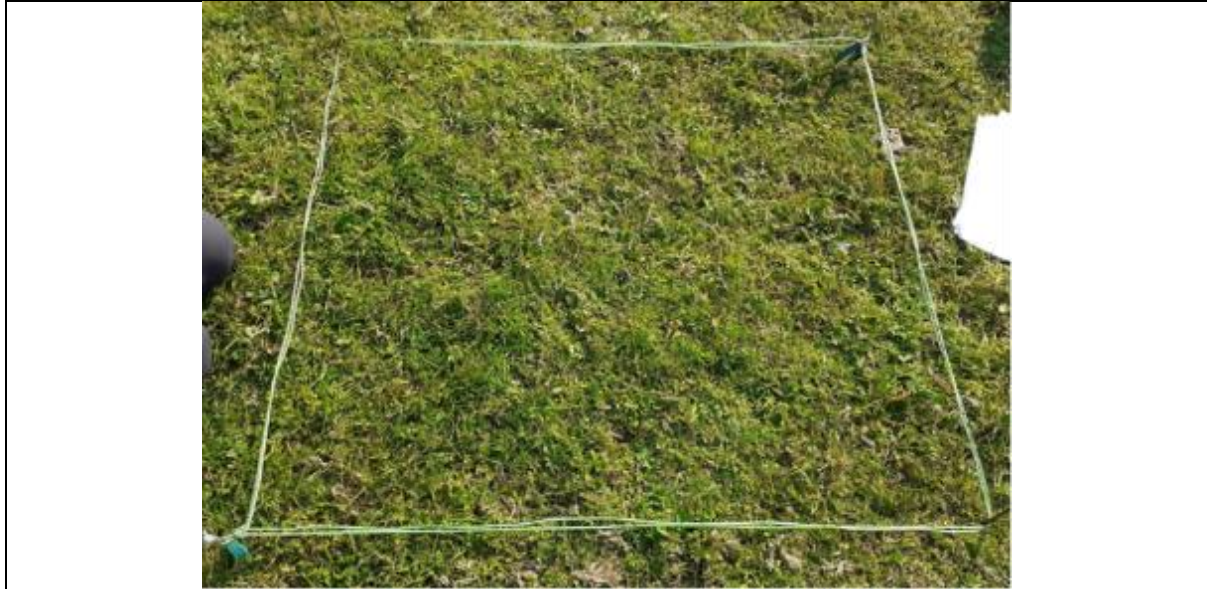
Table 20 Notes and photo from Relevé 16, Transect 6 (T6R16), Rahasane Turlough

Comments, notes, or threats:

This area was closely grazed by sheep and cattle, both of which were present at time of survey. The ground was very firm and dry underfoot at the time of the survey. The relevé is located in a very flat area, which is almost fully vegetated. Some very slight poaching was noted in the vicinity, outside the relevé.

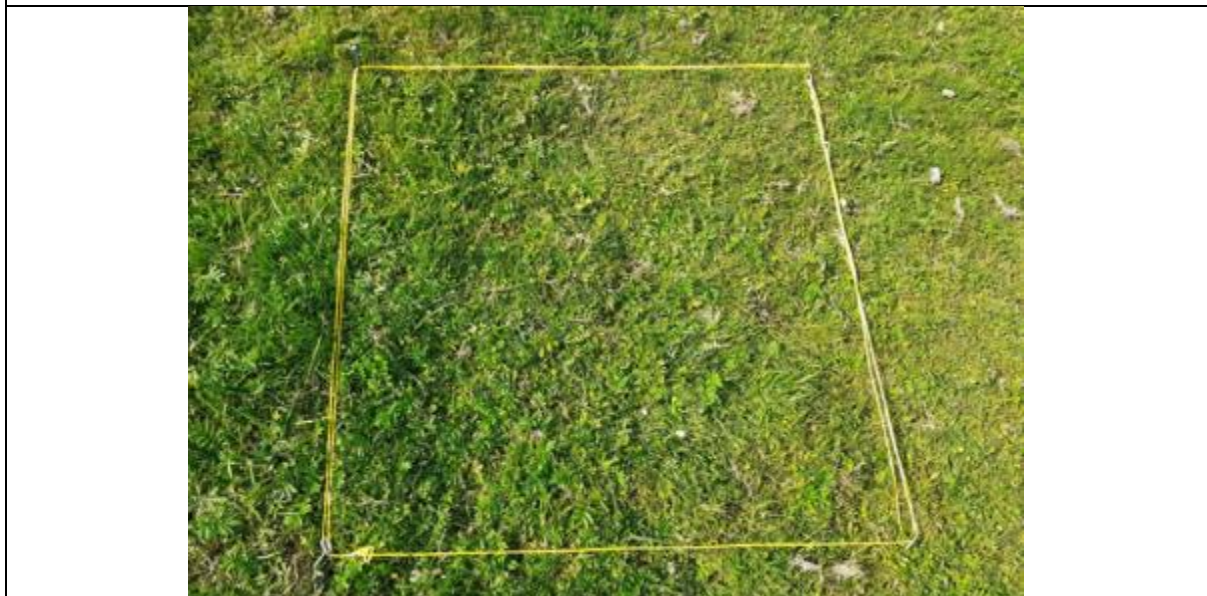
Table 21 Notes and photo from Relevé 18 Transect 6 (T6R18), Rahasane Turlough**Comments, notes, or threats:**

This relevé is located in a quite level area, fully vegetated with a continuous sward. The area is grazed by sheep and cattle; some dung was present, but no poaching was evident. The ground was dry and firm underfoot at the time of the survey.
