Dunkellin River and Aggard Stream Flood Relief Scheme

Architectural heritage and conservation report on completed works at Dunkellin and Craughwell bridges which are protected structures. Final Report March 2022

March 2022

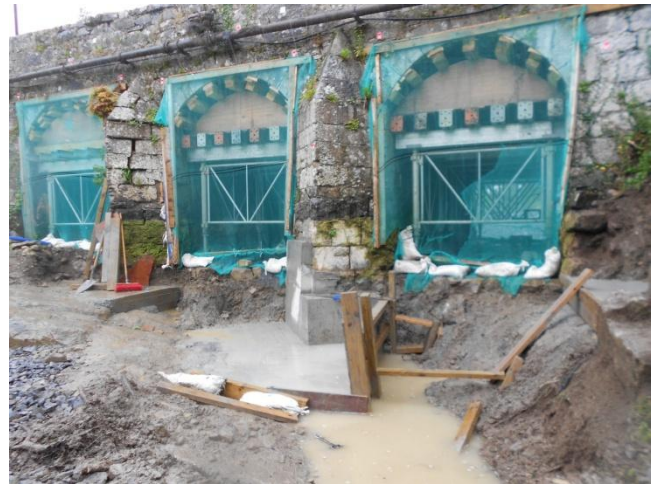
The cutwaters which are in the main river channel between arches C and D, and E and F, were in poor condition, particularly that between C and D where a large sycamore sapling was growing. Some parts of the parapet guarding walls contained loose stones and mortar joints were locally badly washed out. The consolidation of the two cutwaters and the parapet walls was not done by the OPW but by Stankard Stone Masons under contract with Galway County Council.

27 August 2019, cut waters prior to consolidation works.

Consolidation of the cutwaters involved complete dismantling and rebuilding of the cutwater between arches D and E where a large sycamore was growing, and limited resetting of stones and some replacement of damaged or missing stones in the cutwater between E and F. Both cutwaters were re-pointed following rebuilding/repair. The work was done in October / November 2019, which was late in the year so an NHL5 mix was specified. The available setting time for the mortar was also curtailed by the imminent date for the reintroduction of the diverted river water.

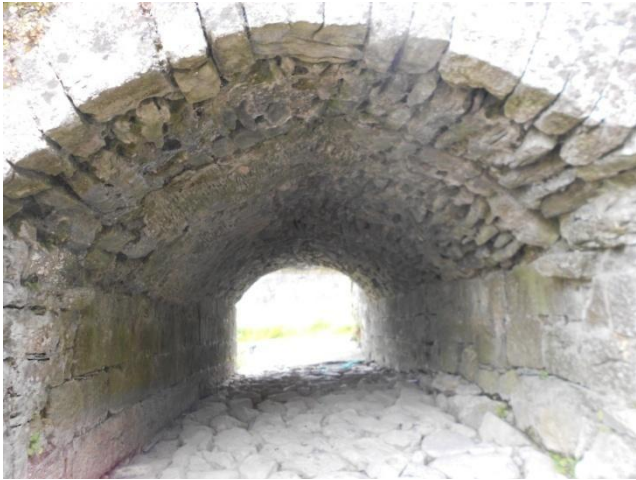
*Arch A, View looking upstream
Photographs May 2020 prior to works*

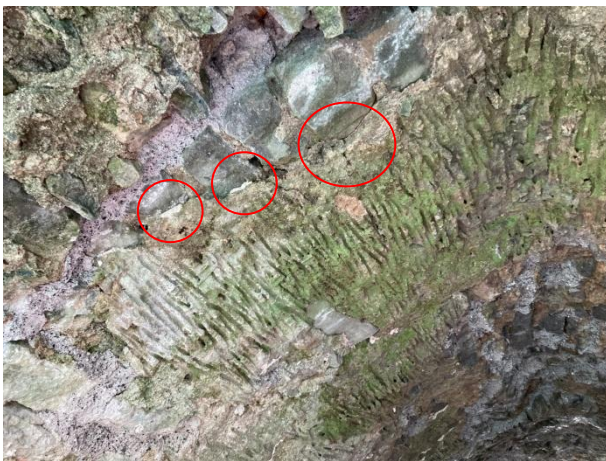
*View looking upstream
Fine mortar mix was injected behind the wicker centring to re-adhere it to the background stonework. New mortar is just visible at the edge of the wicker (circled red)*

Consolidation of the wicker centring was done by injecting mortar behind exposed edges and into gaps and cracks in the wickerwork. Mortar for injection consisted of fine sand and lime putty mix, or where gaps were very small, pure lime putty. Mortar was of a fairly liquid consistency. This was injected using a 60ml syringe with an outlet diameter of 5mm.

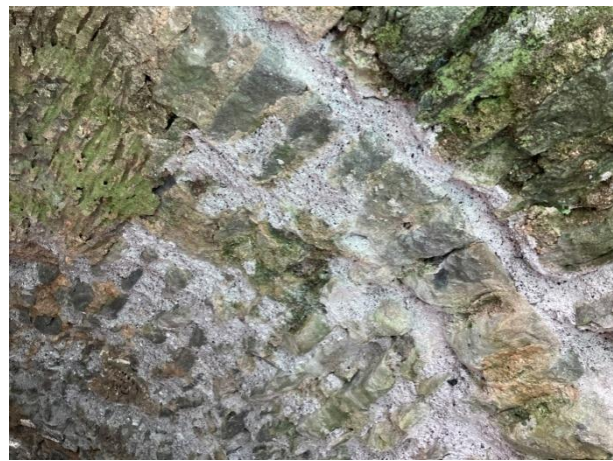
*View looking upstream
General consolidation of vault stonework using pinnings and coarse mortar mix.*

Consolidation of the vault stonework consisted of the tightening of loose stones by inserting wedges of suitable stone pieces and the vigorous throwing and securely pushing back of coarse mortar into joints between stones.

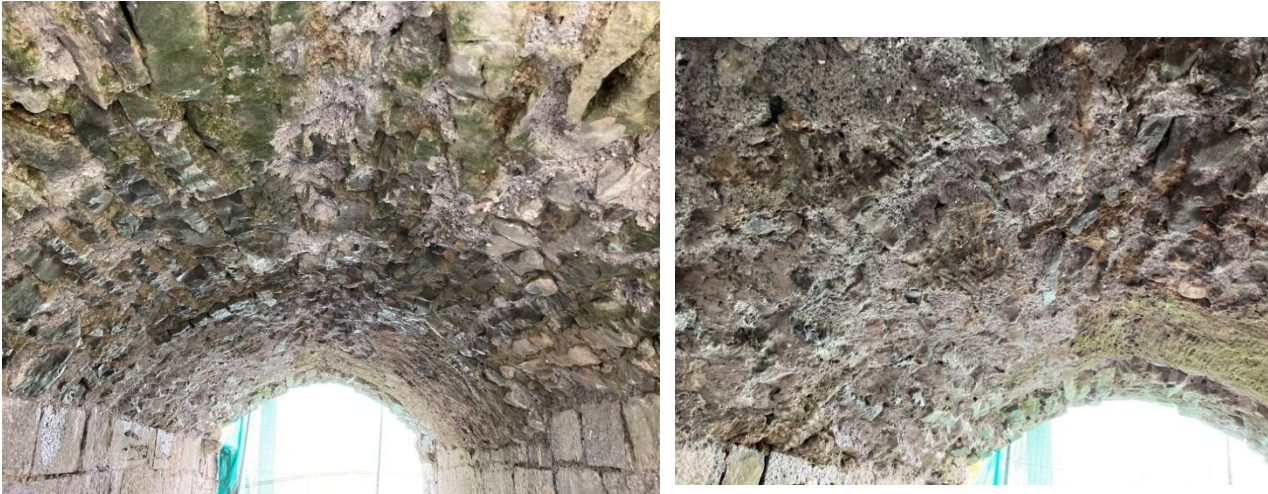
Views looking downstream, Arch A, post works.

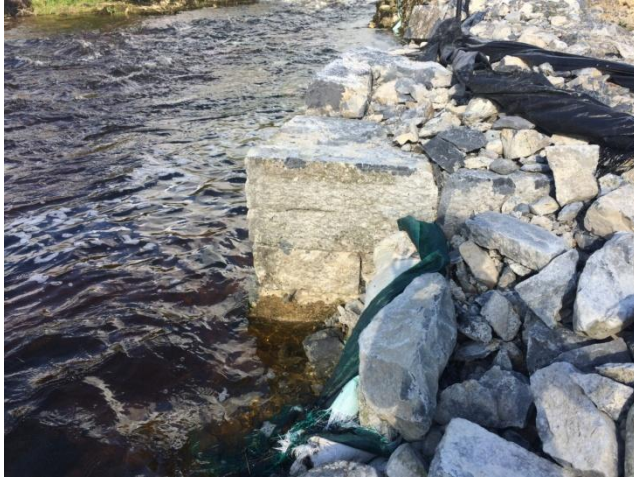
Remains of the abutment on the south side of Arch F.

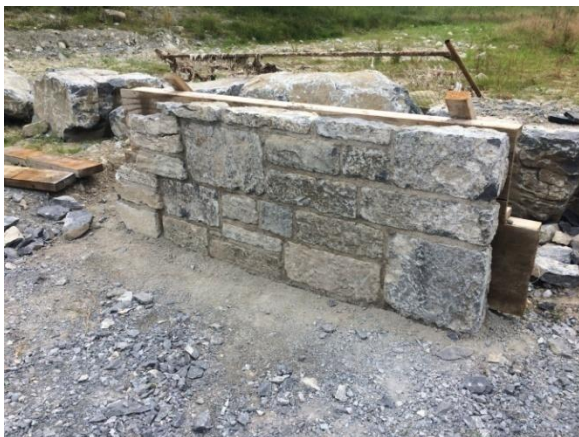
*Photographs taken July 2019.
Sample panels of stonework were erected for
approval in preparation for building of stone cladding.*

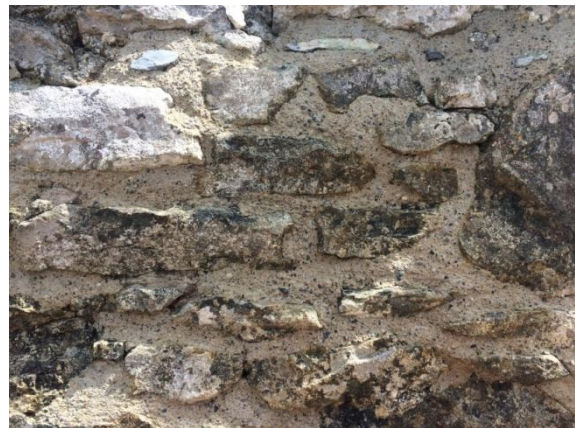
*Sample panel of re-pointing for approval.
Texture of mortar is in keeping with original.
Washed chip was added to the sand.*

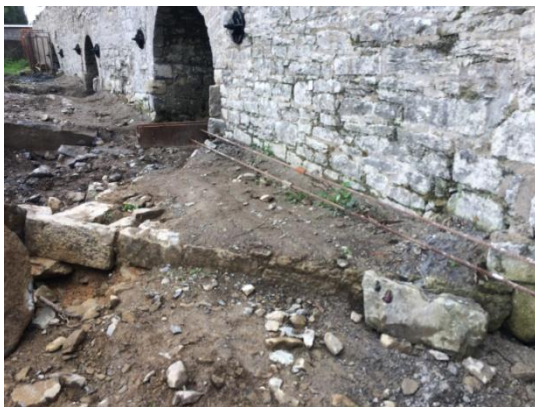
Base of cutwater between arches C and D.

Upstream view with the uncovered base of the original stone cut water between arches C and D. The stonework of the cutwater was consolidated with displaced stones reinstated in original locations where this could be established. Other salvaged stone was used to consolidate the core and to replace a few missing facing stones where necessary for stability. In line with good conservation practice conjectural rebuilding was not undertaken.

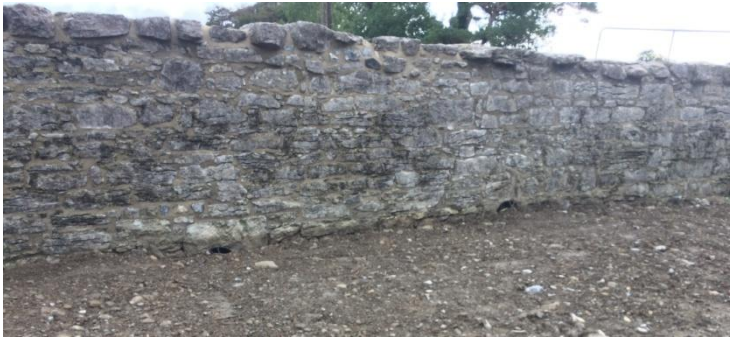
View of repaired guarding wall, downstream face.

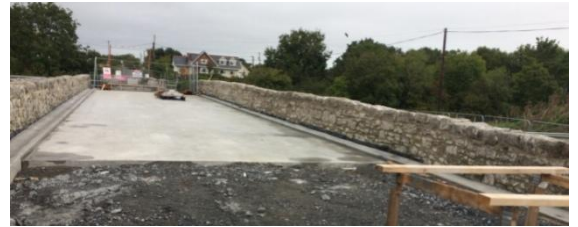
General view of repaired guarding walls at southern approach to new bridge span.

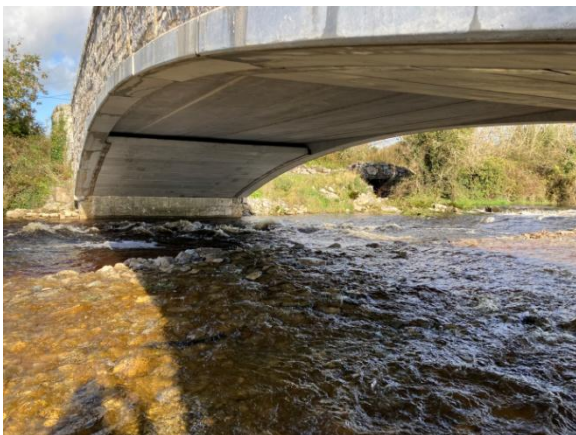
Underside view of new bridge span showing infill panels following the curve of the arch and concealing the horizontal precast beams forming the bridge deck.

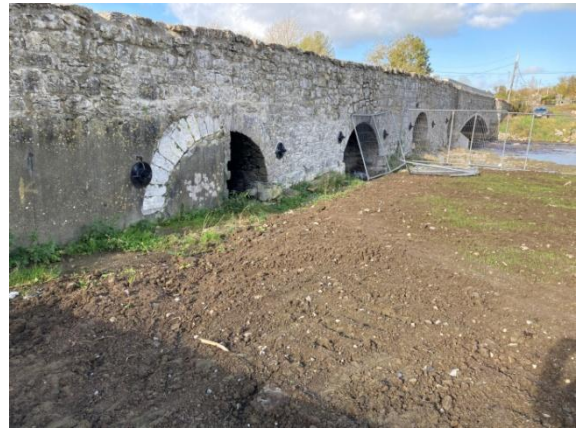
General view of upstream face of the bridge. For structural reasons the existing part infilling of arch A was not undone but the 20th century cement based plaster was carefully removed from the voussoirs to allow appreciation of the original arch and the rhythm of the whole composition.

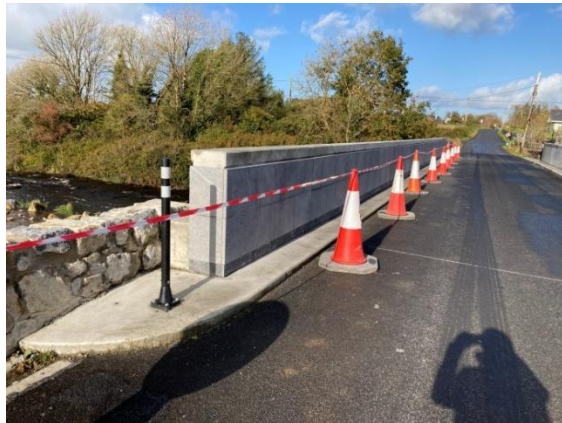
View of the bridge deck and guarding wall (looking north). Cut stone cladding was applied to the face of the concrete wall to soften its impact. Cut stone was used to clearly distinguish it from the original walls.

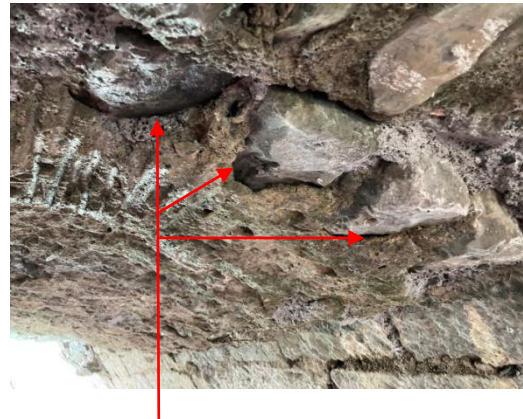
Consolidation not complete here on day of inspection

moderate wetting/drying cycle can be established in these parts of the bridge fabric. Consolidation of these areas should be completed when conditions allow.

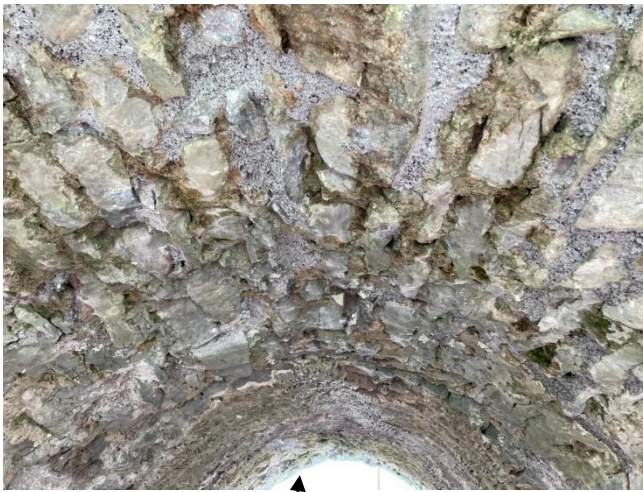
Looking downstream. ↑ General consolidation of vault seen in foreground.

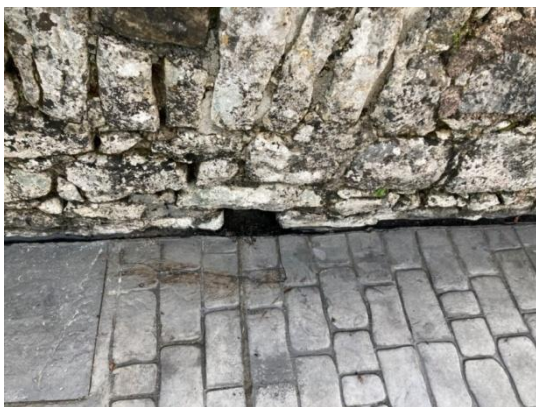
View of joint at an outlet
