## MONITORING PROPOSALS

All monitoring proposals relating to the pre-commencement, construction and operational phases of the Proposed Project are set out in the relevant chapters of the Environmental Impact Assessment Report (EIAR).

This section of the Construction and Environment Management Plan groups together all of the monitoring proposals presented in the EIAR. The monitoring proposals are presented in Table 6-1 below.

# Ecological Report- Derryclare

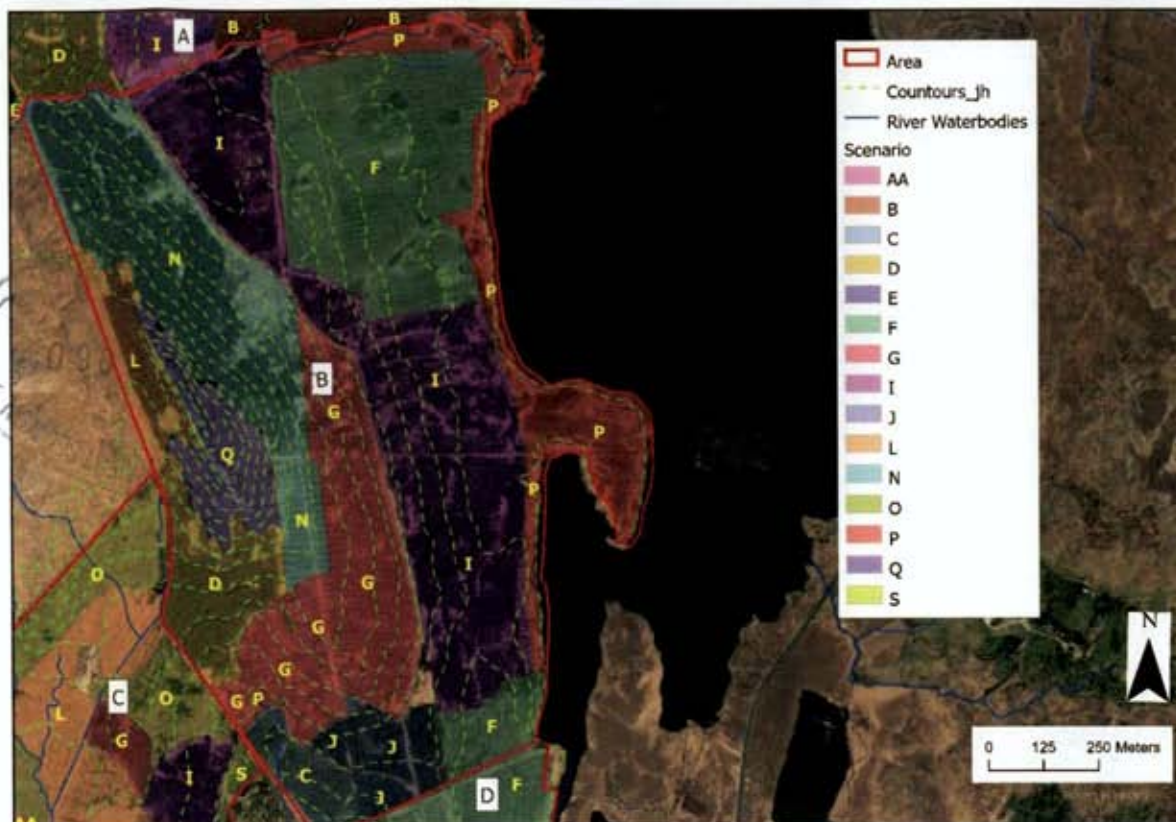
Figure 7 Management Scenarios for Area B (See Table 2)

slope have been considered. Areas with similar attributes were grouped under different scenarios (Figure 7). This exercise was carried out in order to assess the great variety of attributes over a large site. Pressures within each scenario area are described and proposed actions to achieve target habitats described (Table 2).

Table 2. Target habitats, pressures, actions and notes for various scenarios in Area B (See Figures 6&7).

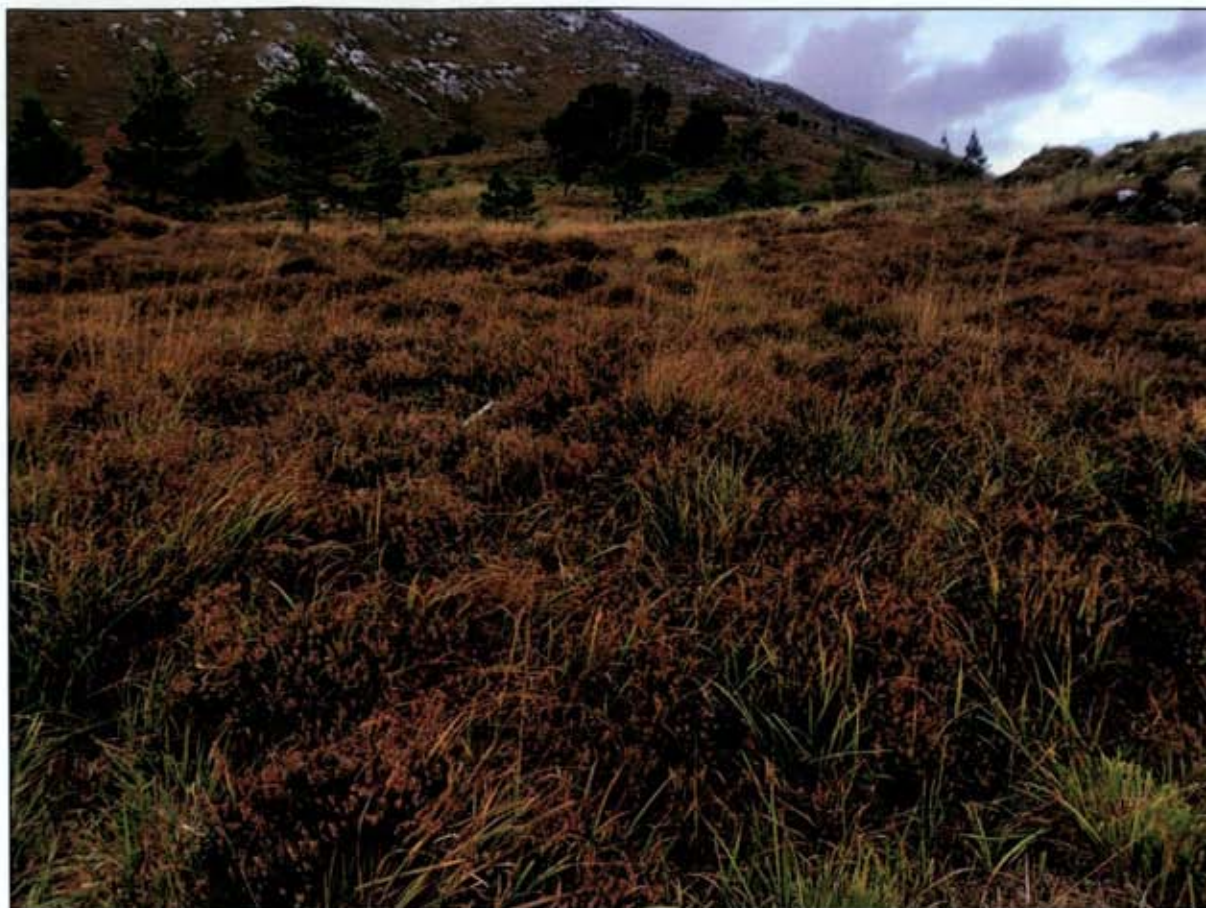
Plate 1- 1 Releve 1 E0483099; N0750634

Area of wet heath and lowland blanket bog with undeveloped woodland in the wider area.

Relevé 1	Grid reference: E483099; N750634	Date: 27/10/2022
Species	Common Name	% Cover
<b>Vascular Plants</b>		
<b>Shrubs/Dwarf Shrubs</b>		
<i>Calluna vulgaris</i>	Ling heather	80
<i>Erica tetralix</i>	Cross-leaved Heath	2
<b>Herbs</b>		
<i>Molinia caerulea</i>	Purple Moor-grass	10
<i>Potentilla erecta</i>	Tormentil	2
<b>Non-vascular Plants</b>		
<i>Calliergonella cuspidata</i>		5
<i>Sphagnum capillifolium</i>		5
<b>Bare Ground</b>		
Exposed rock		3
Poached ground		5
<b>Peat Depth</b>		
0.2-0.4m		
Habitat Classification	Wet Heath (HH3)

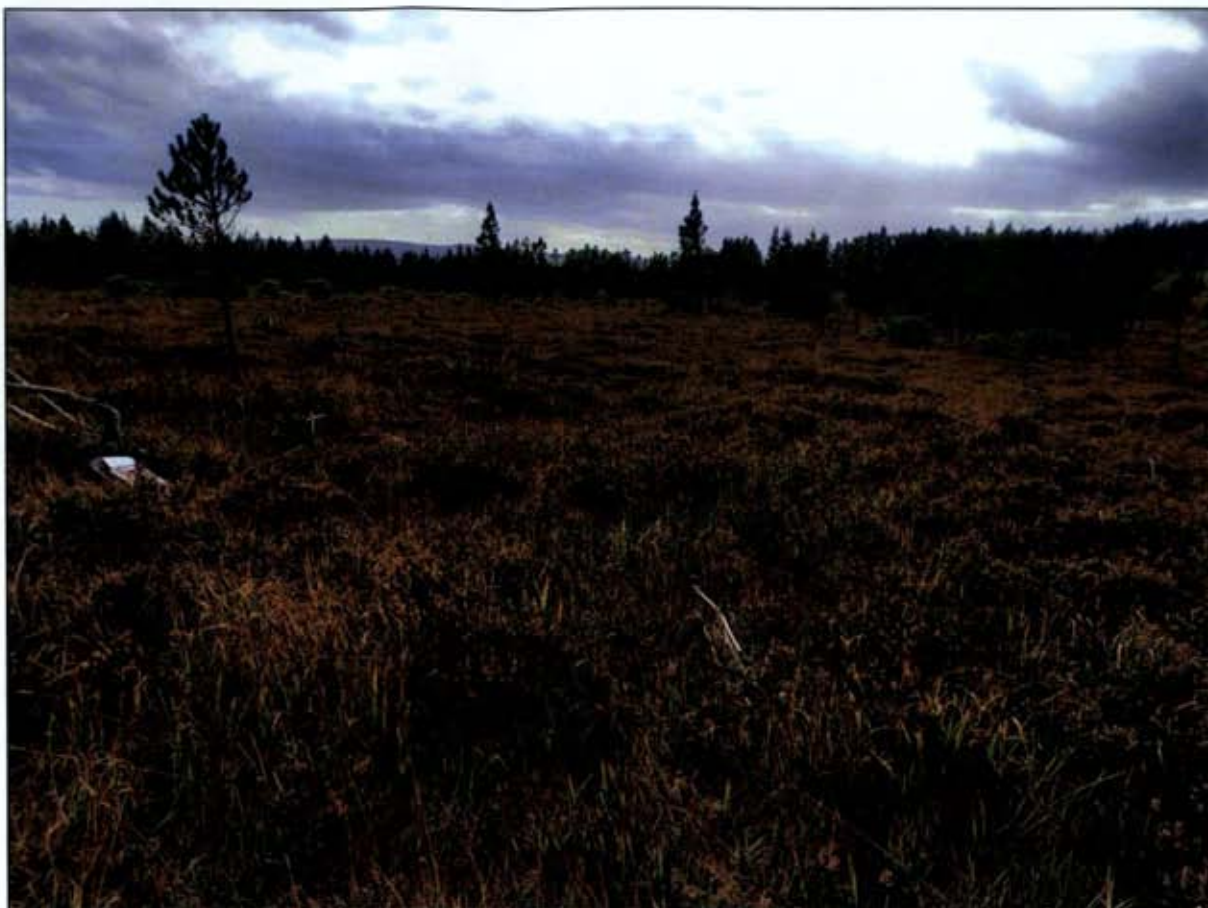
Plate 1- 2 Releve2 E0483096; N0750595

Area of wet heath and lowland blanket bog with undeveloped woodland in the wider area.

Relevé 2	Grid reference: E483096; N750595	Date: 27/10/2022
Species	Common Name	% Cover
<b>Vascular Plants</b>		
<b>Trees</b>		
<i>Pinus contorta</i>	Lodgepole pine	1
<b>Shrubs/Dwarf Shrubs</b>		
<i>Calluna vulgaris</i>	Ling heather	65
<i>Erica tetralix</i>	Cross-leaved Heath	2
<b>Herbs</b>		
<i>Molinia caerulea</i>	Purple Moor-grass	30
<i>Potentilla erecta</i>	Tormentil	+
<i>Pedicularis sylvatica</i>	Lousewort	1
<b>Non-vascular Plants</b>		
<i>Sphagnum divinum/medium</i>		15
<i>Sphagnum capillifolium</i>		15
Bare Ground		3
Peat Depth		1m
Habitat Classification	Lowland Blanket Bog (PB3)

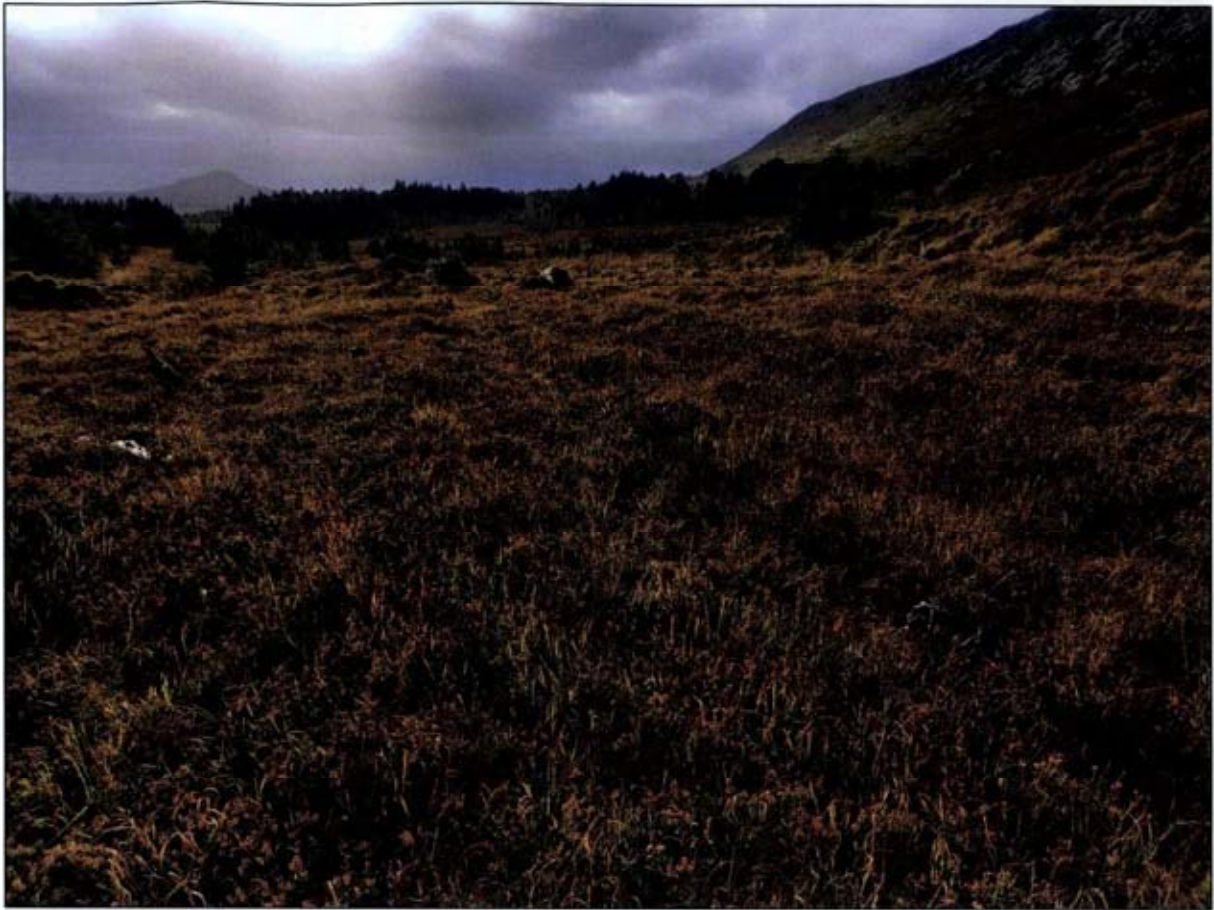
Relevé 3	Grid reference: E483189; N750684	Date: 27/10/2022
Species	Common Name	% Cover
<b>Vascular Plants</b>		
<b>Shrubs/Dwarf Shrubs</b>		
<i>Calluna vulgaris</i>	Ling heather	85
<i>Erica tetralix</i>	Cross-leaved Heath	4
<b>Herbs</b>		
<i>Molinia caerulea</i>	Purple Moor-grass	15
<i>Potentilla erecta</i>	Tormentil	3
<b>Non-vascular Plants</b>		
<i>Sphagnum divinum/medium</i>		10
<i>Campylopus introflexus</i>		3
Bare Ground		3
Peat Depth		0.5-0.9m
Habitat Classification	Wet Heath (HH3)/Lowland Blanket Bog (PB3)

Historically planted area of wet heath and lowland blanket bog with drains and old tree stumps evident.

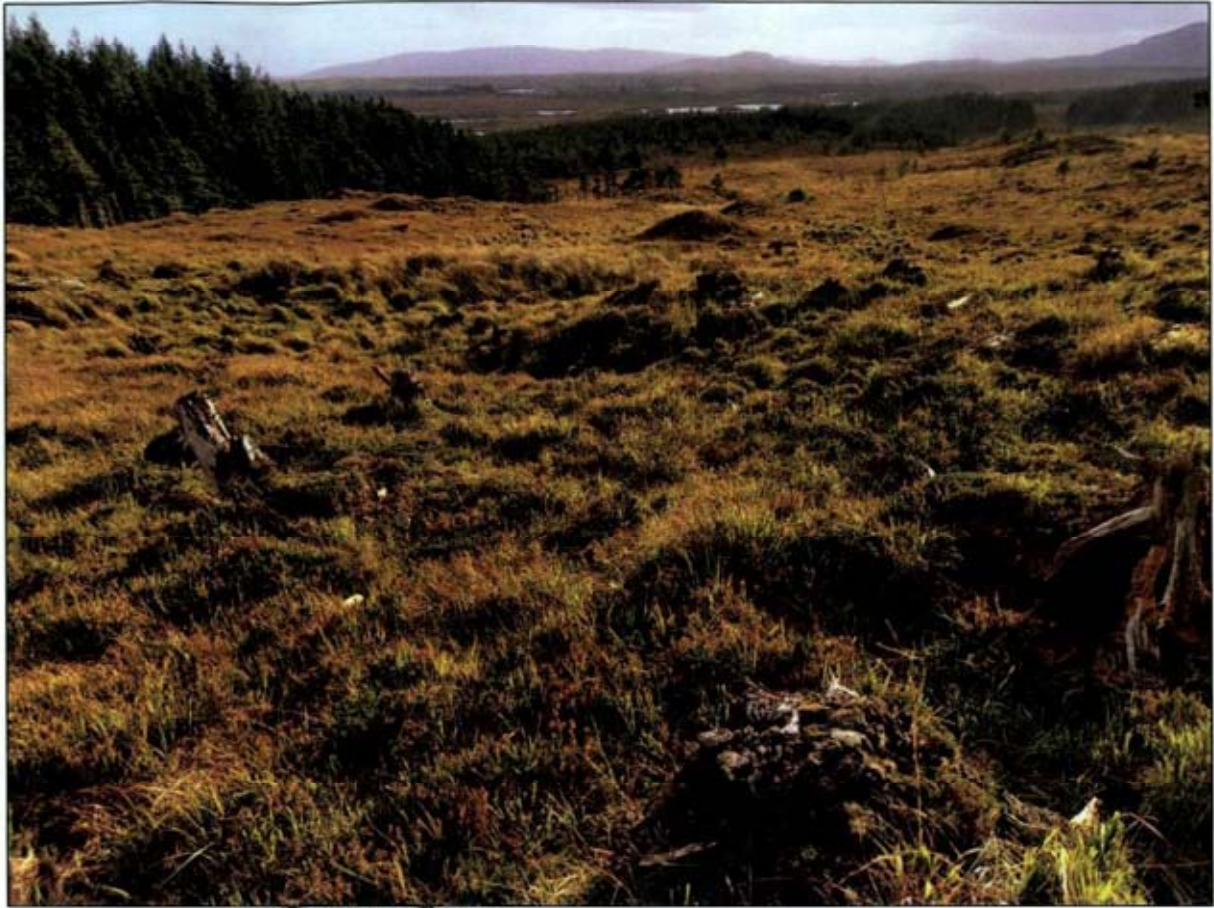
Relevé 4	Grid reference: E483258; N751020	Date: 27/10/2022
Species	Common Name	% Cover
<b>Vascular Plants</b>		
<b>Shrubs/Dwarf Shrubs</b>		
<i>Calluna vulgaris</i>	Ling heather	45
<i>Erica tetralix</i>	Cross-leaved Heath	5
<b>Herbs</b>		
<i>Molinia pupurea</i>	Purple Moor-grass	40
<i>Potentilla erecta</i>	Tormentil	1
<i>Pedicularis sylvatica</i>	Lousewort	1
<i>Blechnum spicant</i>	Hard Fern	2
<b>Non-vascular Plants</b>		
<i>Polytrichum commune</i>		+
<i>Campylopus introflexus</i>		1
Bare Ground		7
Peat Depth		0.1-0.3m
Habitat Classification		Wet Heath (HH3)

Upper gradient of Derryclare Mountain with evidence of historically planted trees

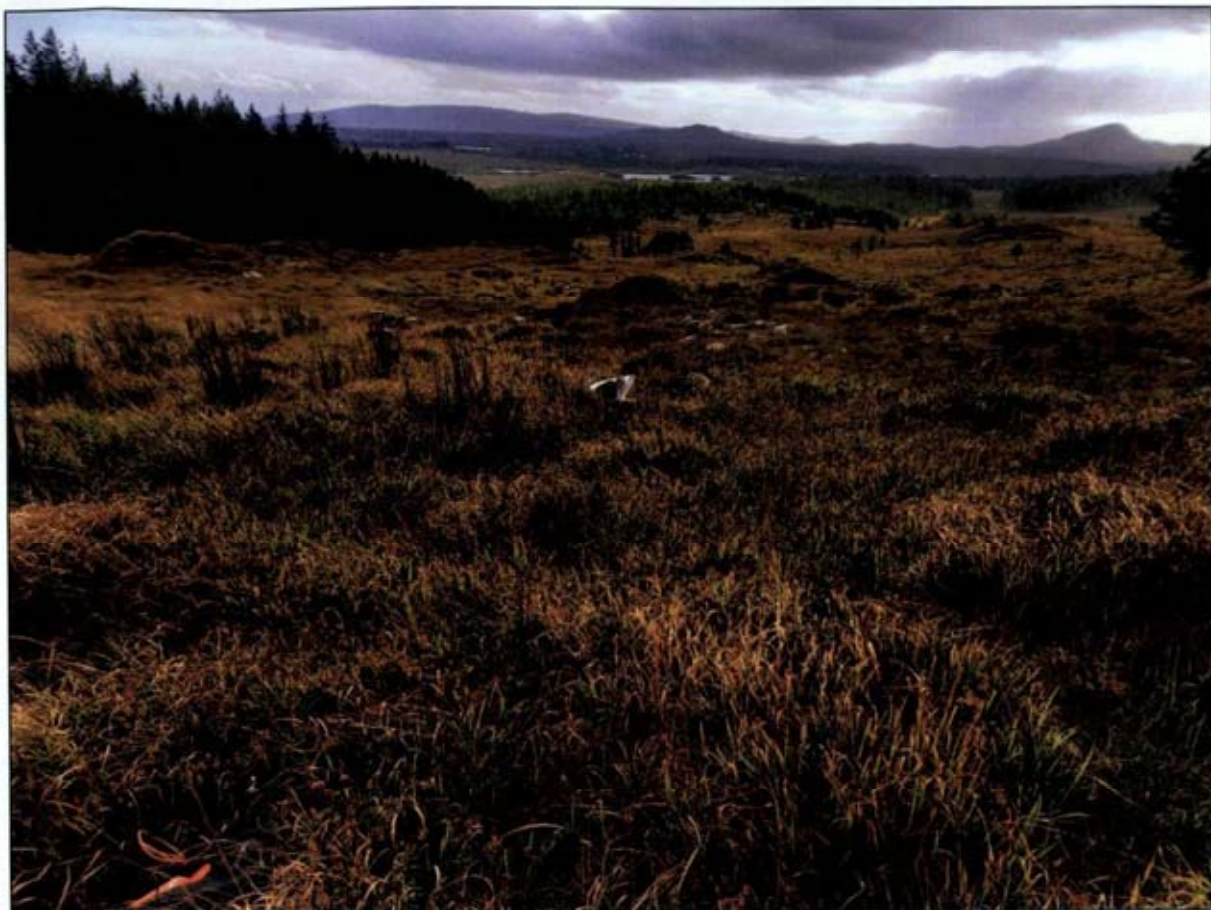
Relevé 5	Grid reference: E483272; N751043	Date: 27/10/2022
Species	Common Name	% Cover
Vascular Plants		
Shrubs/Dwarf Shrubs		
<i>Calluna vulgaris</i>	Ling heather	80
<i>Erica tetralix</i>	Cross-leaved Heath	3
Herbs		
<i>Molinia caerulea</i>	Purple Moor-grass	25
<i>Potentilla erecta</i>	Tormentil	2
<i>Pedicularis sylvatica</i>	Lousewort	1
<i>Blechnum spicant</i>	Hard Fern	2
Non-vascular Plants		
<i>Rhytidiadelphus loreus</i>		8
<i>Sphagnum divinum/medium</i>		10
<i>Cladonia portentosa</i>		+
Bare Ground		3
Peat Depth		0.3-0.6m
Habitat Classification		Wet Heath (HH3)

Upper gradient of Derryclare Mountain with evidence of historically planted trees

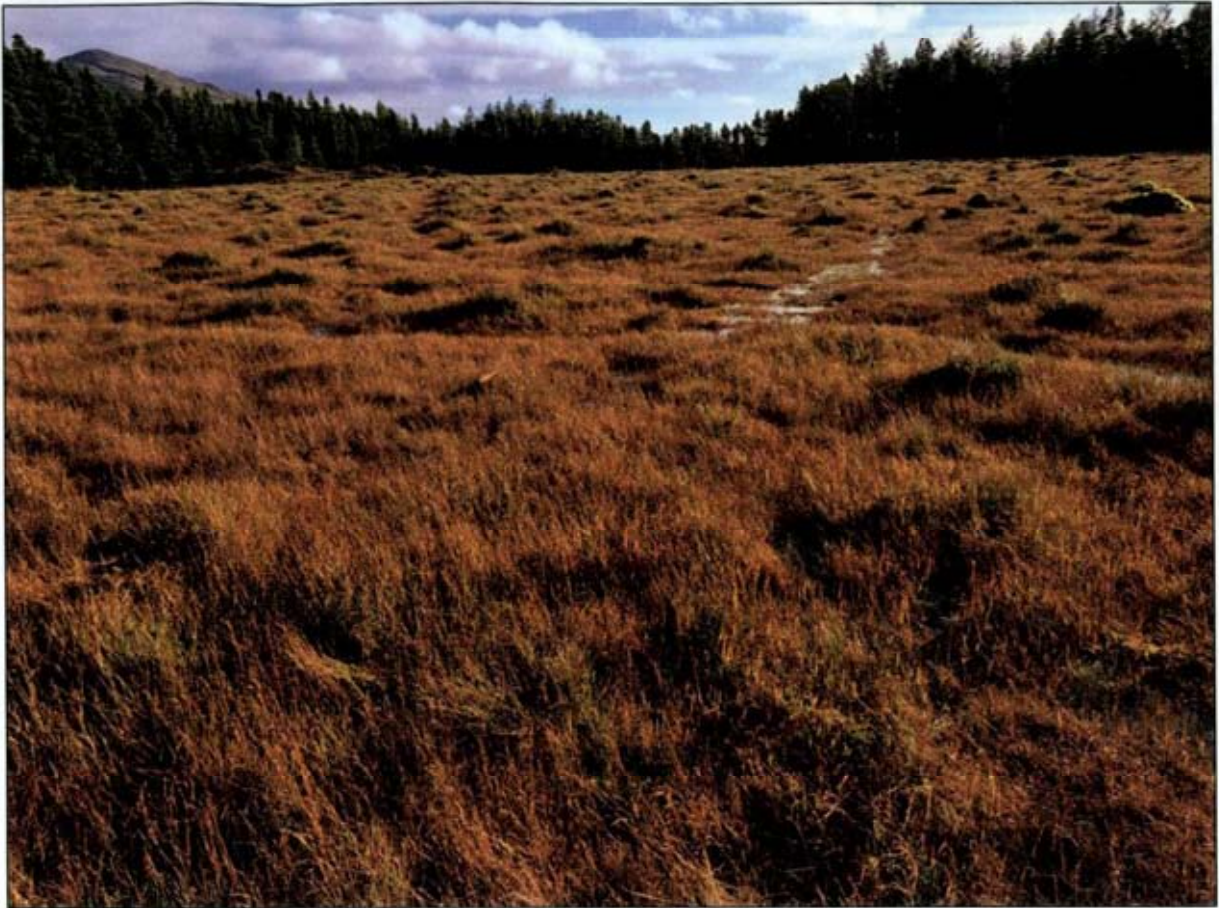
Relevé 6	Grid reference: E482455 N749133	Date: 15/11/2022
Species	Common Name	% Cover
<b>Vascular Plants</b>		
<b>Shrubs/Dwarf Shrubs</b>		
<i>Calluna vulgaris</i>	Ling heather	5
<i>Erica tetralix</i>	Cross-leaved Heath	3
<i>Myrica gale</i>	Bog Myrtle	5
<b>Herbs</b>		
<i>Molinia caerulea</i>	Purple Moor-grass	25
<i>Schoenus nigricans</i>	Black Bog rush	1
<i>Rhynchospora alba</i>	White-beak Sedge	50
<i>Eriophorum vaginatum</i>	Hare's-tail Cottongrass	5
<i>Eriophorum angustifolium</i>	Common Cottongrass	10
<i>Narthecium ossifragum</i>	Bog Asphodel	1
<b>Non-vascular Plants</b>		
<i>Sphagnum cuspidatum</i>		25
<i>Sphagnum divinum/medium</i>		5
<i>Cladonia portentosa</i>		2
<b>Pools/Bare Ground</b>		10
<b>Peat Depth</b>		>1m
<b>Habitat Classification</b>	Lowland Blanket Bog (PB3)

Area of intact and quaking blanket bog with regular pools and high coverage of Rhynchospora

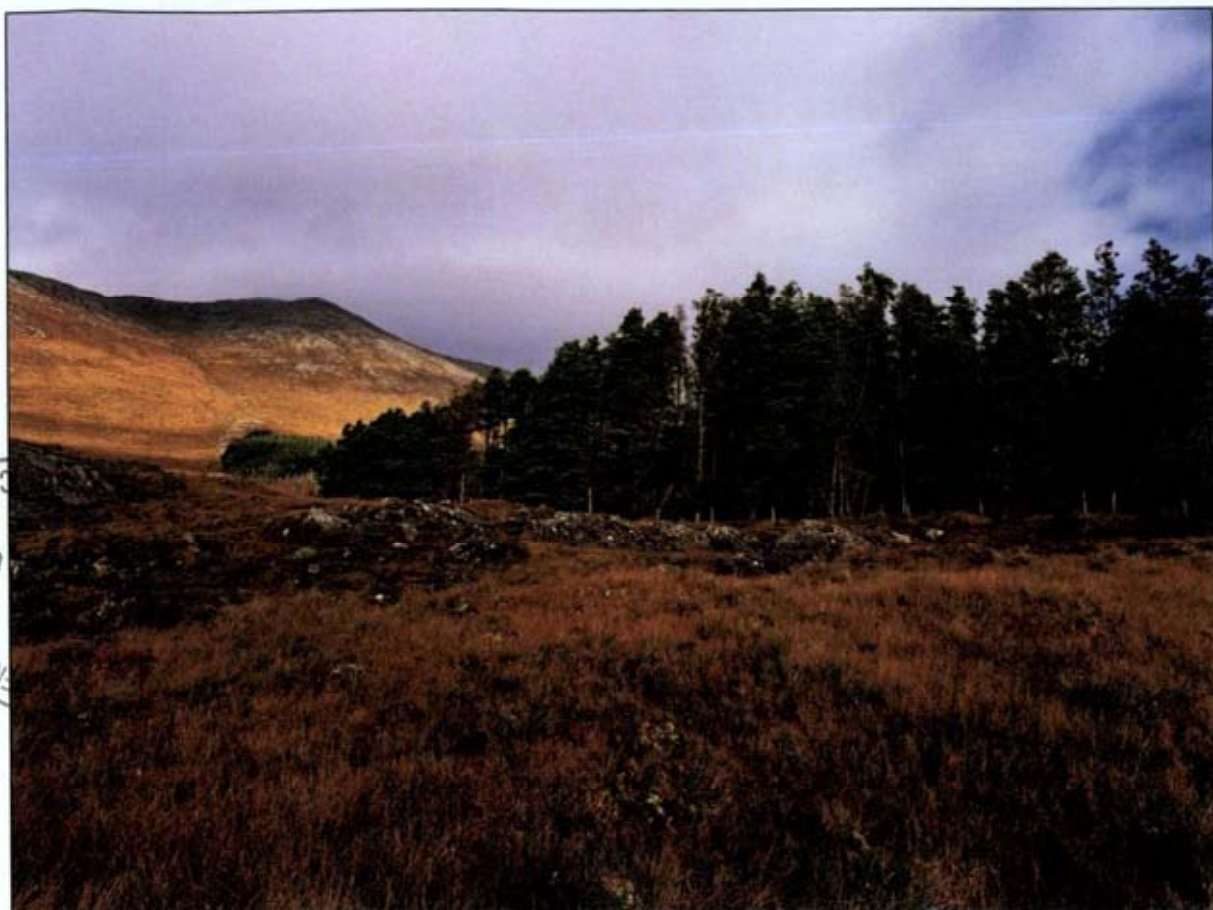
Relevé 7	Grid reference: E482344 N748836	Date: 15/11/2022
Species	Common Name	% Cover
<b>Vascular Plants</b>		
<b>Shrubs/Dwarf Shrubs</b>		
<i>Calluna vulgaris</i>	Ling heather	5
<i>Erica tetralix</i>	Cross-leaved Heath	3
<i>Myrica gale</i>	Bog Myrtle	5
<b>Herbs</b>		
<i>Molinia caerulea</i>	Purple Moor-grass	1
<i>Schoenus nigricans</i>	Black Bog rush	1
<i>Rhynchospora alba</i>	White-beak Sedge	50
<i>Eriophorum vaginatum</i>	Hare's-tail Cottongrass	8
<i>Eriophorum angustifolium</i>	Common Cottongrass	10
<i>Narthecium ossifragum</i>	Bog Asphodel	1
<b>Non-vascular Plants</b>		
<i>Sphagnum cuspidatum</i>		8
<i>Sphagnum papillosum</i>		5
<i>Pleurozia purpurea</i>		1
<i>Campylopus introflexus</i>		5
<i>Cladonia portentosa</i>		8
<b>Pools/Bare Ground</b>		5
<b>Peat Depth</b>		>1m
<b>Habitat Classification</b>	Lowland Blanket Bog (PB3)

Area comprises a mosaic of Wet Heath (HH3) with shallow peat and exposed rock and Lowland Blanket Bog (PB3) with deeper peats

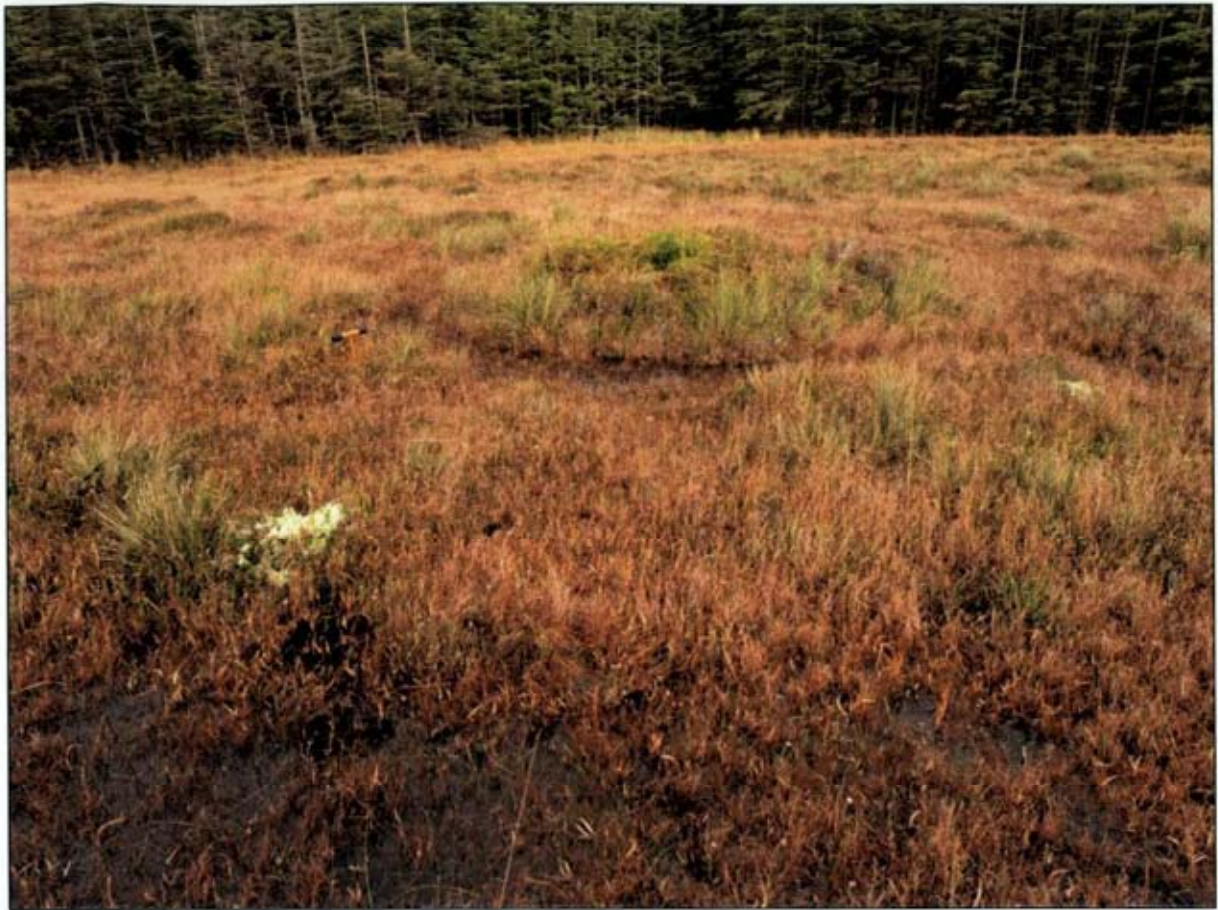
Relevé 8	Grid reference: E482514 N749163	Date: 15/11/2022
Species	Common Name	% Cover
<b>Vascular Plants</b>		
<b>Shrubs/Dwarf Shrubs</b>		
<i>Calluna vulgaris</i>	Ling heather	10
<i>Erica tetralix</i>	Cross-leaved Heath	5
<b>Herbs</b>		
<i>Molinia caerulea</i>	Purple Moor-grass	2
<i>Schoenus nigricans</i>	Black Bog rush	5
<i>Rhynchospora alba</i>	White-beak Sedge	10
<i>Eriophorum vaginatum</i>	Hare's-tail Cottongrass	5
<i>Eriophorum angustifolium</i>	Common Cottongrass	5
<i>Narthecium ossifragum</i>	Bog Asphodel	5
<b>Non-vascular Plants</b>		
<i>Campylopus introflexus</i>		25
<i>Sphagnum capillifolium</i>		25
<i>Cladonia portentosa</i>		5
<b>Pools/Bare Ground</b>		30
<b>Peat Depth</b>		>1m
<b>Habitat Classification</b>	<b>Lowland Blanket Bog (PB3)</b>

Area of intact and quaking blanket bog with regular pools and high coverage of Rhynchospora

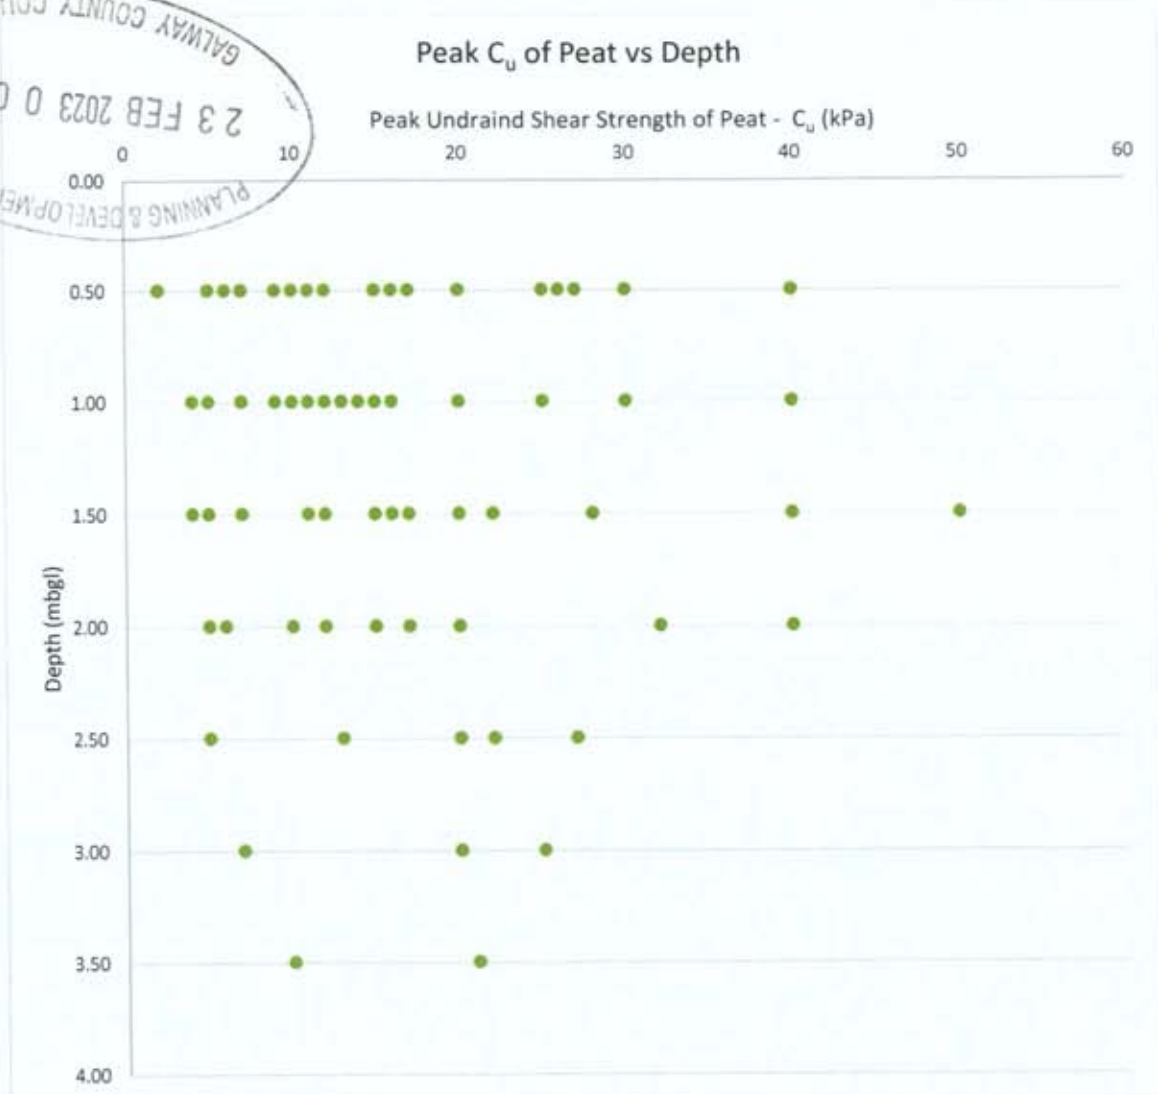
Figure 5-1: Peak Undrained Shear Strength ( $c_u$ ) Profile for Peat with Depth

In addition to probing, in-situ shear vane testing was carried out as part of the ground investigation. Strength testing was carried out at selected locations across the site to provide representative coverage of indicative peat strengths. The results of the vane testing with depth are presented in Figure 5-1.

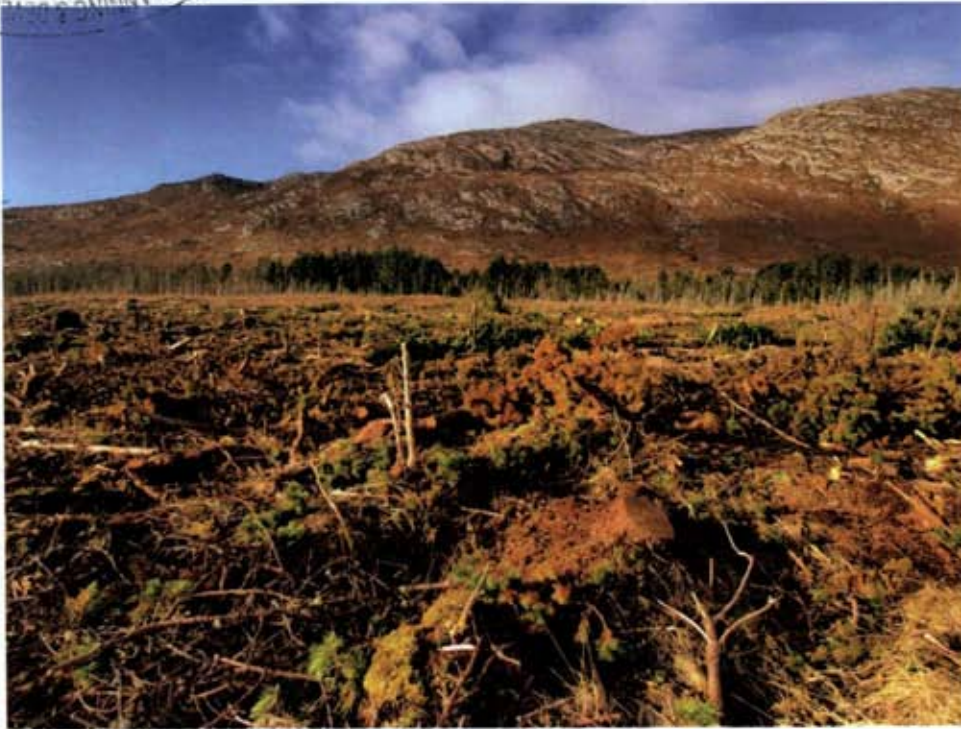
PP018 (view W)

General Photos from Restoration Harvest Block GY27\_3\_09

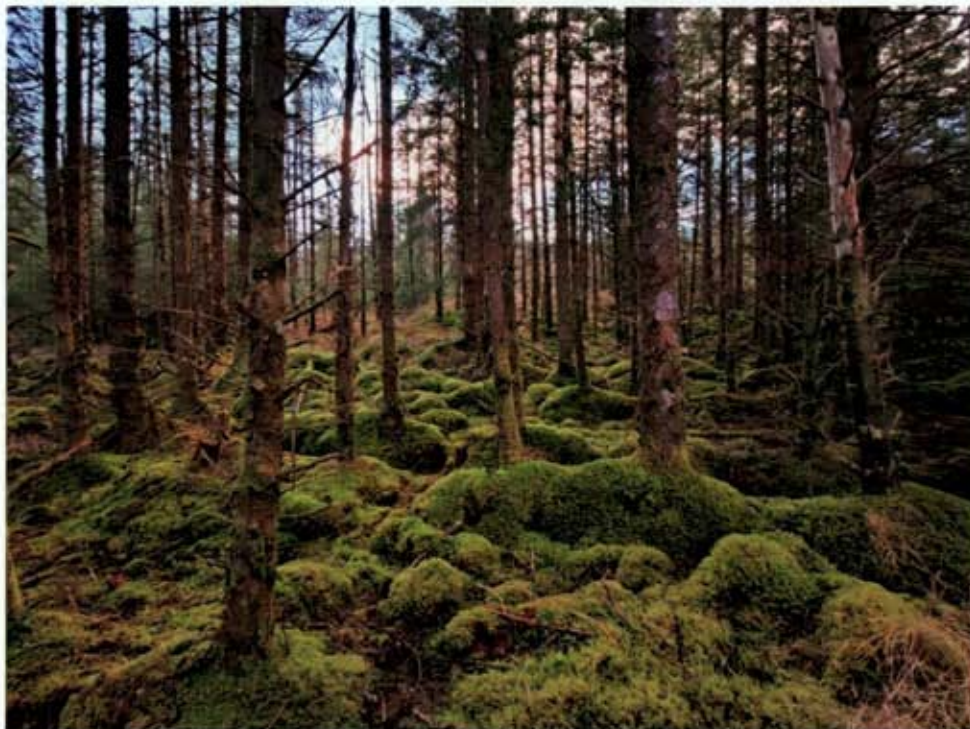
PP042 (view S)

General Photos from Restoration Harvest Block GY27\_HB0009

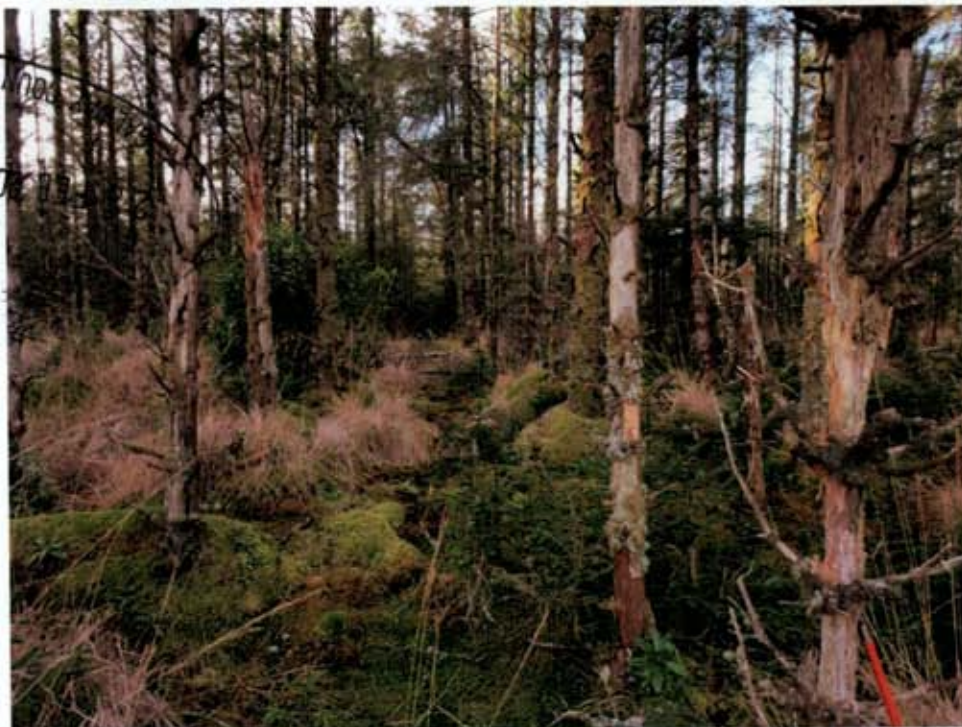
PP041 (view West)

General Photos from Restoration Harvest Block GY27\_HB0011

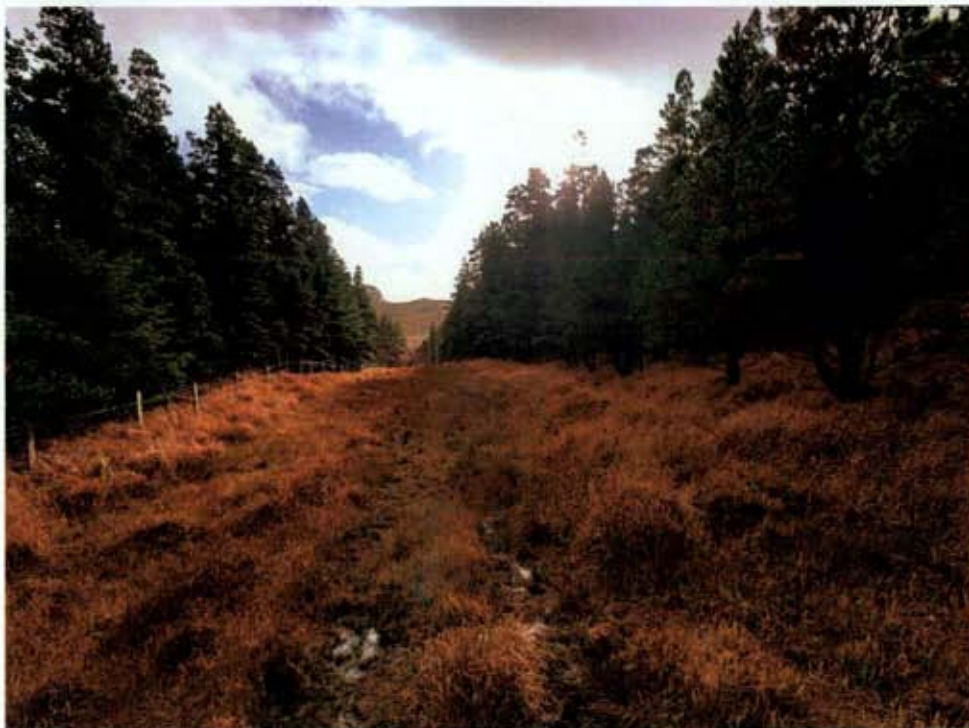
PP031 (view S)

General Photos from Restoration Harvest Block GY27\_HB0012

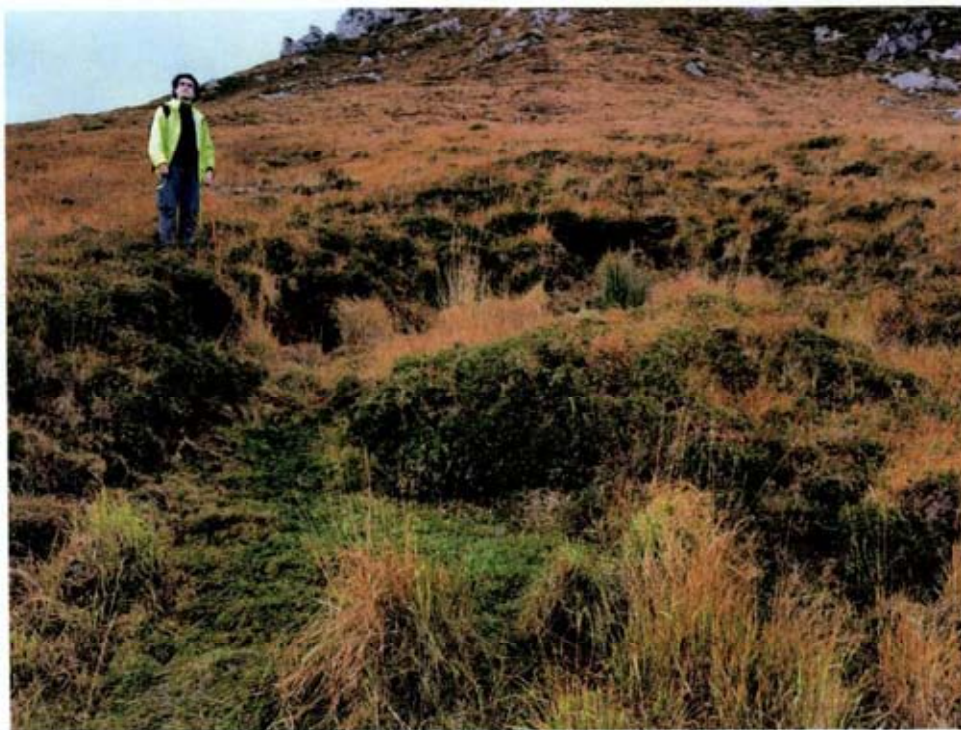
Photo of POI008 Historic Peat Landslip – view W towards backscarp face.

The calculated FoS for load condition 2 is in excess of 1.30 for each of the peat probe locations (72 no. locations), with the exception of peat probe location POI008, which gave a undrained FOS of 0.89. POI008 represents an isolated historic peat failure, which is located outside of the RHB and shows no sign of recent instability. The remaining locations were analysed with a range of FoS of 1.40 to 8.02, again indicating a low risk of peat instability with respect to the RHBs and access roads.

Note 2 – this peat failure is deemed to be a shallow (<1m) and isolated occurrence, which will have a negligible impact on the proposed rehabilitation works. It will therefore be discounted from any further assessment.

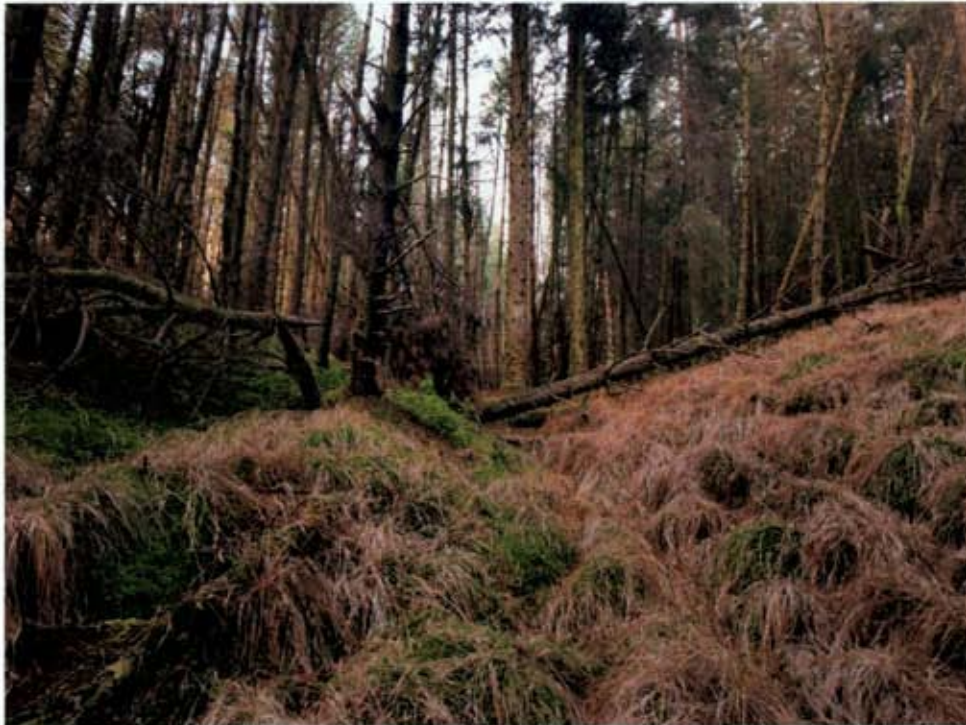
PP024 (view N)

General Photos from Restoration Harvest Block GY27\_HB0013

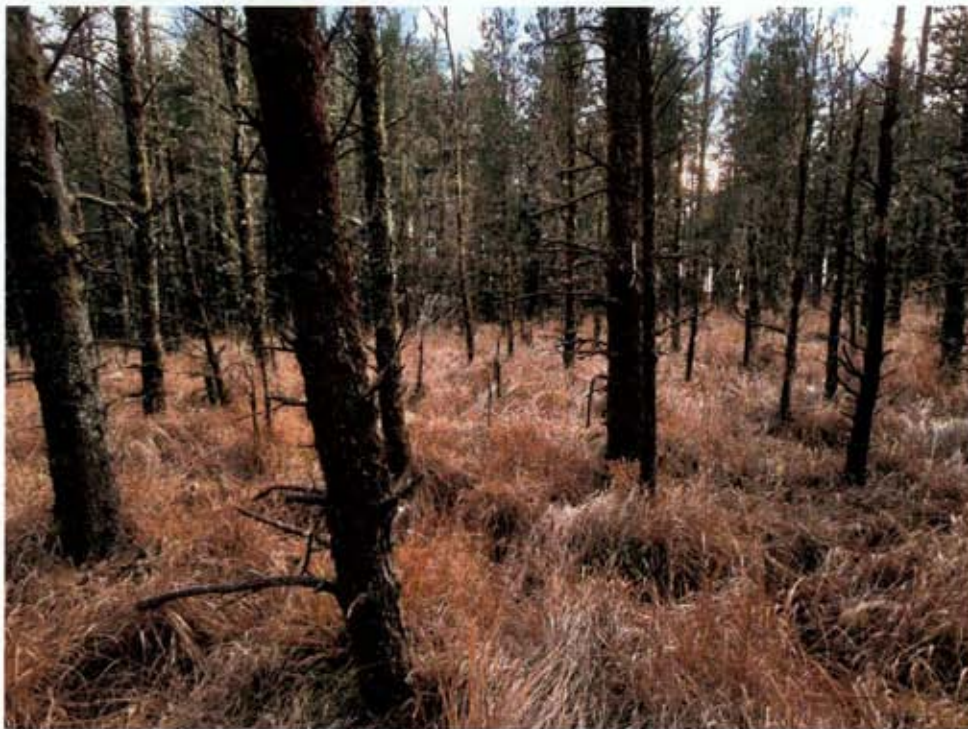
PP011 (view S)

General Photos from Restoration Harvest Block GY27\_HB0015

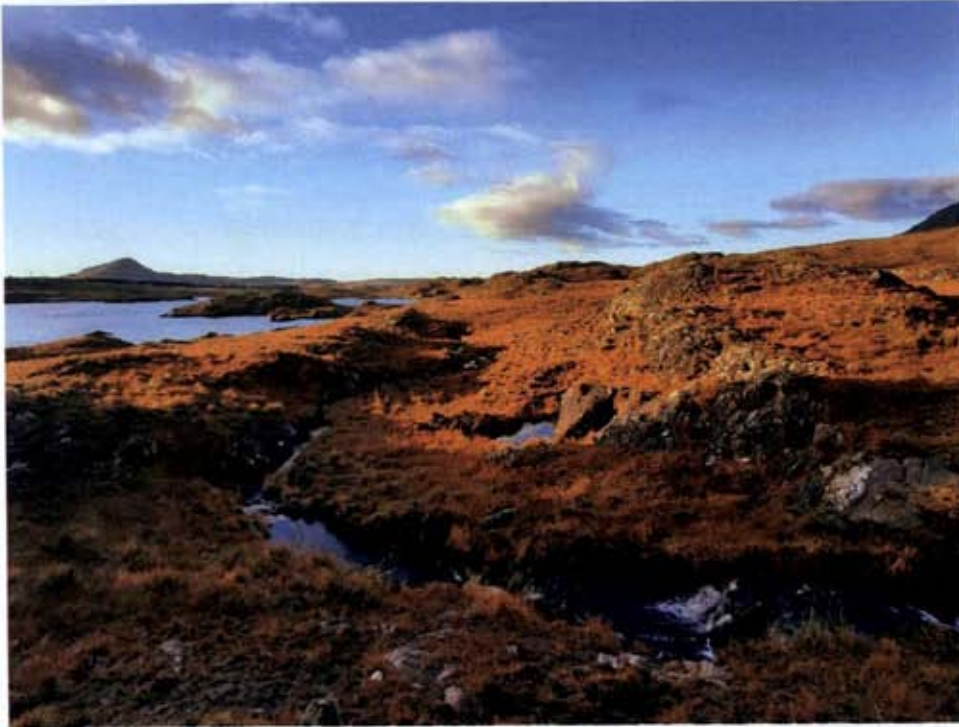
**PP003 (view W)**

**General Photos from Restoration Harvest Block GY27\_HB0017**

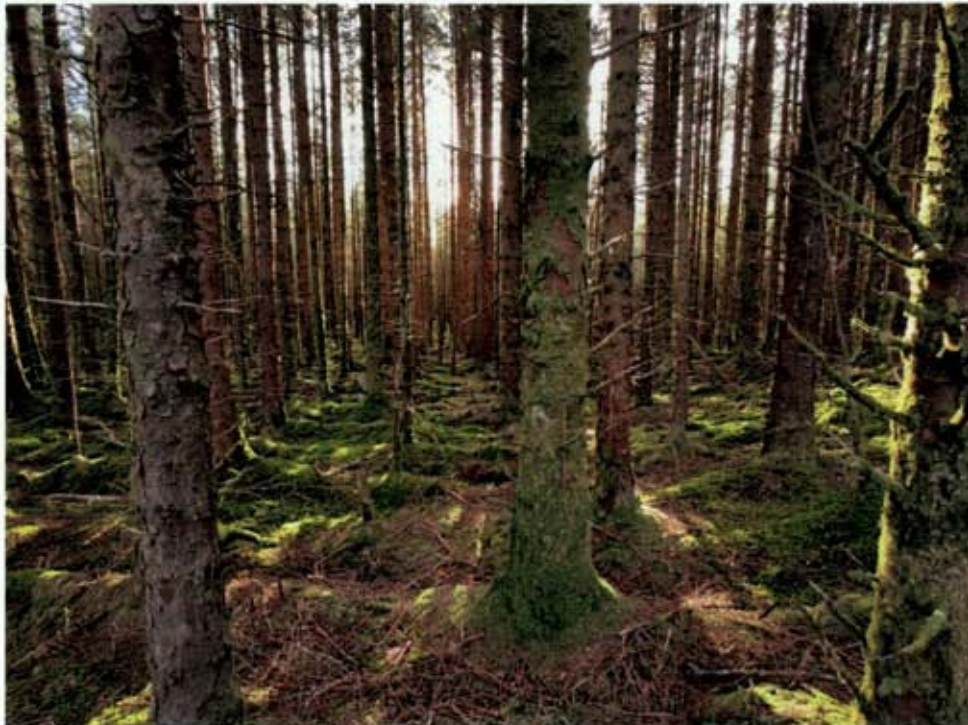
PP040 (view N)

General Photos from Restoration Harvest Block GY27\_HB0018

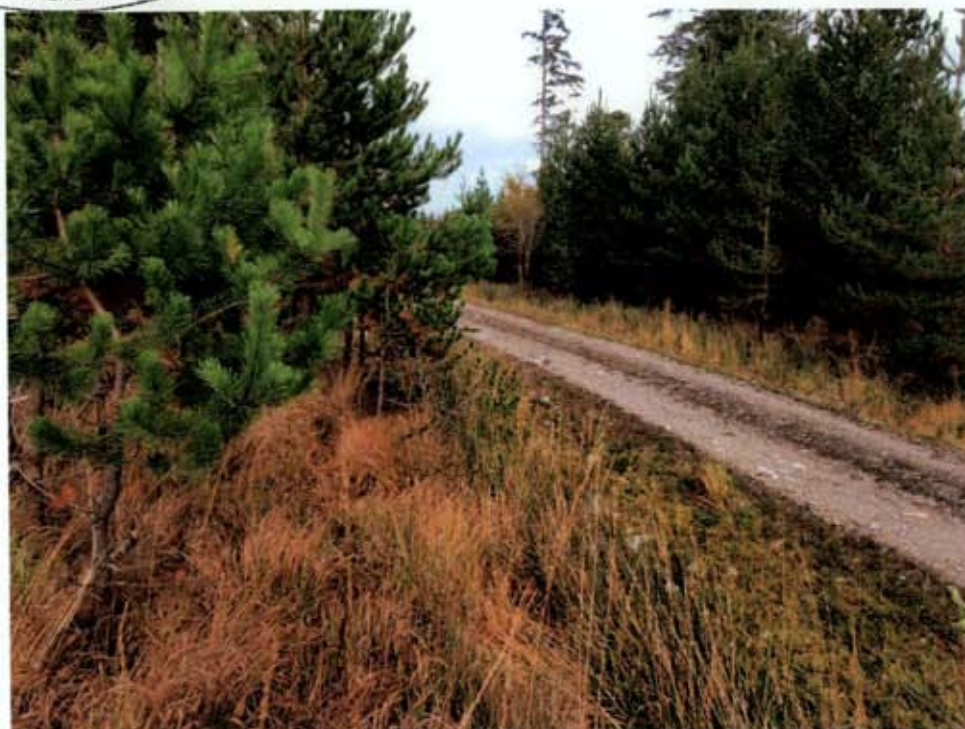
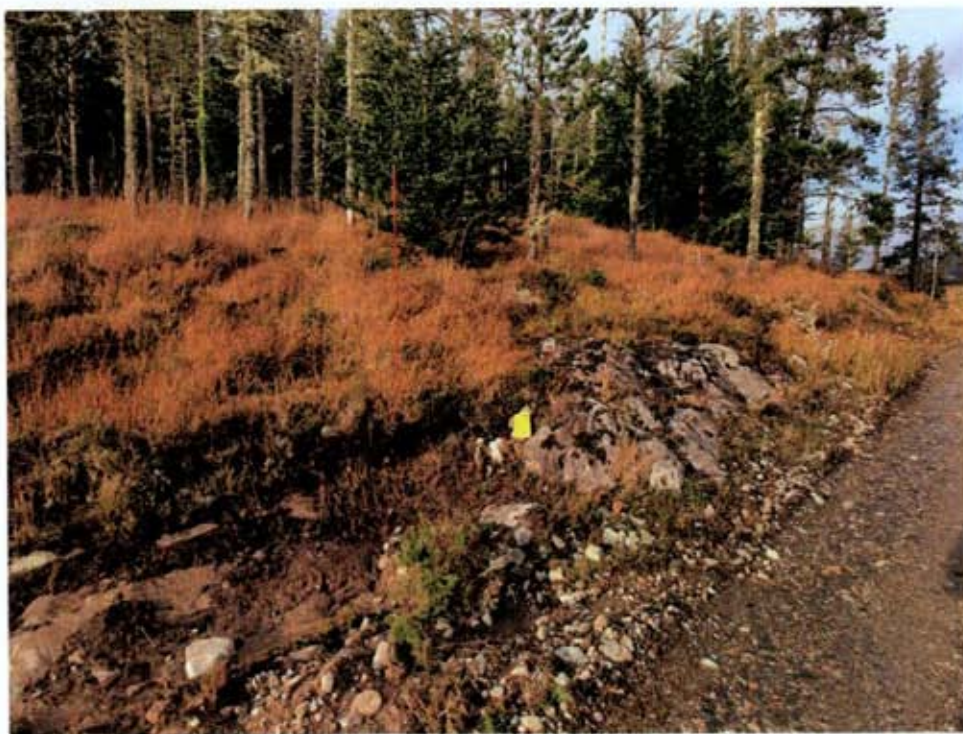
PP016 (view N)

General Photos from Restoration Harvest Block GY27\_HB0020

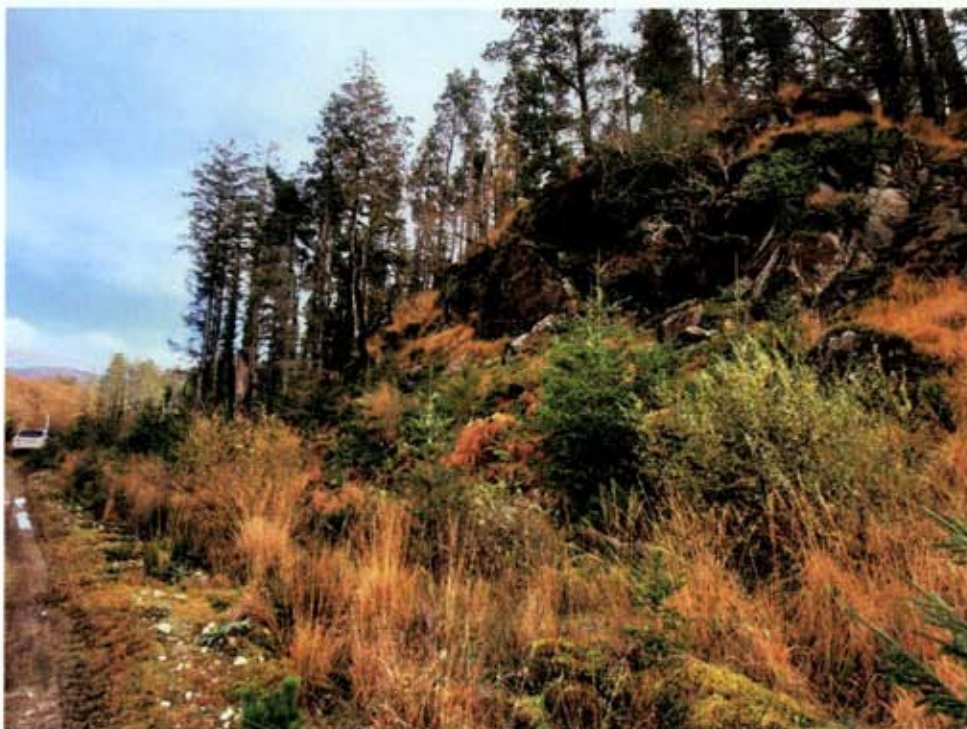
PP006 (view NE)

General Photos from Restoration Harvest Block GY27\_HB0024

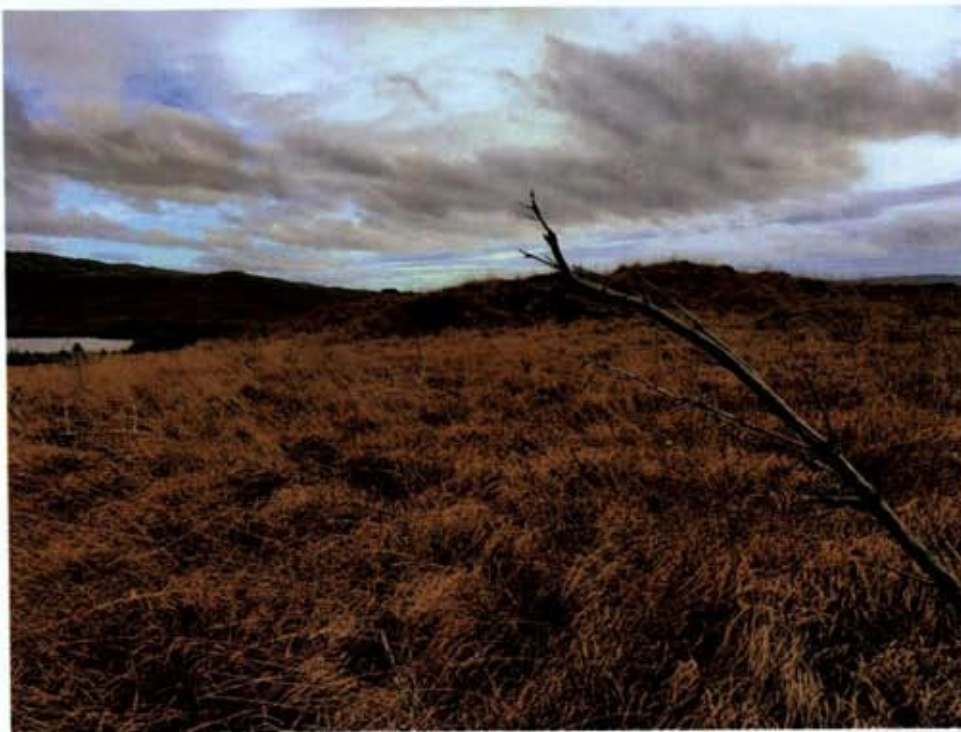
PP073 (view E)

General Photos from Restoration Harvest Block GY27\_HB0027
