## MONITORING PROPOSALS

All monitoring proposals relating to the pre-commencement, construction and operational phases of the Proposed Project are set out in the relevant chapters of the Environmental Impact Assessment Report (EIAR).

This section of the Construction and Environment Management Plan groups together all of the monitoring proposals presented in the EIAR. The monitoring proposals are presented in Table 6-1 below.

# Ecological Report- Derryclare

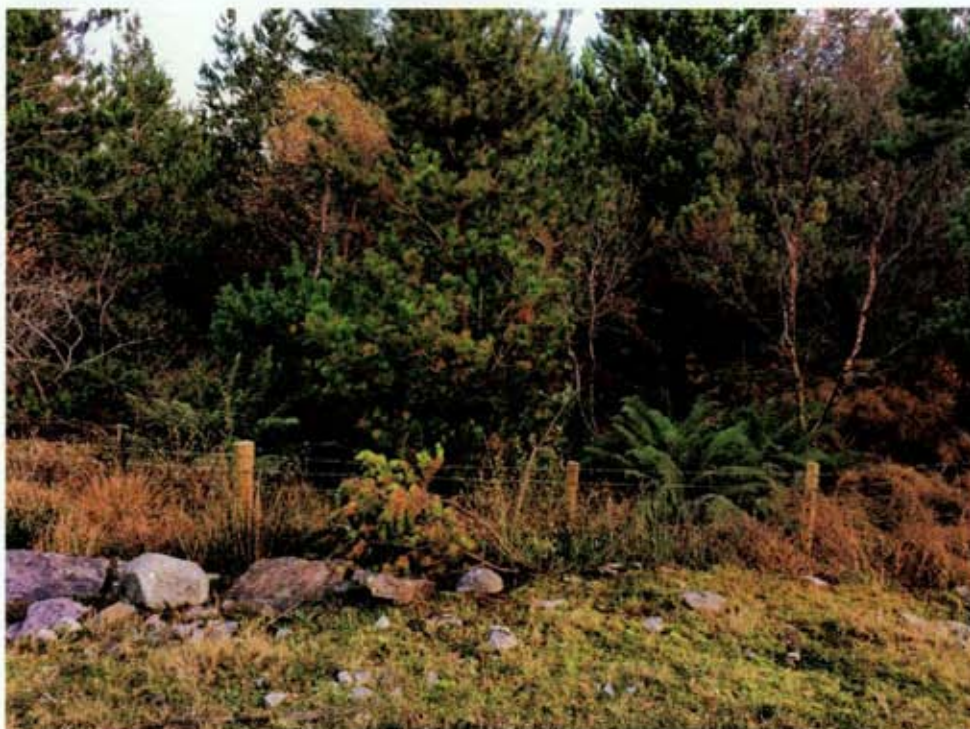
PP067 (view E)

General Photos from Restoration Harvest Block GY27\_HB0028

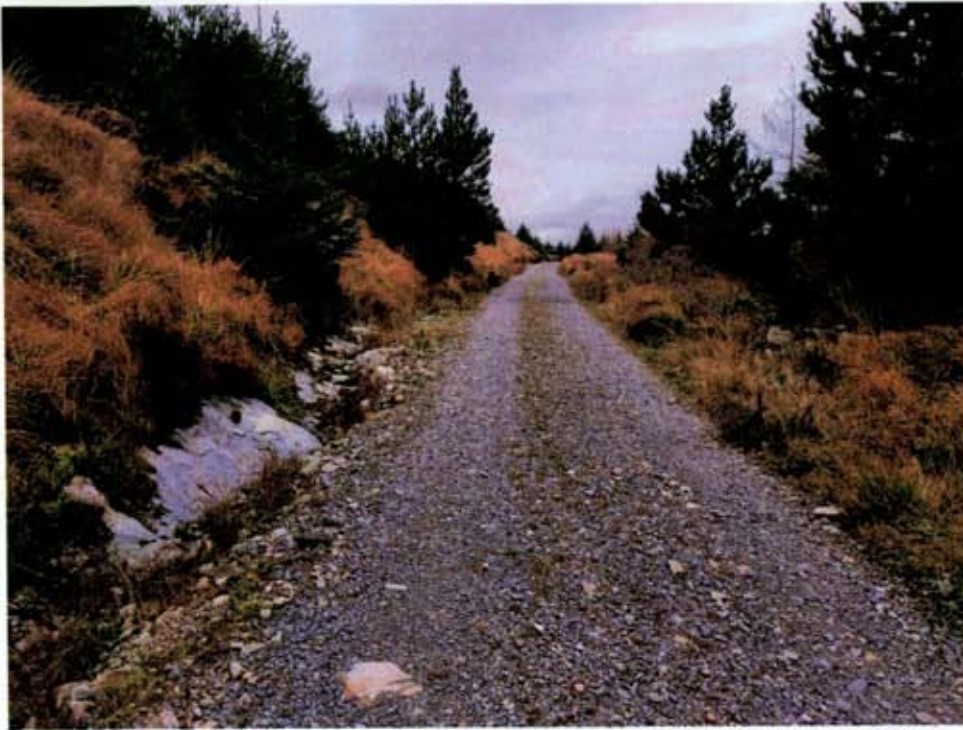
General Photos from Existing Access Road GY27R0025  
PP055 (view N)

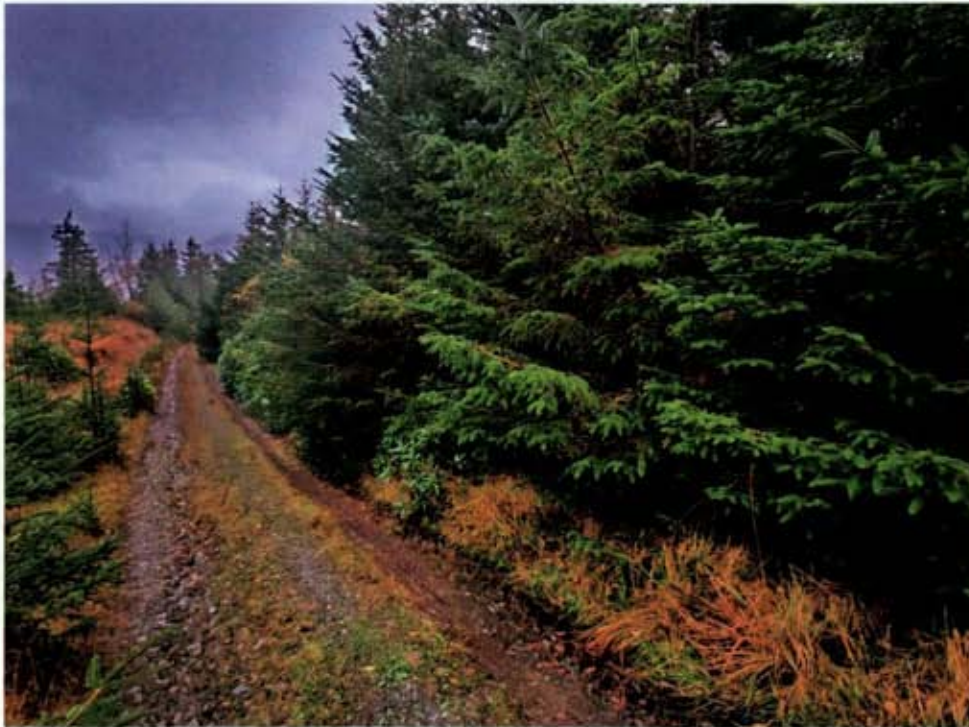
PP063 (view E)

General Photos from Existing Access Road GY27R0026

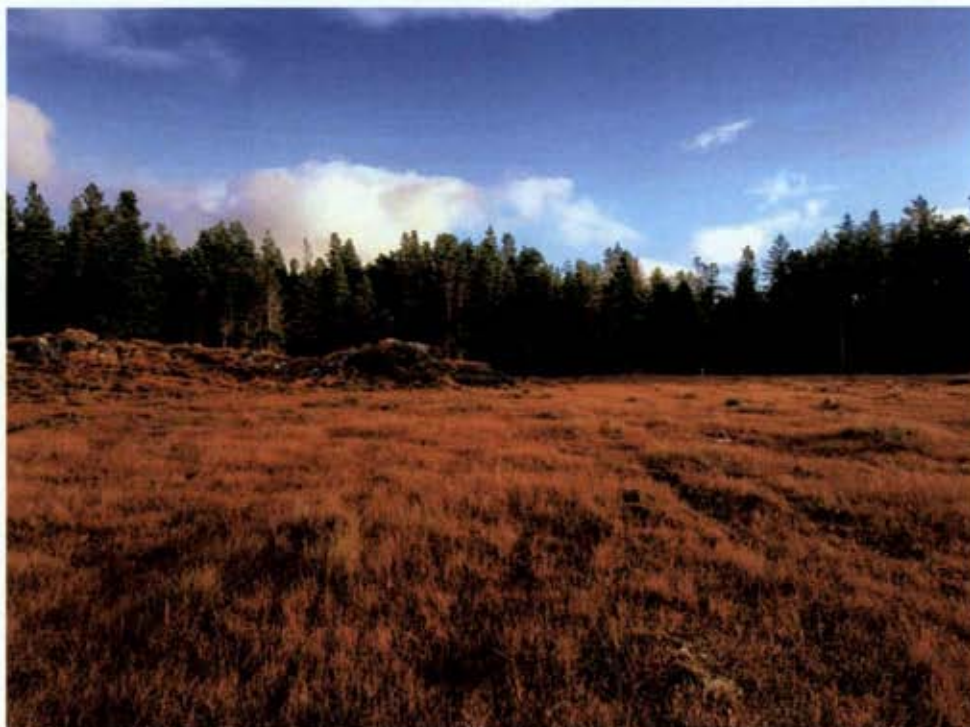
PP001 (view E)

Flat peatland area between RHBs GY27\_HB0016 and GY27\_HB0017

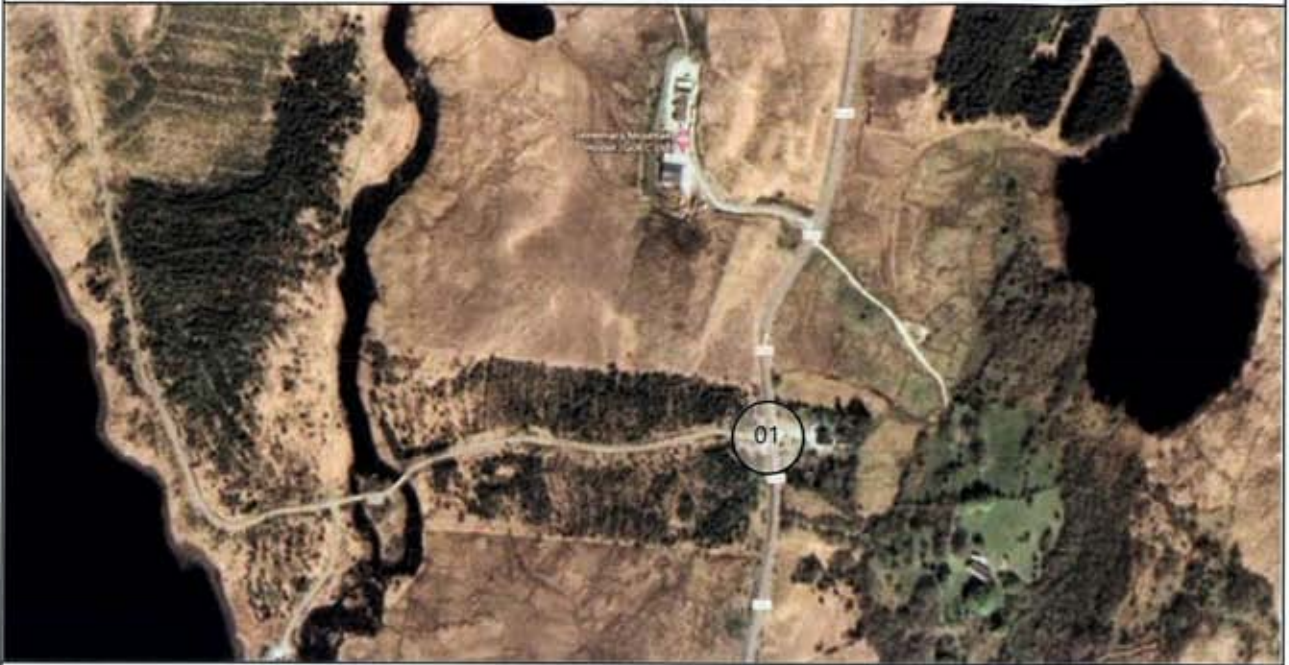
## Site Location

Job number: TRA/23/008	Job Date: 12 <sup>th</sup> January 2023	Drawing No: TRA/23/008-01	traffinomics 
	Client: Alan Lipscombe	Job Day: Thursday	Author: SPW
