Dunkellin River and Aggard Stream Flood Relief Scheme

Architectural heritage and conservation report on completed works at Dunkellin and Craughwell bridges which are protected structures. Final Report March 2022

March 2022

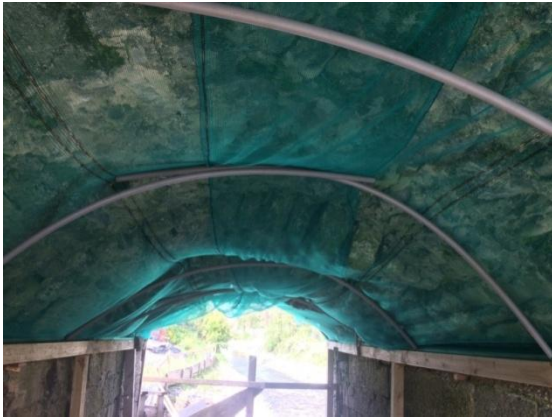
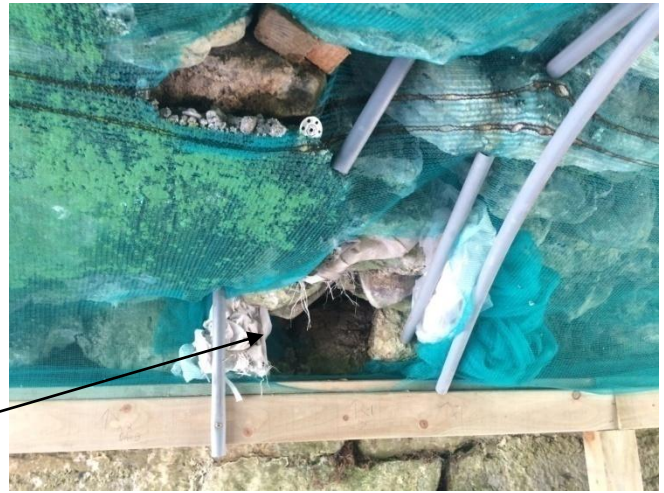
Photographs from August 2019

Netting was erected below the vaults to prevent roosting by bats and birds except where nests or roosts were already established (as in arched vault D) where access to nests was left open for as long as they were being used.

Netting also served to catch any debris which might fall during works.

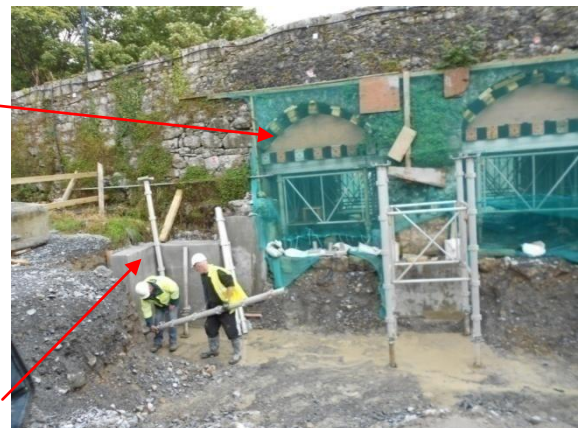
Substantial timber props were inserted to ensure stability of the structure during works. It was imperative that vibration or any disturbance to the existing structure was kept to an absolute minimum in order that historic fabric would not be lost, including the medieval wicker centring. In this photograph deepening of the river channel has been done downstream of the bridge but lowering of the bed below the bridge itself has not begun. Building of concrete retaining walls at the abutment is underway.

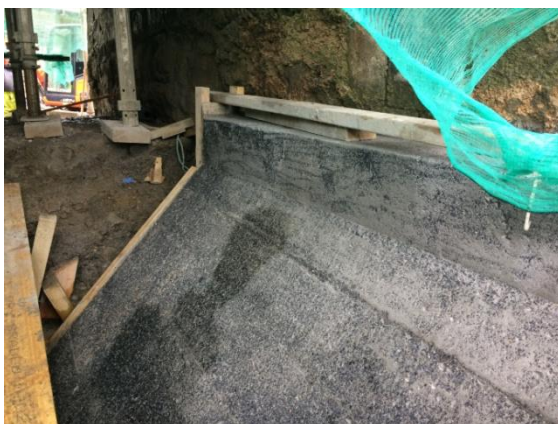
Photograph from Sept 2019 ↓

Excavation below arches E and F has been completed and a section of the concrete 'V' apron is in place.

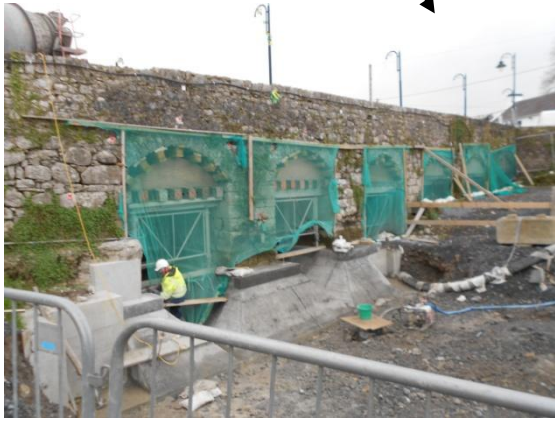
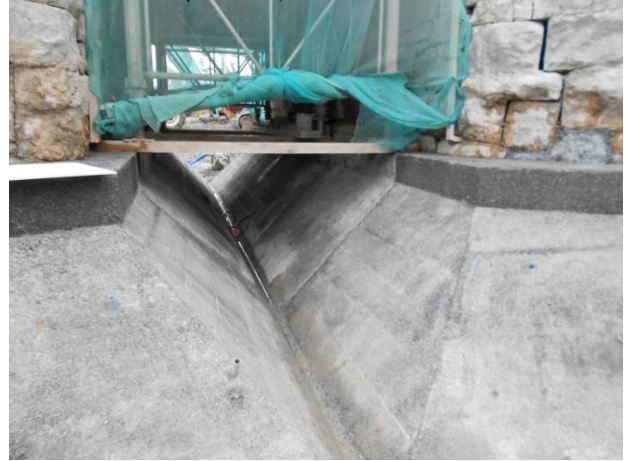
Photographs from October 2019

*Downstream view, arches E and F in foreground.
Concrete 'V' aprons are complete under arch vaults E and F and in-situ concrete aprons to base of piers to provide scour protection.*

Detail view of concrete apron.

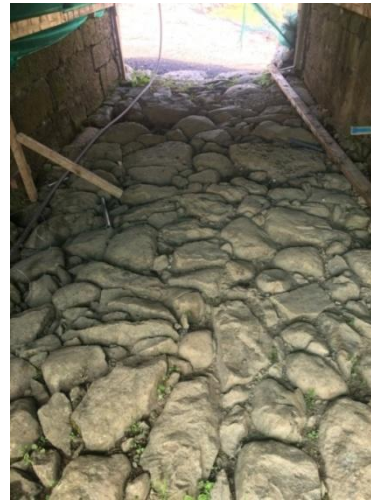
Photograph from April 2019 of floored river bed below arch vault C. Probable c.1780 date.

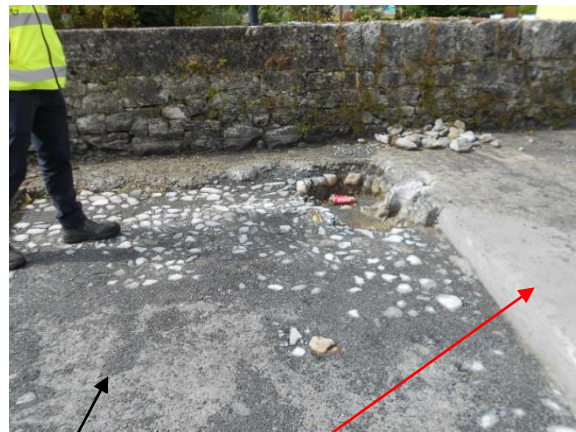
Skim layer of concrete over cobbles over arched vaults and mass concrete over the abutments

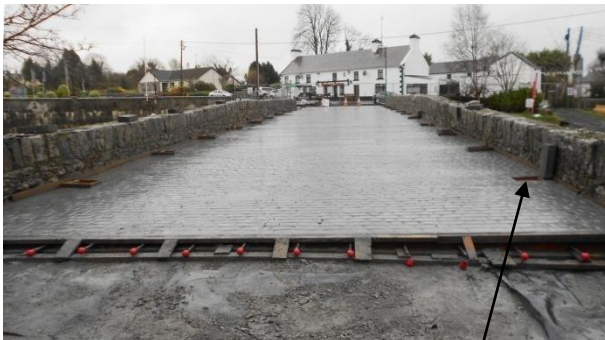
View of new surface in Nov 2019. Rectangular formwork around 'holes' in the surface mark the location of the supports for the temporary protection.

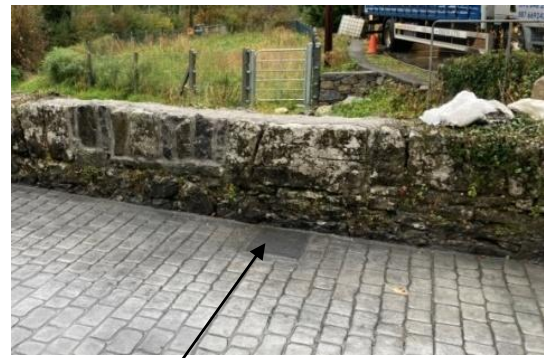
'Holes' were subsequently filled in in matching material.

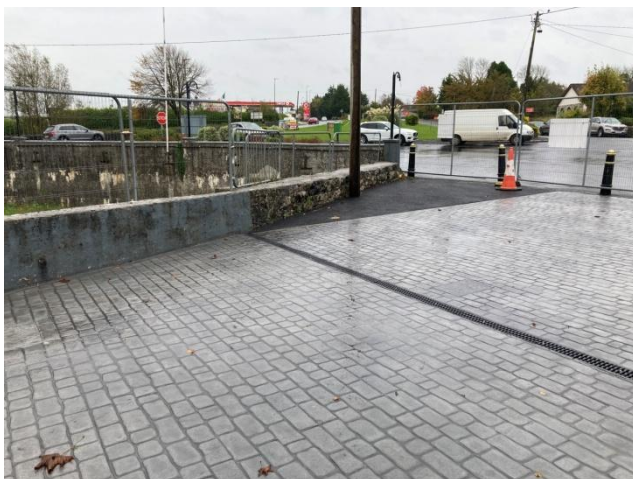
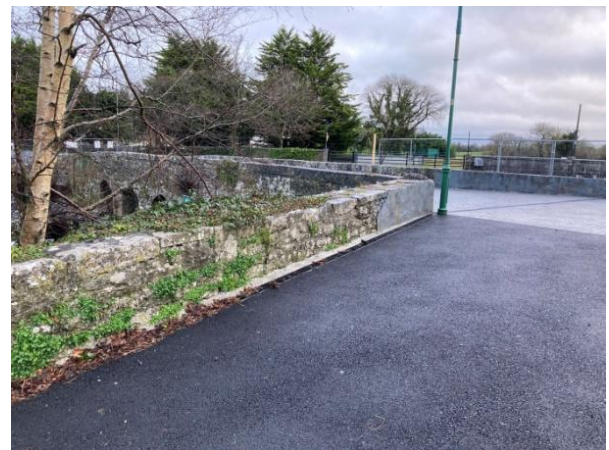
Views of the south end of the bridge deck show the new imprinted concrete surface following the line of the old road, with tarmac infill either side.

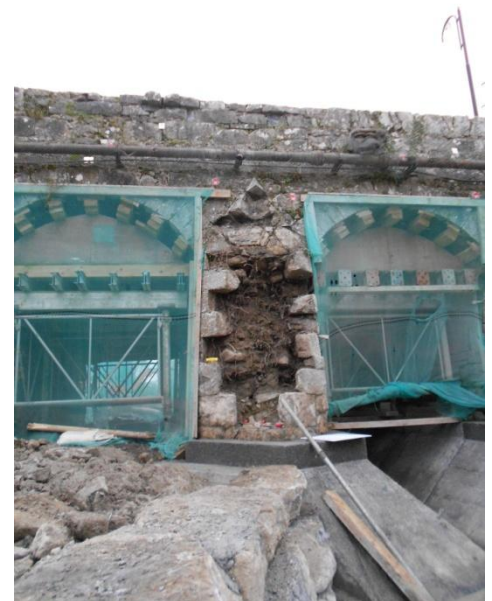
30 October 2019 general and close-up view of cutwater D/E following dismantling.

Stones were numbered prior to dismantling and re-erected in their original positions. Some stones had suffered damage with pieces spalled off and arrises no longer sharp but flaws were accepted and new stone was not introduced. During rebuilding of cutwater D/E the core of the cutwater was filled with a concrete mix as work progressed. This was accepted due to the difficult conditions and time constraints on the job, and because, due to the hard nature of the limestone, the use of cement should not be detrimental to the stonework.

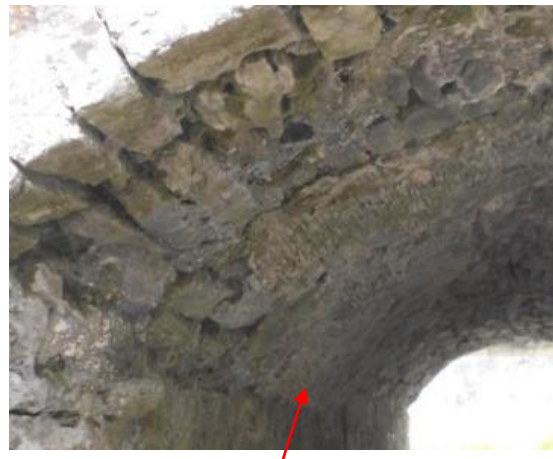
Closer view of wicker centring

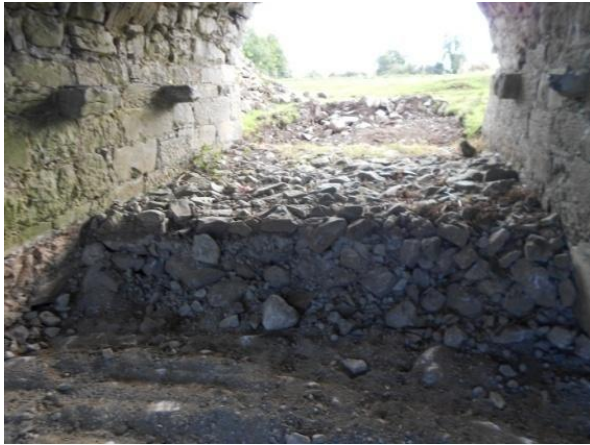
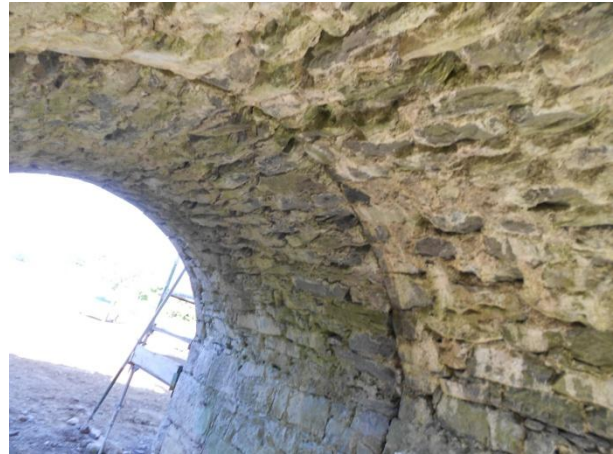
*Photographs taken 10 August 2018
Accumulated material on arch floor being removed.
Joint between earlier and later construction clearly visible on underside of the vault.*

*17th and 18th century flooring exposed following
removal of accumulated material.*

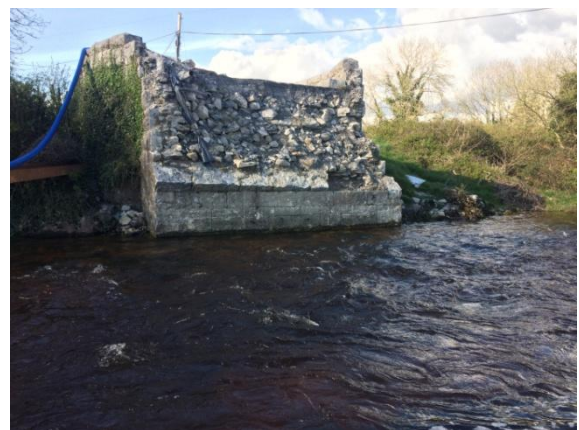
Photographs taken April 2019. Views of northern side of Arch F abutment following collapse. Note that the curved wall where the road narrowed at the bridge abutment survived. It was considered important that this example of skilled 19th century stone craftsmanship be preserved and this was done. Suggestions of widening the bridge which would have involved the loss of this element were rejected as not in line with good conservation practice.

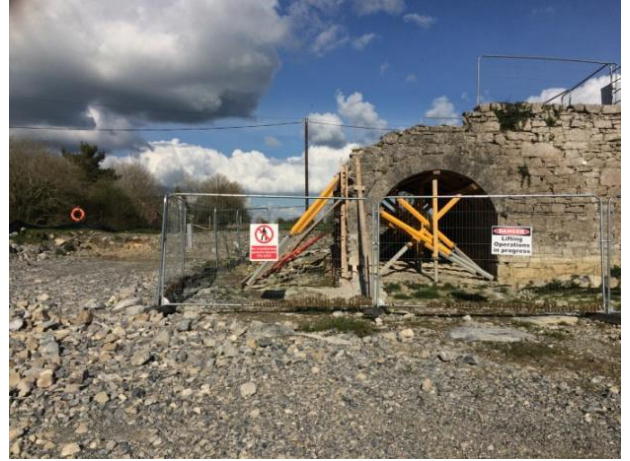
Arch D is shored after the collapse.

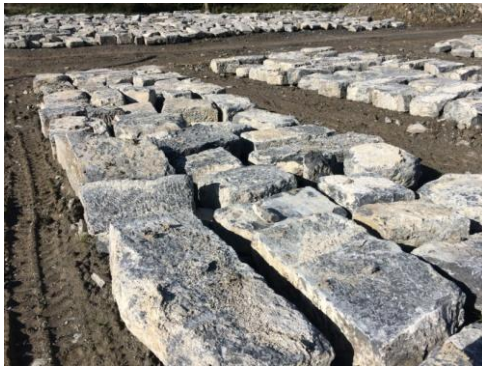
*Photographs taken April 2019. Comprehensive careful
sorting of stone was undertaken following the collapse.*

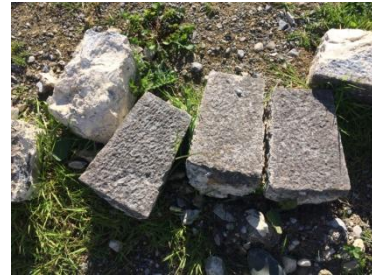
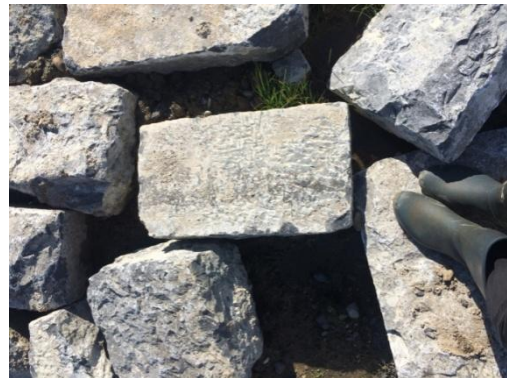
*Photographs taken July 2019.
Sample panels of stonework were erected for
approval in preparation for building of stone cladding.*

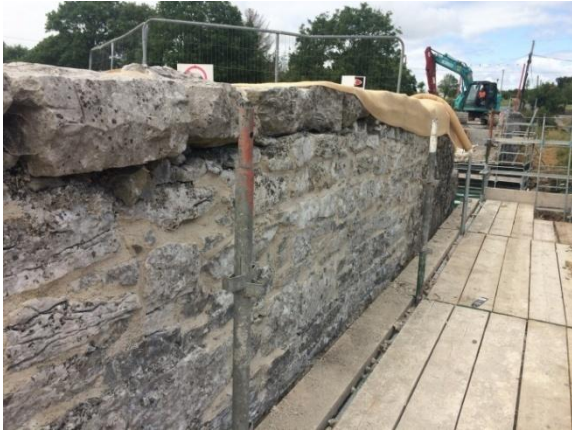
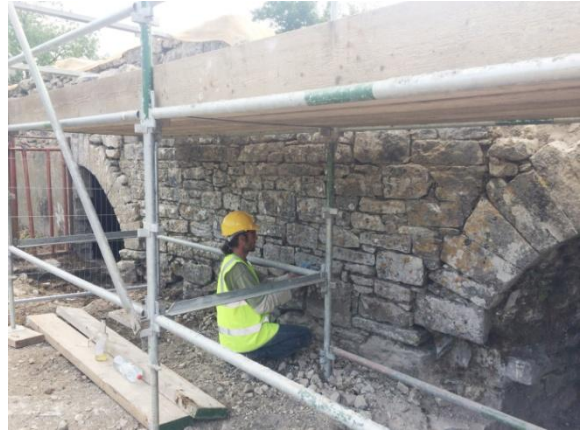
July 2019, re-pointing and raking out in progress on different parts of the upstream side of the bridge.

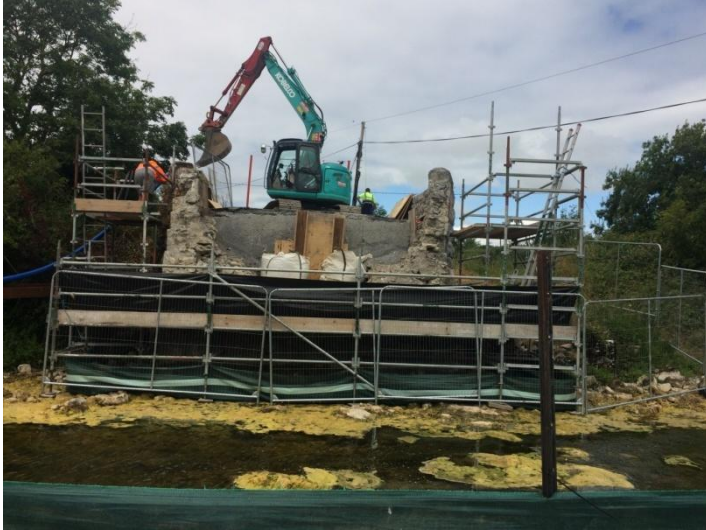
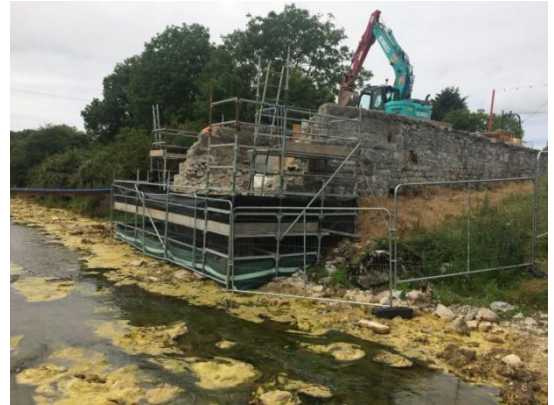
July 2019, preparatory work underway for new concrete support at northern abutment.

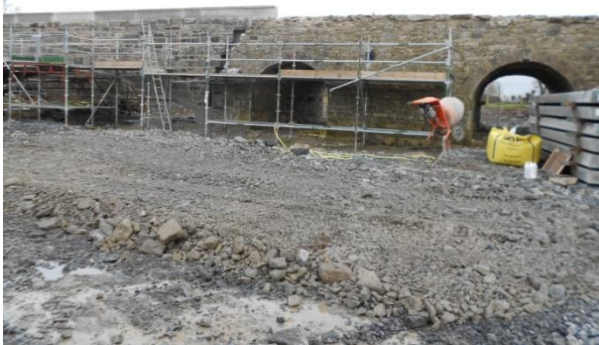
General view of downstream face, arches D and C

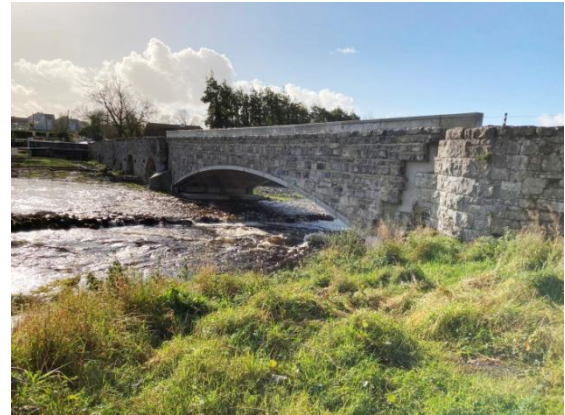
General view from north end, upstream side. The retained curved wall detail enhances the composition, confirming the decision to reject the possible option to increase the width of the bridge following the collapse.

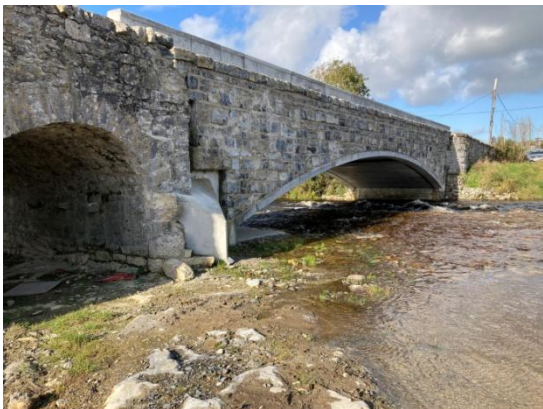
Upstream view from south with new concrete cutwater at arch D in foreground

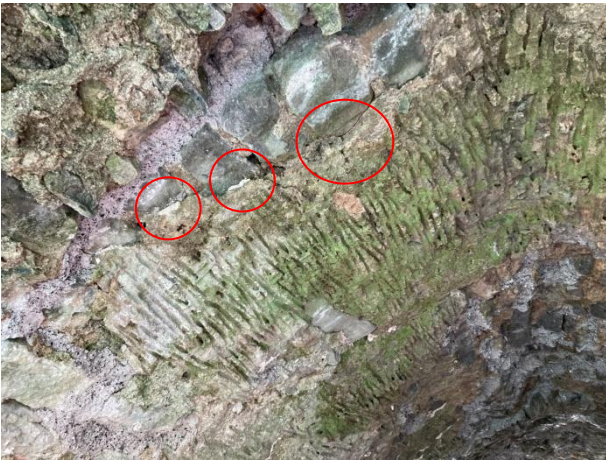
*View looking upstream
Fine mortar mix was injected behind the wicker centring to re-adhere it to the background stonework. New mortar is just visible at the edge of the wicker (circled red)*

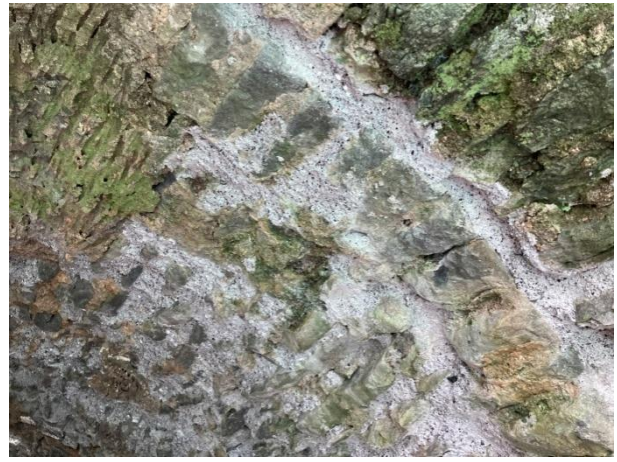
*View looking upstream
General consolidation of vault stonework using pinnings and coarse mortar mix.*

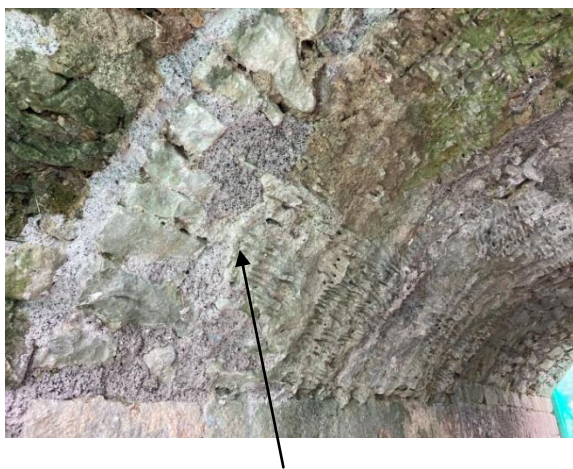
Looking upstream, consolidation of wicker edges and general consolidation of stonework

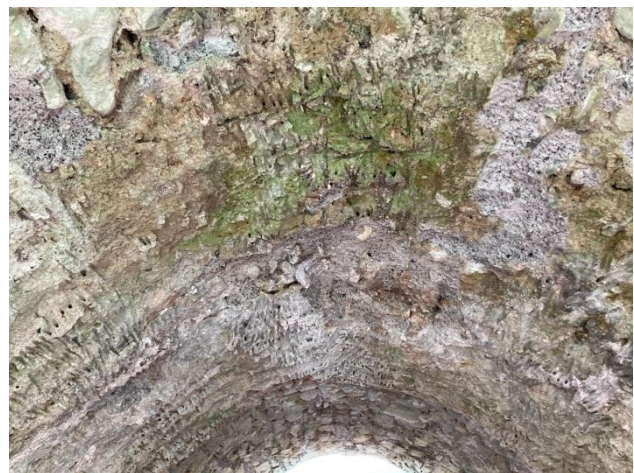
Further views looking upstream. Some loss of wicker noted on this side compared to extent recorded in April 2019

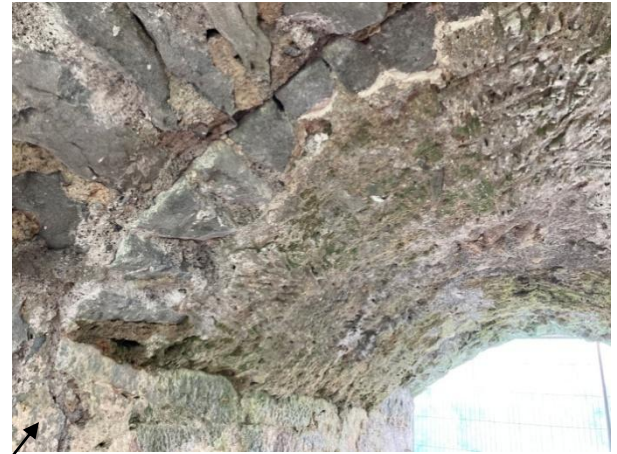
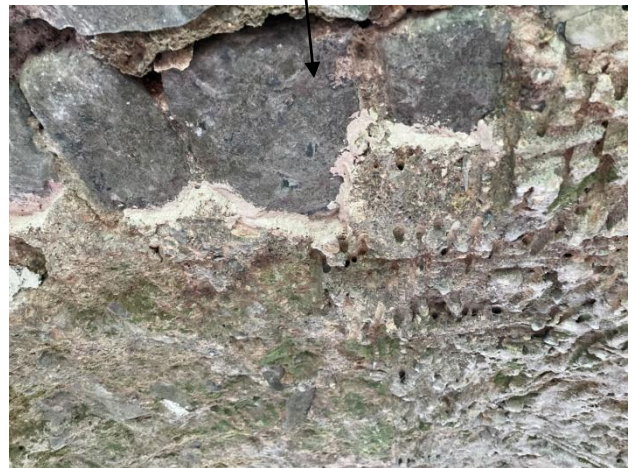
Close-up views of consolidated edges of wicker

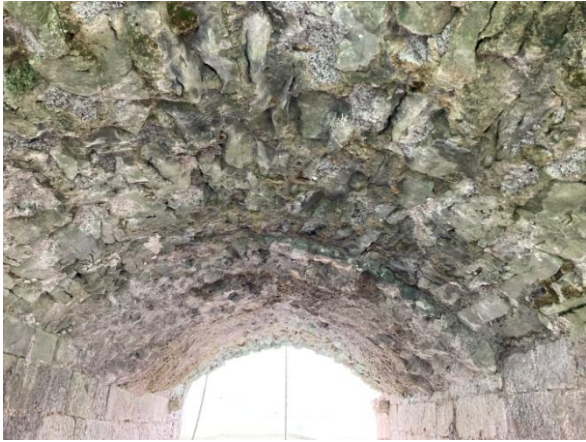
Looking downstream - large area of wicker intact.

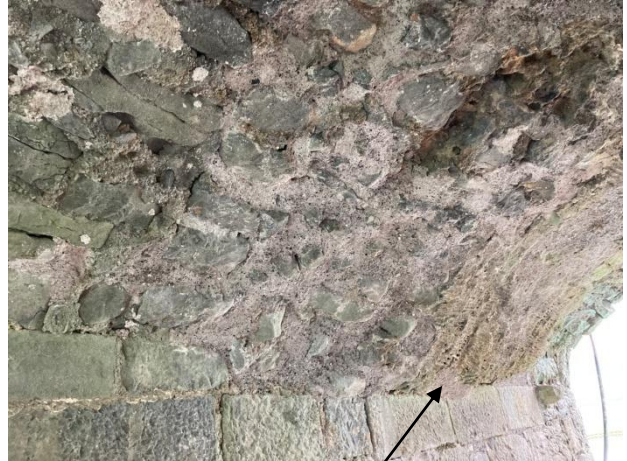
Looking downstream. General consolidation not complete at vault edges (see foreground of photo) as sealing of bridge deck was not completed in November and water was coming through the structure in large quantities in these locations preventing the placing of mortar.

moderate wetting/drying cycle can be established in these parts of the bridge fabric. Consolidation of these areas should be completed when conditions allow.

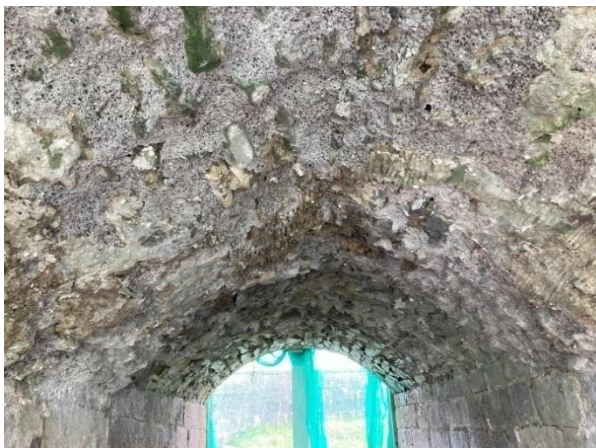
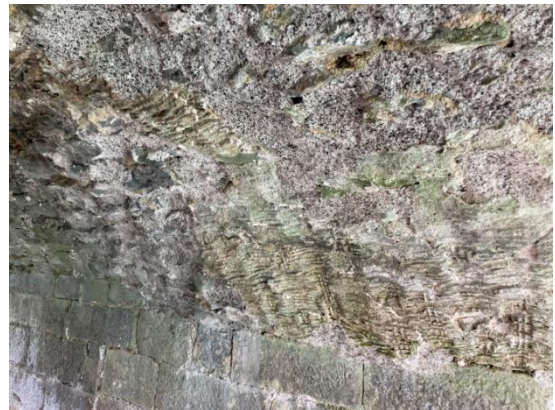
Looking upstream - views of general consolidation of stonework

Consolidation of the vault stonework consisted of the tightening of loose stones by inserting wedges of suitable stone pieces and the vigorous throwing and securely pushing back of coarse mortar into joints between stones.

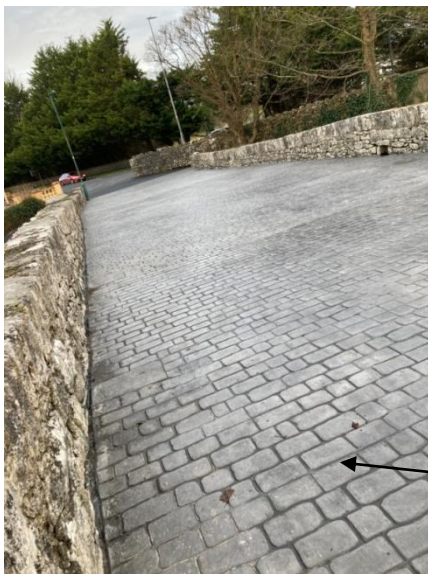
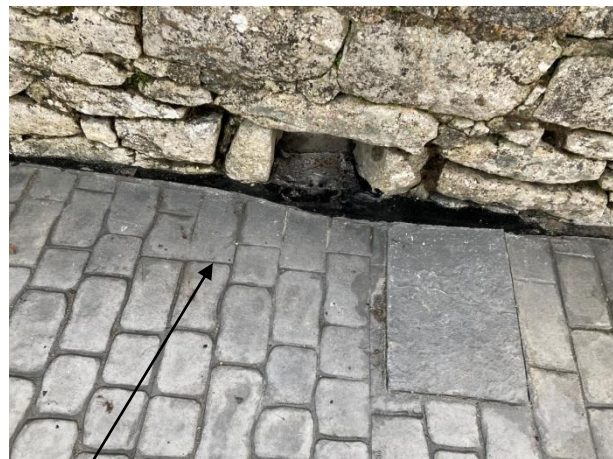
Photographs Dec 2020 *Showing completed sealing of the bridge deck/parapet wall junction.*

*View of sealed joint at an outlet in parapet wall.
General view on joint at west parapet wall.*

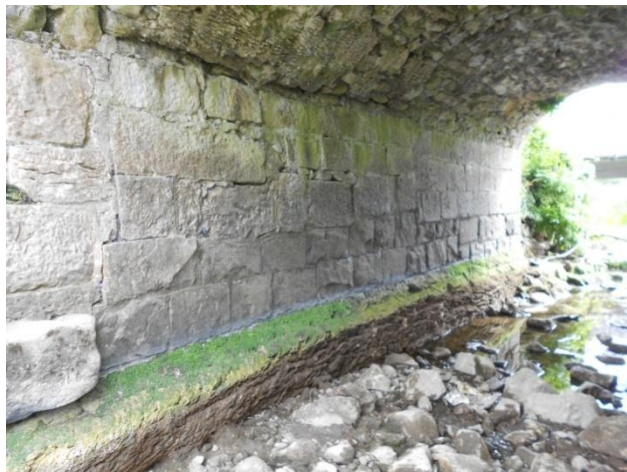
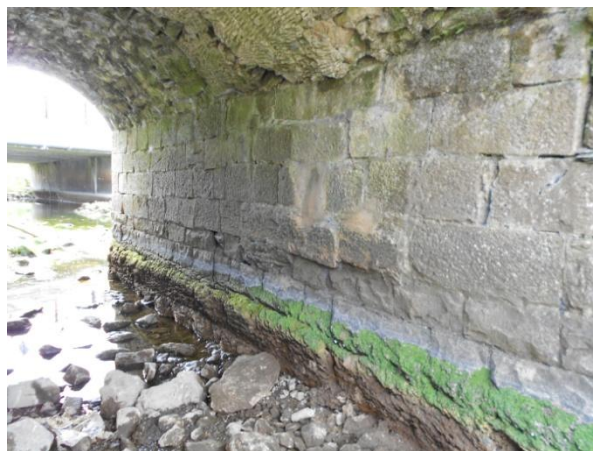
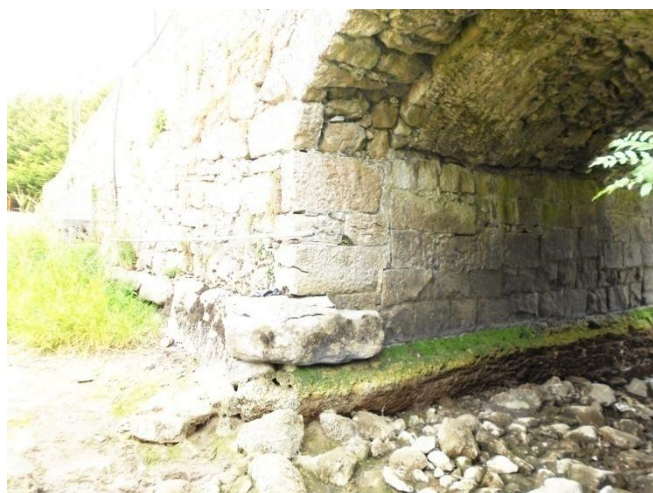
Arch F

Record of arches D, E and F. Photographs taken 19 Jul 2018.
